## MSP430F5632 Device Erratasheet

The revision of the device can be identified by the revision letter on the [Package Markings](#) or by the [HW\\_ID](#) located inside the TLV structure of the device

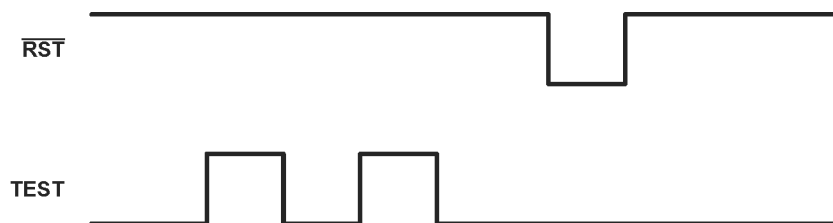
Note: This toggling of TEST pins is not subject to timing constraints. The appropriate level transitions on TEST pin, followed by a RST pulse after 50us, are sufficient to trigger an exit from BSL mode.

**Workaround** To exit the BSL one of the following methods must be used.

- A Power cycle
- or
- Toggle the TEST pin twice when nRST is high and after 50us pull nRST low.
