# **AM1808 ARM Microprocessor Silicon Revisions 2.3, 2.1, 2.0, and 1.1**

## **Silicon Errata**

Literature Number: SPRZ313H  
March 2010–Revised September 2014

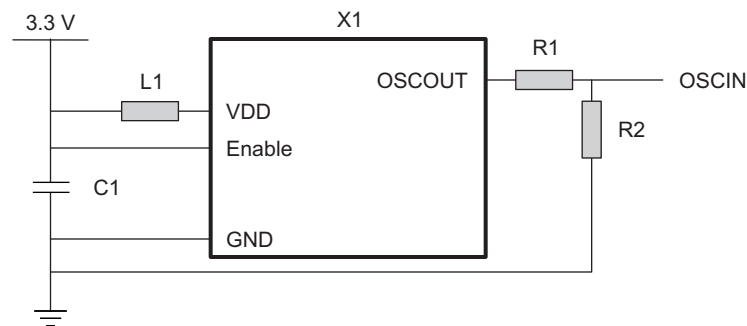
**Figure 2. External 3.3V Clock Source**

On all silicon revisions, certain design elements make this device susceptible to radiated noise during an ESD strike, as described in the standard IEC 61000-4-2. Exposure to the electrical noise caused by the ESD can cause soft device failures due to noise coupling on the system clock (OSCIN). ESD events within the IEC spec range do not cause permanent device damage and full functionality is recoverable with a device reset. The sensitivity to this noise issue is primarily due to the 1.2V oscillator/clock input implemented on this device. The low voltage range, coupled with slow rise and fall times, provides a lower noise margin than other TI devices with higher voltage internal oscillators (for example, 1.8V or 3.3V oscillators).

If ESD robustness is a concern, it is strongly recommended to avoid using the internal oscillator as a clock source. An external 3.3V clock source with a resistor voltage divider as in [Figure 2](#) can be used to externally generate the required 1.2V input clock. By using an external clock input with fast rise/fall times (less than 5 ns), the noise margin improves significantly, increasing ESD noise resistance.

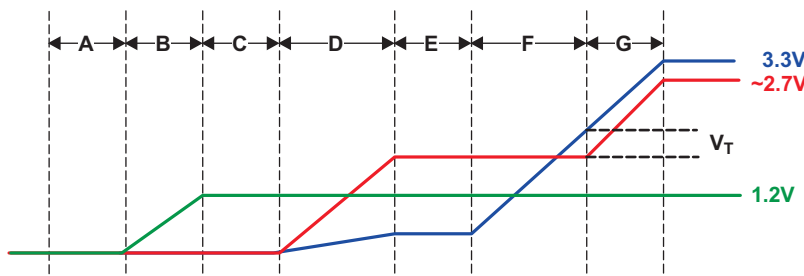
**Figure 4. Faulty power-supply ramp**

The behavior is the same until zone G. When the DVDD3318\_x supply exceeds DVDD18 by a transistor  $V_T$ , the DVDD18 supply begins to be pulled up by the DVDD3318\_x supply and follows the DVDD3318\_x supply by DVDD3318\_x -  $V_T$ . Since the DVDD18 supply is often connected to other 1.8V supplies in the design, these other supplies can be pulled up also.

The condition occurs because the dual-voltage IO buffers have voltage detection circuitry that monitors DVDD3318\_x during reset and determines whether the applied supply voltage is 1.8V or 3.3V. This detection circuitry then configures the IOs to operate at the appropriate voltage. As the DVDD3318\_x supply ramps, there is a small range near DVDD18 +  $V_T$  where the voltage detection circuit finds the state indeterminate and briefly turns on circuitry associated with both voltage options creating a current path between them. This current path can cause the DVDD18 supply to be pulled up. The mechanism for this behavior is explained below:

- (a) Maintain sufficient bulk capacitance on the DVDD18 supply such that the charging current for these capacitors provides all or part of the required >140 mA. Bulk capacitance in this context means the total capacitance seen by the DVDD18 supply (filter capacitors, bypass capacitors, etc.). Capacitor charging current is defined as  $I = C \cdot (dV/dt)$ . So the ramp rate of the DVDD3318\_x supply and the total bulk capacitance on the DVDD18 supply can be used to calculate the current produced. This solution provides additional power supply filtering and little current leakage after the supplies are ramped (depending on the type of capacitors used). The table below shows some examples of the bulk capacitance that would be required to use this solution alone:

2. Choose a regulator for the DVDD18 supply (or grouped 1.8V supplies) that is capable of actively regulating voltage up and down. Many high-efficiency switching regulators switch current into the load only when the voltage needs to be raised and rely on the load to pulldown the current. In this error condition, a regulator of this type will not be able to compensate for the leakage current described above. Synchronous buck regulators use external inductance to pulldown the regulated voltage when necessary.

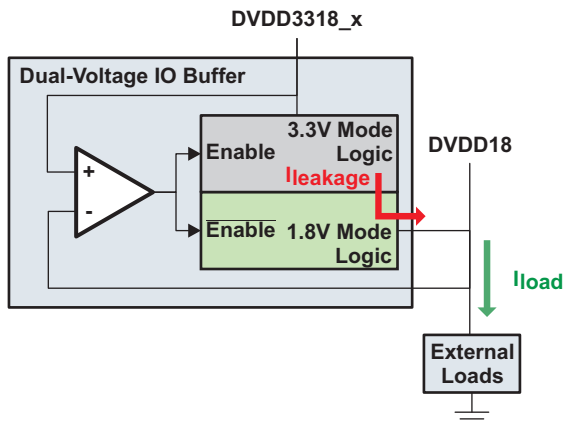
Figure 6. Error State of the IO buffer during Zone G

As DVDD3318\_x exceeds DVDD18 +  $V_T$ , some of the circuitry across the boundary of the two voltage domains will turn on and causes a leakage current (in red) to flow between the two voltage domains. This current pulls up the DVDD18 supply unless the power source providing that supply can oppose it or unless the load current is strong enough to counteract it.

If DVDD18 continues to rise as DVDD3318\_x ramps, the comparator never sees enough difference between the two supplies to switch to 3.3V mode.

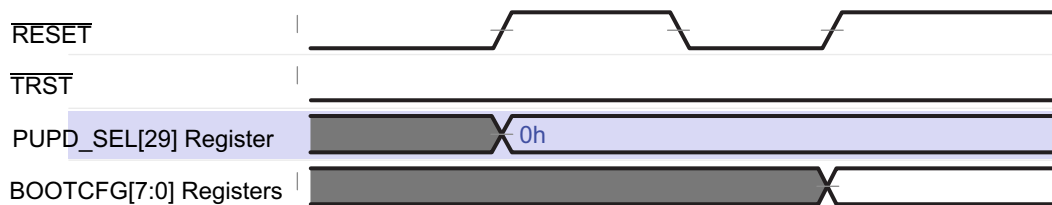
### Initialization of PUPD\_SEL[29] and BOOTCFG[7:0] Registers with Weak or No External Pull Resistors on BOOT[7:0] Pins

Internal pullups being enabled on the BOOT[7:0] pins may result in boot failures. If weak external pulldown resistors are used on the PCB to select the boot mode, they may not be able to overpower the internal pullups. This can result in the wrong boot mode being latched in the BOOTCFG[7:0] register when coming out of Reset.

Once the device is out of Reset, the PUPD\_SEL[29] register is initialized, and the internal pulldown resistors for the BOOT[7:0] pins are all enabled. Issuing a second Power-On Reset ( $\overline{\text{POR}}$ ) results in the intended boot mode being latched, since the pins are internally pulled down as expected.

[Initialization of PUPD\\_SEL\[29\] and BOOTCFG\[7:0\] Registers with Weak or No External Pull Resistors on BOOT\[7:0\] Pins](#) shows the behavior of the PUPD\_SEL[29] register before and after reset. Assuming weak or no external pull resistors are on the BOOT[7:0] pins, the BOOTCFG register will latch the unknown values after the device initially comes out of Reset. Note that,  $\overline{\text{TRST}}$  **must** always be low in order to issue a  $\overline{\text{POR}}$  and latch the boot pin values -- the boot pins are not latched after a Warm Reset.

Section 4, *Device Operating Conditions*, of the device datasheet shows the electrical characteristics information which can be used to calculate the maximum external pull resistance required. The value is dependent on the DVDD3318\_C I/O supply level.

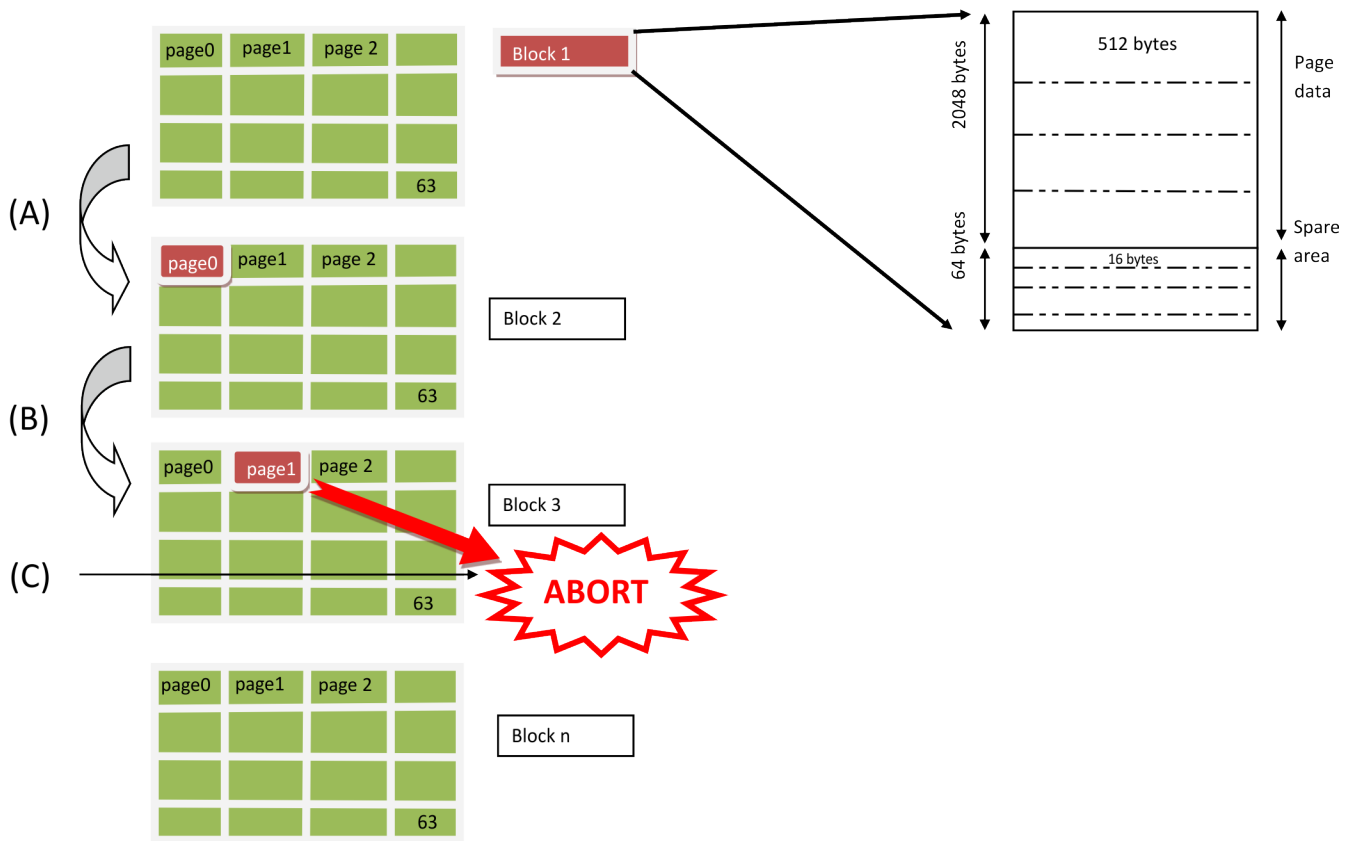
### D800K008 ROM Behavior Before Application of Software Patch<sup>(1)</sup>

However, over the life span of the NAND flash, ECC data stored in the spare area can develop errors due to bit flips. When the calculated syndrome indicates an error in the ECC data, the ECC Correct and Read functions of the RBL abort the read process even though, it is possible to correct up to 4 bit errors combined in user and ECC data. Consequently the device fails to boot.

If page0 of the good block has an ECC data error or an uncorrectable error (more than 4 bit errors combined), the RBL skips to the next block (shown as (B) in [D800K008 ROM Behavior Before Application of Software Patch<sup>\(1\)</sup>](#)). This bad block check mechanism enables the device to check up to the first 32 blocks in the NAND flash for booting (the boot process will fail if all 32 blocks have uncorrectable or ECC data errors in page0). Note that the RBL does not abort on detecting an error in ECC data on page0.

Once the RBL finds a good block with a good page0, it continues to read subsequent pages in that block. If an uncorrectable or ECC error is detected in subsequent pages, the RBL will abort with a boot error (shown as (C) in [D800K008 ROM Behavior Before Application of Software Patch<sup>\(1\)</sup>](#)). The workaround, described below, enables the boot process to continue for both types of errors (ECC data and uncorrectable errors).

This workaround is implemented using a software patch that is loaded in device RAM at boot time and is designed to change the default behavior of the ECC Correct and Read functions in the RBL. The patch binary replaces function pointers to the ECC Correct and Read functions in the ROM function table, (defined in device internal memory), during boot. The patch binary will reside in page0 of the NAND block and so will be applied only after the page0 of a good block has been read.

Once the patch is read, all subsequent page reads in the block will use the new ECC Correct and Read functions. ECC data errors on any page (other than page0) are ignored, any user data error (up to 4 bit errors total) is corrected and the boot process continues. If an uncorrectable error is detected on any page, the block is skipped and the boot process is restarted on the next good block. The behavior of the device boot from the NAND after application of the patch is shown in [D800K008 ROM Behavior With Software Patch Applied<sup>\(1\)</sup>](#).

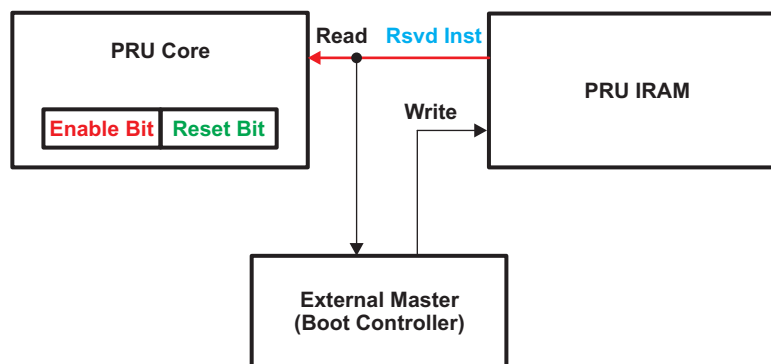
**Figure 9. Boot Failure on Power-On**

When the device is first powered-on, the read bus from the PRU IIRAM is not initialized and will contain random values (see [Figure 9](#)). Under unpredictable circumstances, the random value on the read bus may resemble a reserved instruction which can be interpreted by the PRU when the core is reset and not enabled.

If the PRU core executes this reserved instruction, it will not be able to properly execute the first functional op-code in the PRU IIRAM when the core is later enabled. In this fail state, the PRU will never acknowledge to the Boot Controller that the reset vector table was successfully initialized and the Boot Controller will be stuck in a polling loop waiting for the PRU to complete its task.

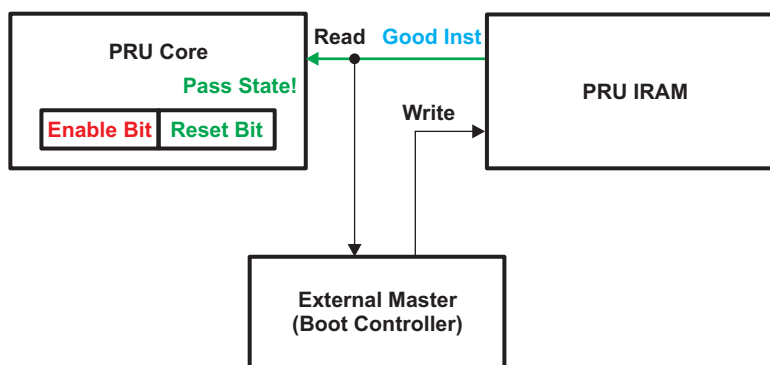
Figure 10. Secondary Reset

Although the PRU core execution is stuck, the PRU IRAM read bus is now initialized with a non-reserved instruction that was fetched from the IRAM by the PRU core (see [Figure 10](#)). If a secondary reset is provided to the device (either POR or WARM), the PRU will be able to execute its functional instructions as expected.

Note that in order to recover from this fail state with a secondary reset, the Boot Controller must be allowed to execute up to the point where the PRU has fetched a known instruction from the PRU IRAM. The approximate count of 15k clock cycles is sufficient.
