*RM48x Microcontroller*

**Silicon Revision D**

# **Silicon Errata**

Literature Number: SPNZ223B  
March 2015–Revised May 2016

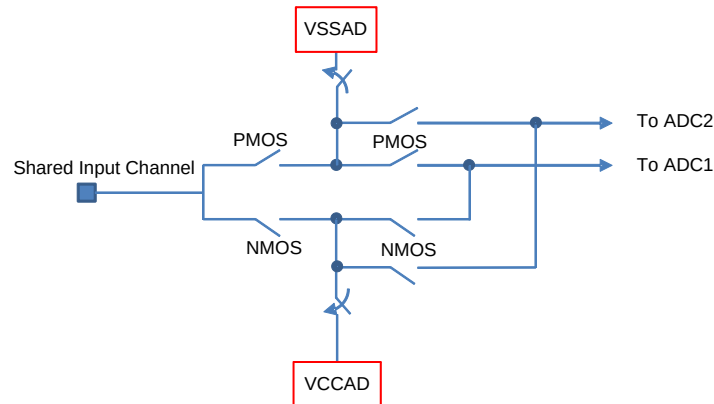
**Figure 2. Shared Input Channel in "Open" State**

**Issue** This microcontroller (MCU) has two Analog-to-Digital Converters (ADCs). Some of the input channels are unique to ADC1 while some are shared between ADC1 and ADC2. [Figure 2](#) shows a block diagram of an input channel shared between ADC1 and ADC2.

The PMOS and NMOS switches are open indicating that this shared input channel is not currently being sampled either by ADC1 or by ADC2. Also, there are switches to VCCAD and VSSAD that are closed. If any current is injected into this analog input, any leakage through the open PMOS switch will be shunted to VSSAD. These switches to VSSAD and VCCAD are opened as soon as this shared input channel is being sampled by either ADC1 or ADC2.

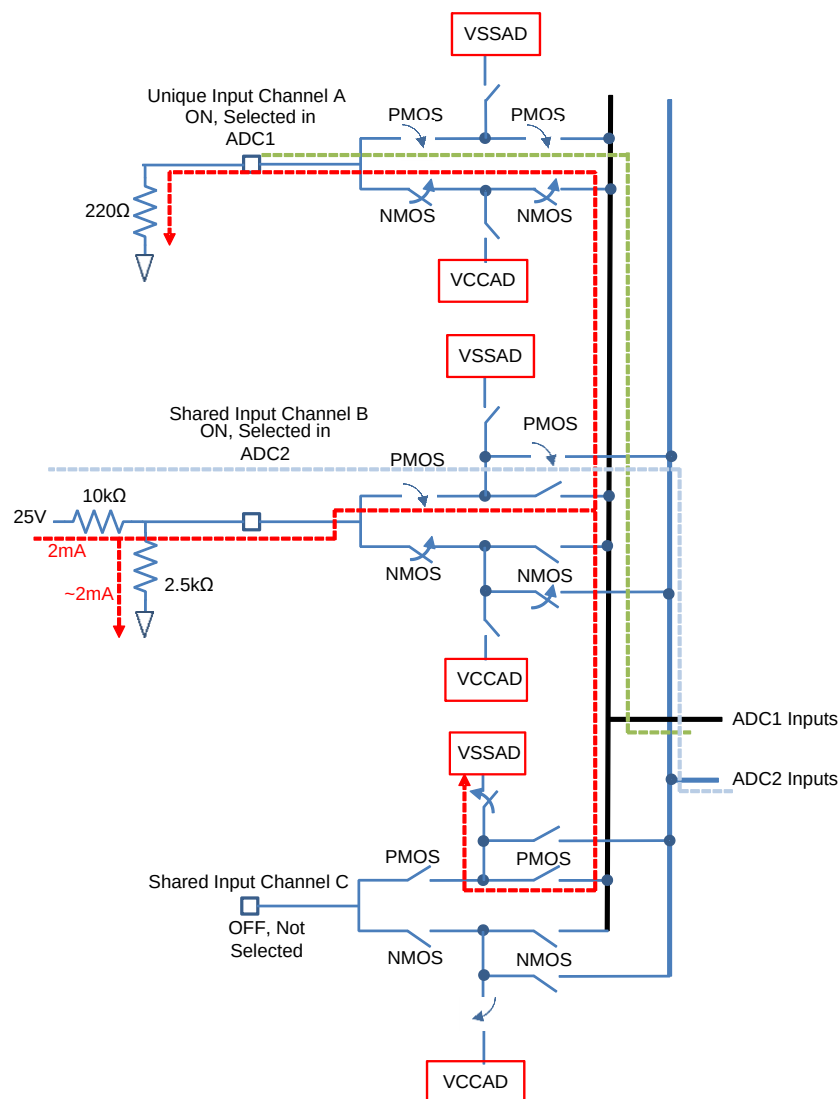
**Figure 3. Example ADC1/ADC2 Channel Connection**

Figure 3 shows an example where a ADC1 is sampling input channel A which is unique to ADC1, and ADC2 is sampling input channel B, which is a shared-input channel. This is shown by the dashed green and light blue current paths.

Another current path is shown in dashed dark red. This is a current injected into channel B as the input level on terminal B is greater than  $V_{CCAD} - 0.3V$ . This is a parasitic current that passes through the "open" PMOS switch, and a part of this current flows to ground through the external 220 ohm resistor connected to input channel A. This causes an offset in the conversion result of channel A being sampled by ADC1.

| <b>Conditions</b> | <p>This issue occurs if:</p> <ol style="list-style-type: none"> <li>1. Input voltage on a shared input channel being sampled by one ADC is (<math>V_{CCAD} - 0.3V</math>) or higher, and</li> <li>2. The second ADC samples another channel such that there is some overlap between the sampling windows of the two ADCs</li> </ol> |

| <b>Workaround(s)</b> | <p>There are two options to minimize the impact of this issue:</p> <ol style="list-style-type: none"> <li>1. Configure the two ADC modules such that their sampling periods do not overlap, or</li> <li>2. Limit the shared analog input upper limit to be lower than (<math>V_{CCAD} - 0.3V</math>). The PMOS leakage is reduced exponentially if the input is lower than <math>V_{CCAD} - 0.3V</math>.</li> </ol> |
