**66AK2Hxx**  
**Multicore DSP+ARM KeyStone II SOC**  
**Silicon Revisions 1.0, 1.1, 2.0, 3.0, 3.1**

# **Silicon Errata**

Literature Number: SPRZ402F  
June 2013—Revised June 2018

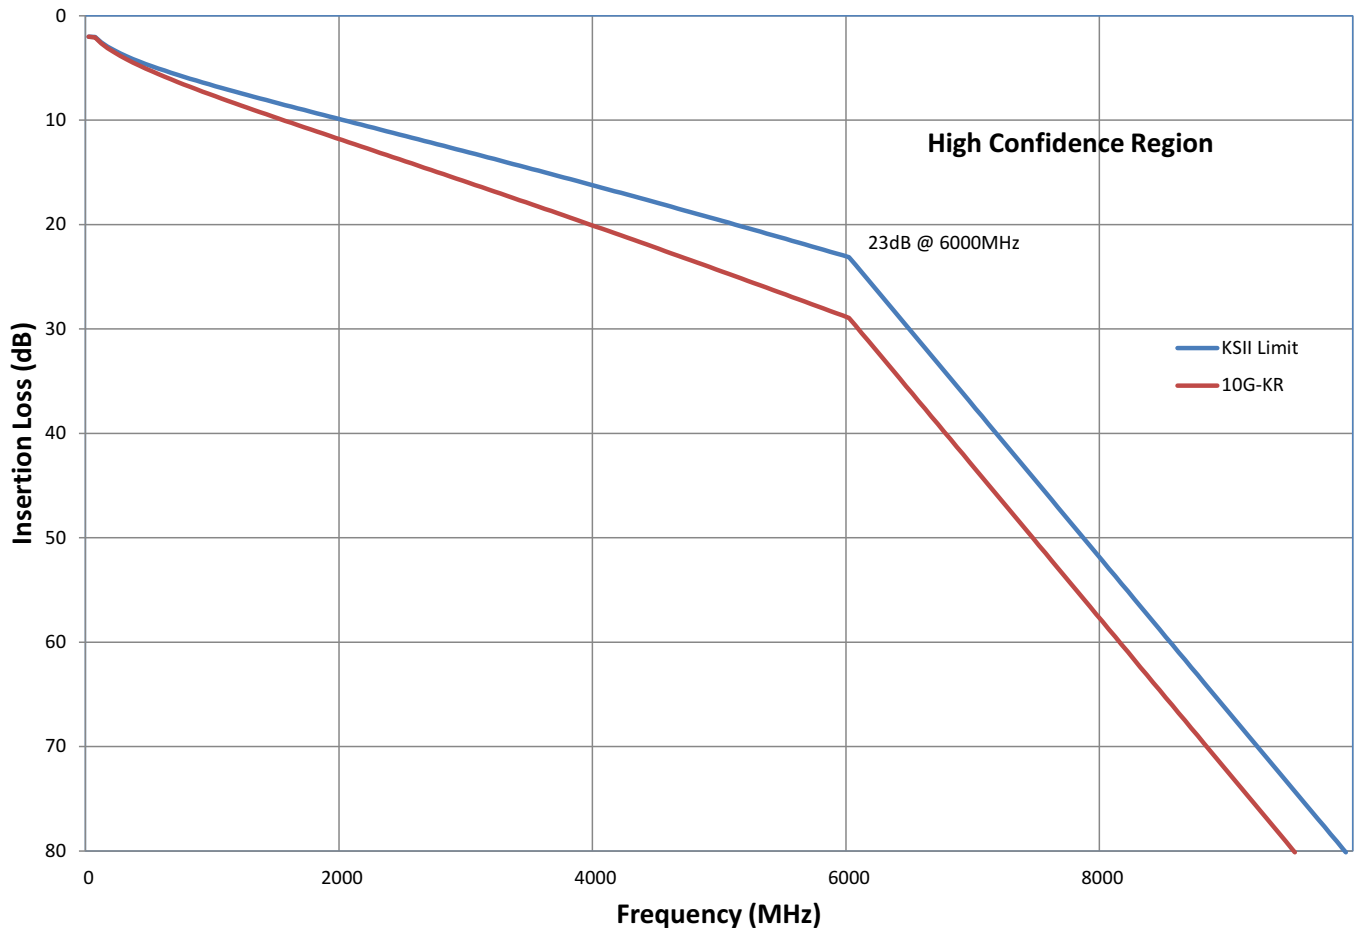
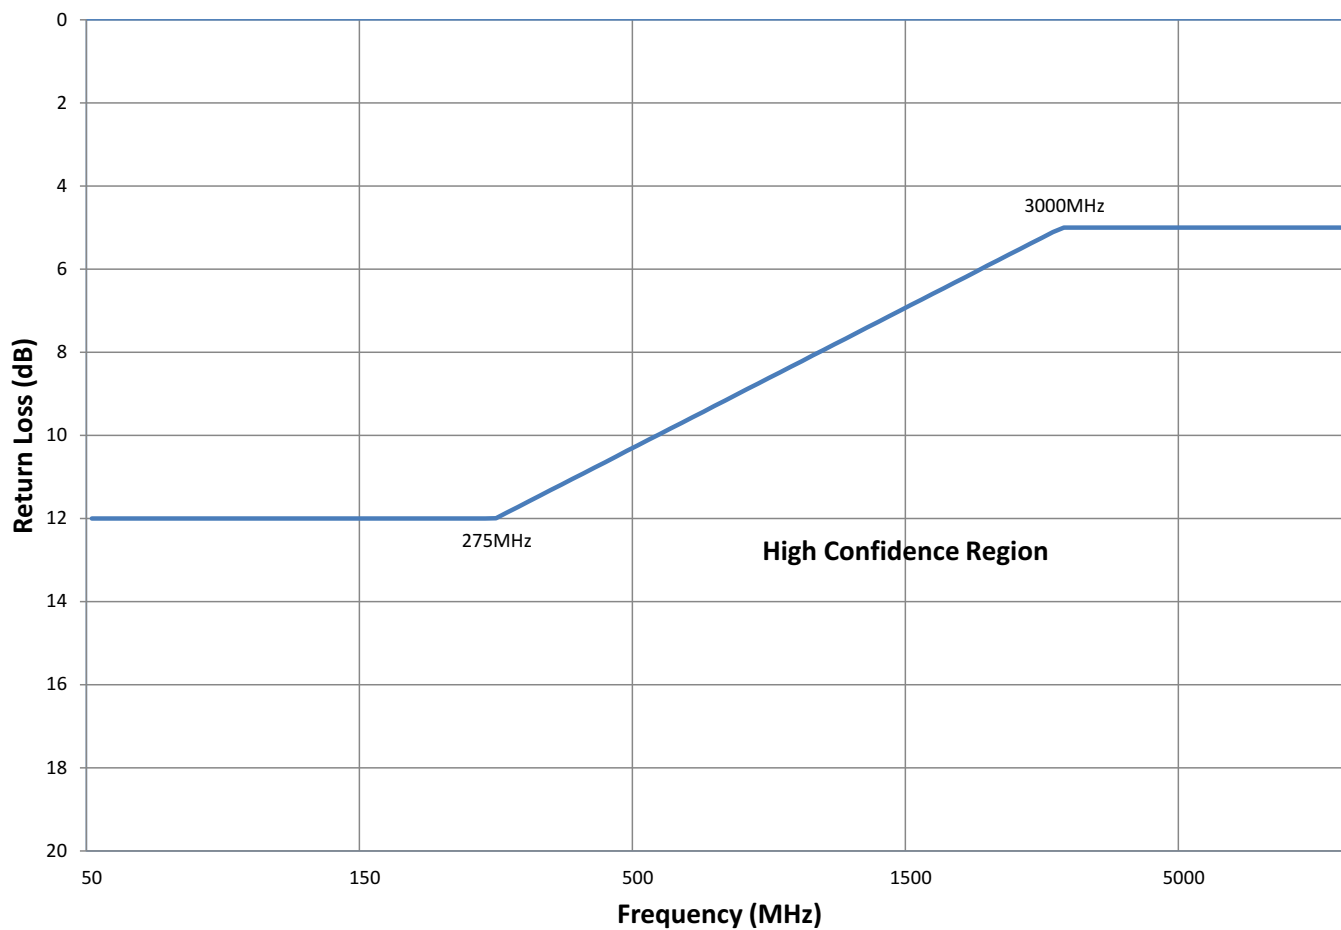
Device characterization has shown that bit error rate performance consistent with the 10GbE-KR standard as published in IEEE 802.3-2008 Annex 69B cannot be met across all device operating extremes. Production devices do operate at the required error rate across all rated operating conditions of voltage and temperature when the channel insertion loss is limited to 20dB at the Nyquist rate of 5.15625GHz. The figure below shows the Insertion Loss template from IEEE 802.3-2008 Annex 69B as well as the reduced Insertion Loss template.

Characterization has shown that channels must also be compliant with the Return Loss template contained in the IEEE 802.3-2008 Annex 69B specification without modification. This is shown below for convenience.

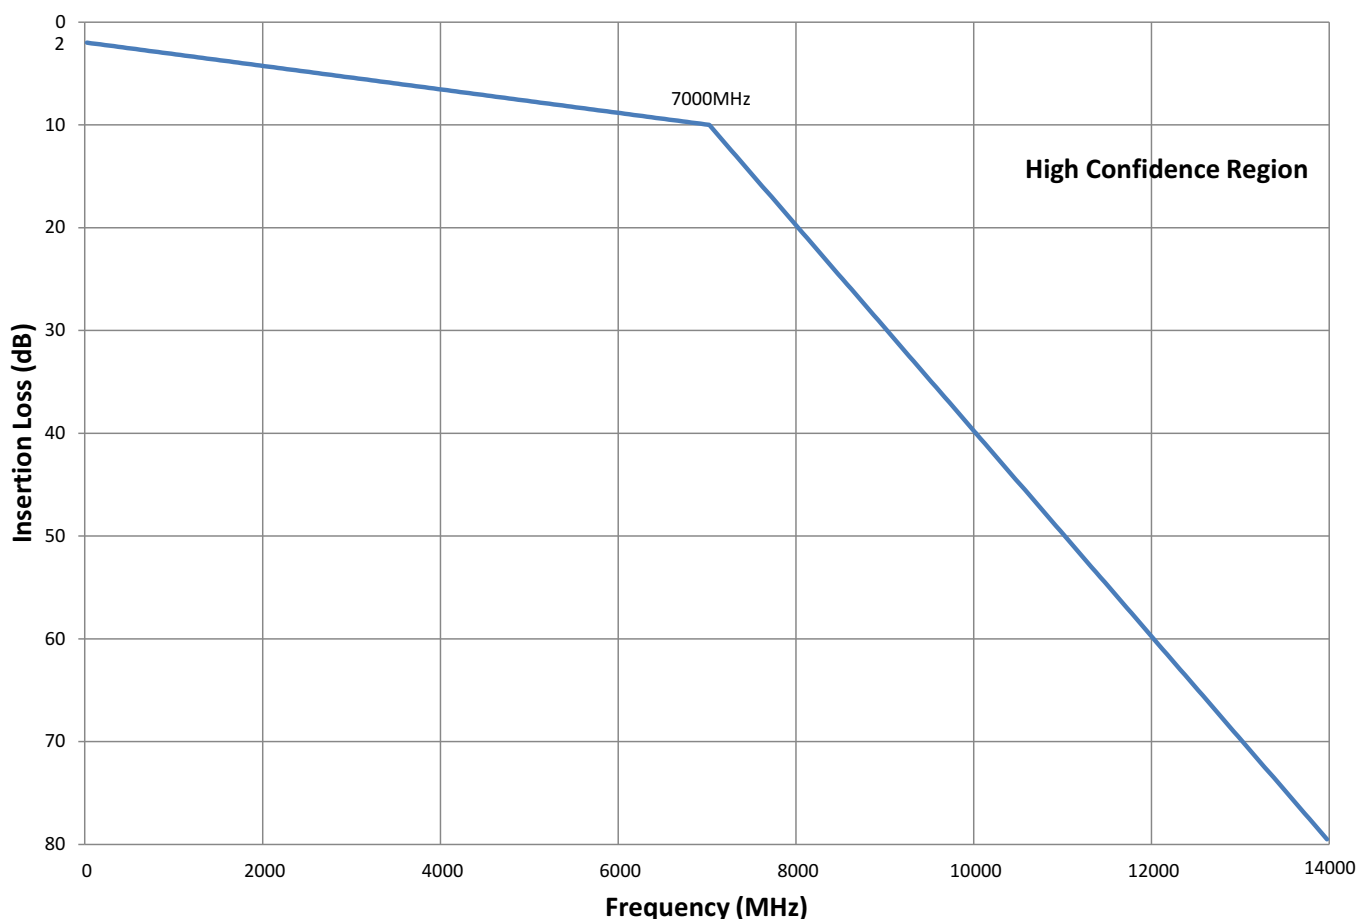
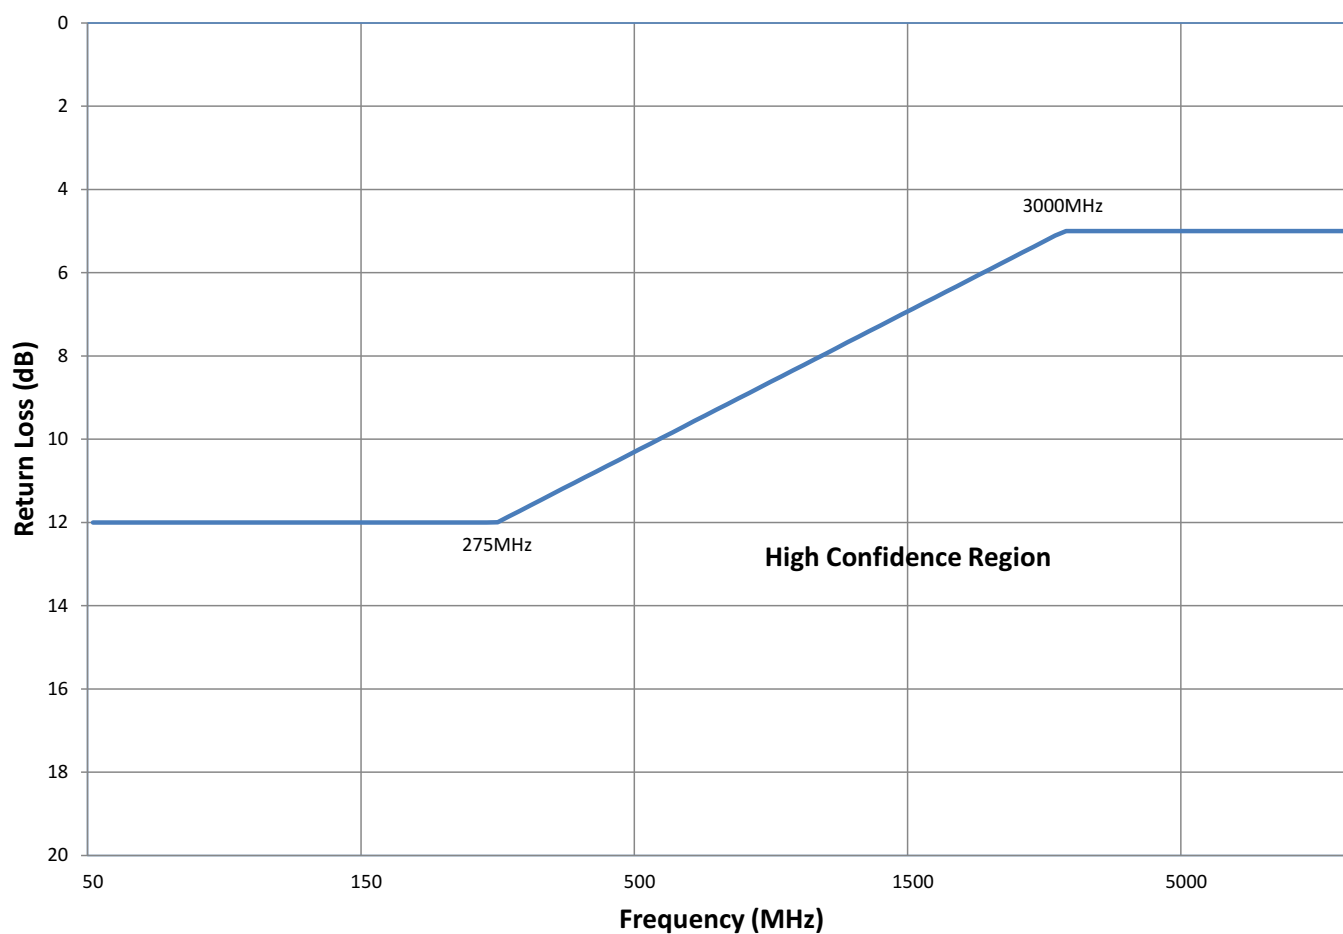
Device characterization has shown that expected bit error rate performance can only be met on layouts that meet constrained channel loss metrics. These can be examined by generating Insertion Loss and Return Loss graphs where loss is plotted versus frequency. Insertion Loss and Return Loss can be estimated during PCB layout using a 3D simulation tool. Insertion Loss and Return Loss should also be measured on early prototypes using a Vector Network Analyzer (VNA). Multiple PCB construction and layout enhancement techniques must be combined to achieve these channel performance requirements as stated in the KeyStone II SERDES User Guide.

An Insertion Loss measurement provides a composite view of the channel's loss versus frequency. Since HyperLink is a short-reach interface, channel loss is limited. Also, due to the high data rate, the Insertion Loss must be monotonic and without discontinuities that would degrade receiver operation. The template shown below provides Insertion Loss limits that will result in a robust channel. This template must be met for the entire channel from transmitter to receiver including the series capacitors.

Device characterization has also shown that channels should be compliant with the Return Loss template shown below. The Return Loss measurement indicates the amount of energy reflected back to the source which is not available to the receiver. Impedance variation in the channel will cause reflected energy that can cause this template to be violated. Careful attention to PCB construction and layout must be followed to meet this requirement. This template must be met for the entire channel from transmitter to receiver including the series capacitors. Note that this is the same template

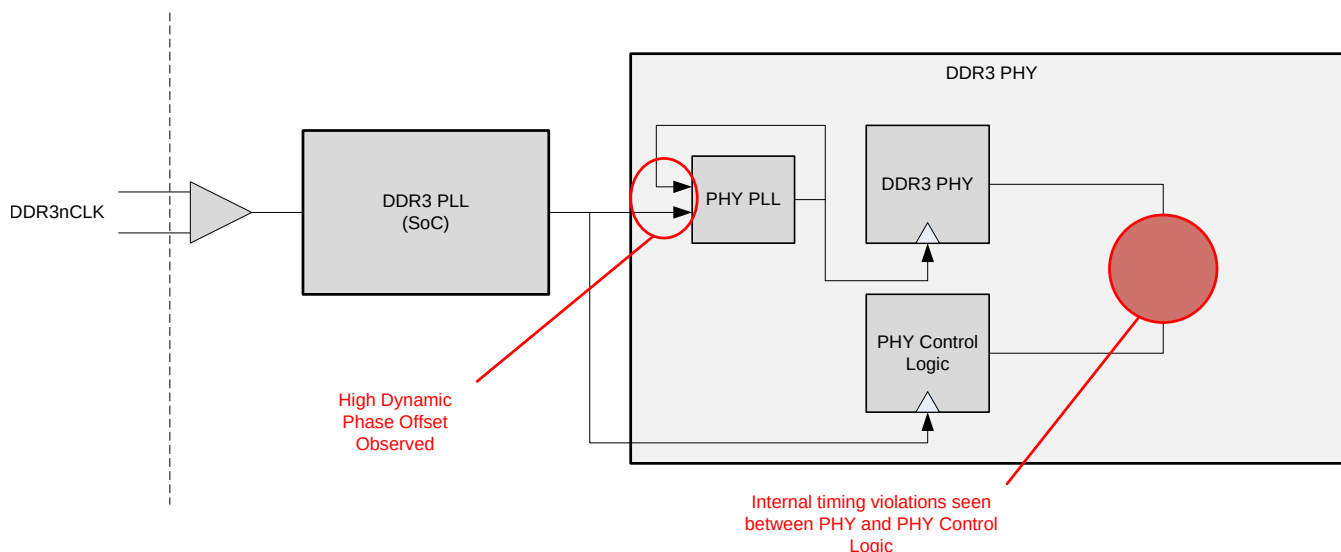
**Figure 5. DDR3 PHY**

DDR3 read operations may show errors due to increased levels of Dynamic Phase Offset (DPO) inside the DDR3 PHY. These errors are characterized by byte lane data corruption or intermittent bit errors. The byte lane data corruption can only be recovered using a device reset.

The DDR3 clocking architecture is illustrated in the figure below. The DDR3 reference clock input (DDR3nCLK) feeds the DDR3 SoC PLL, which outputs a clock to be used by the PHY Control Logic and provide an input to the PHY PLL.

The Dynamic Phase Offset (DPO) is a measure of the DDR3 PHY PLL's ability to track rapid phase changes in the output of the DDR3 SoC PLL. High DPO can create internal timing violations between the DDR3 PHY and DDR3 PHY Control Logic and result in data errors during reads. As indicated by the shaded red circle in the figure above, the timing violations occur in the data transfer between the PHY and PHY control logic. It was determined that the root cause of the elevated DPO were SoC PLL and PHY PLL configurations that were non-optimized for the timing requirements of the system.

The workaround for this behavior is a change in the PLL configurations used for the DDR3 SoC PLL and the DDR3 PHY PLL. New configurations have been generated for DDR3-1600, DDR3-1333, DDR3-1066, and DDR3-800 operation and are presented in the tables below. Per field alert, "DDR3 Limited to Highest Data Rates Due to Possibility of PLL Instability During Temperature Changes after Startup", operation of DDR3-1066 and/or DDR3-800 is not recommended for affected Keystone2 devices in production systems

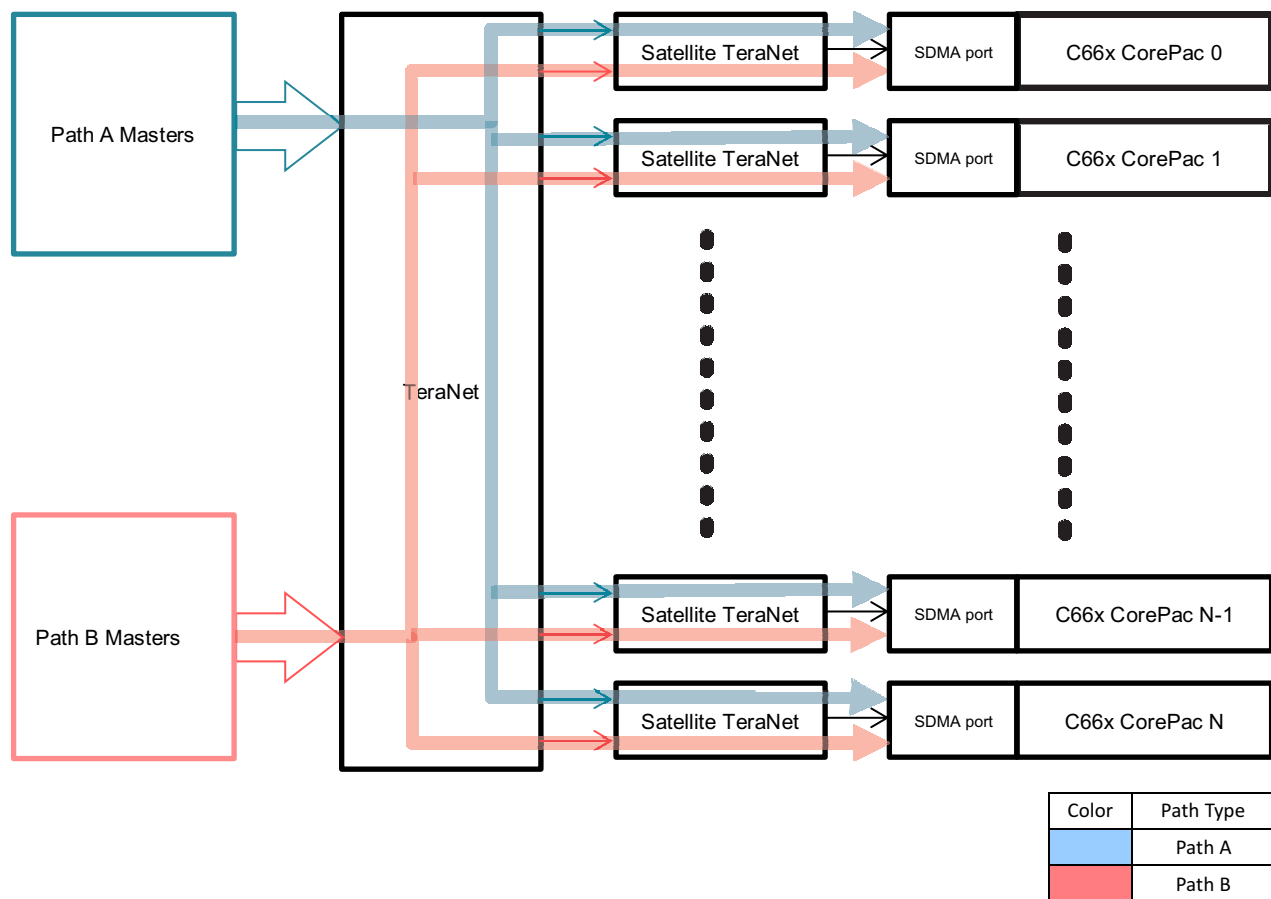
**Figure 6. Satellite TeraNet Paths**

When two masters send out write transactions to two C66x CorePac's L2 slave end points, a hang can occur when the C66x CorePacs are busy and stalling the incoming write transactions.

Each C66x CorePac has a TeraNet component in front of its slave (SDMA) port, which serves as a satellite TeraNet for C66x CorePac's SDMA port. Device masters communicate with the C66x CorePac's L2 memory through these satellite TeraNets. These satellite TeraNets have two input paths, path A and path B, and each path can be accessed by distinct set of masters. Thus, each write transaction appearing at the SDMA ports of C66x Corepac L2 memory can take one of the two possible paths, depending on the master that sent out that transaction.

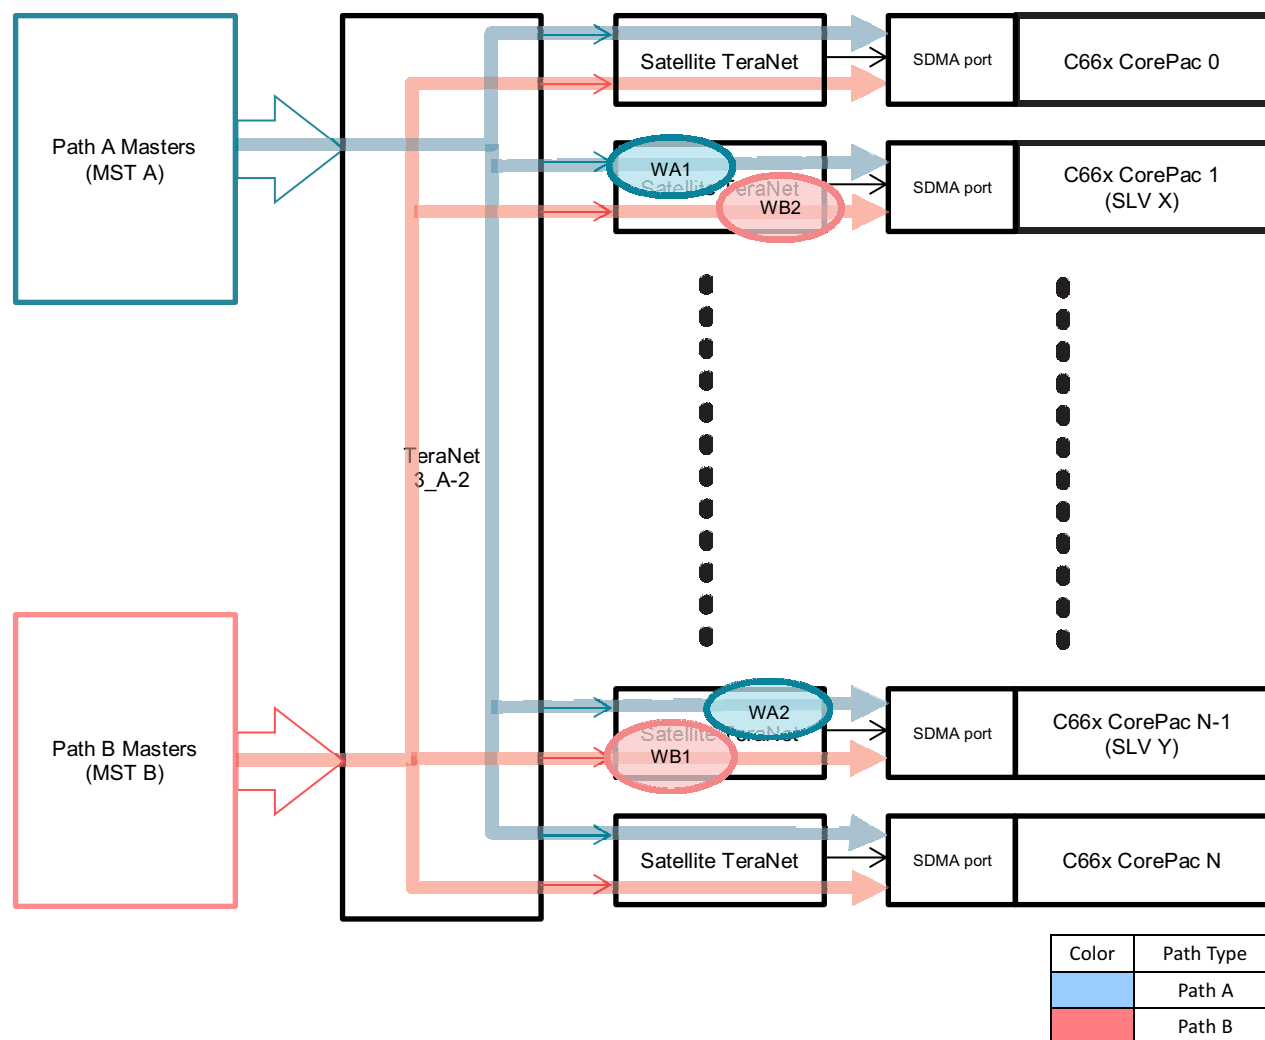
Figure 7. Hang Scenario

**Hang Scenario:** When a master (MST A) that uses path A and another master (MST B) that uses path B send out two writes each (WA1, WA2 and WB1, WB2) to two C66x CorePac slave end points (SLV X, SLV Y), a hang can occur if the following conditions occur:

- Both masters send one write to each of the two slave end points in opposite order:
  - MST A sends two writes: first write WA1 to SLV X, and second write WA2 to SLV Y
  - MST B sends two writes: first write WB1 to SLV Y, and second write WB2 to SLV X
- Writes from two masters arrive on separate paths at slave endpoint:
  - MST A writes arrive on path A
  - MST B writes arrive on path B
- Both slaves are busy, so they stall the incoming write transactions.
- Both slaves select second writes when they are ready:
  - SLV X selects WB2
  - SLV Y selects WA2

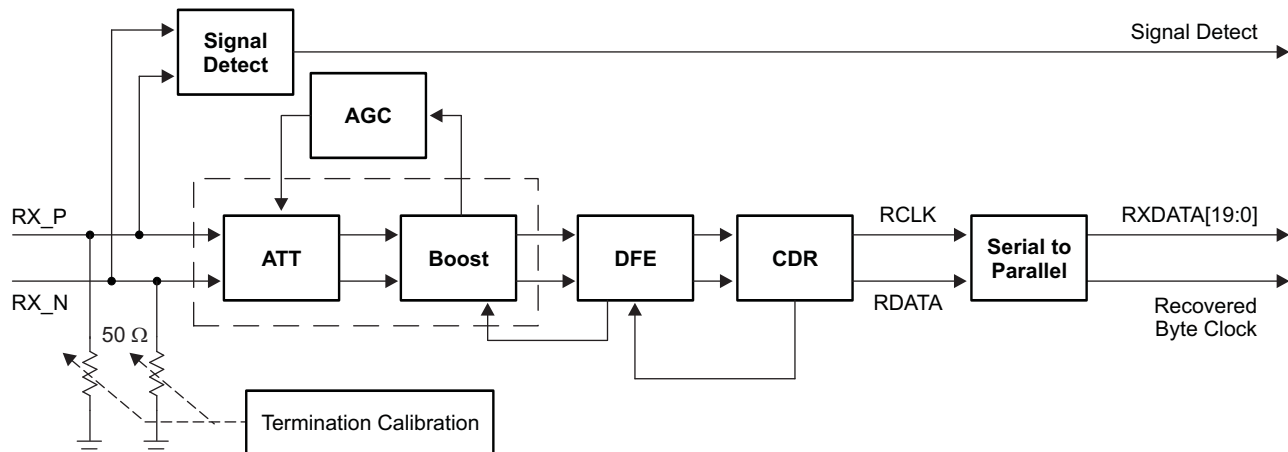
**Figure 10. RX Path Block Diagram**

**Problem Summary:** The SerDes on some peripherals will not automatically adapt its RX equalization when provided with certain data encodings common to that peripheral's electrical standard.

**Details** The TI SerDes contains an adaptation algorithm that allows the RX equalization blocks to adapt their parameters to the SerDes data channel. The adaptation algorithm sets the optimal values for the ATT, BOOST, and DFE blocks in order to equalize the signal, maximize margin, and minimize channel distortion. For higher data rates (i.e. 5Gbps and greater), the high frequency gain provided by the BOOST block is generally considered necessary to compensate for the low-pass characteristics of data channels and widen the data eye.

The SerDes BOOST block was designed to require a specific set of patterns in order to best adapt its parameters to the channel. If these patterns are not found, the BOOST adaptation algorithm will not update the internal block settings and/or may incorrectly update these settings. The required data pattern is a series of six 0's followed by a 101 pattern. This pattern must occur numerous times on both odd and even bit alignments. This data pattern is not present in the 8b/10b coded symbols that are sent over many of the high speed peripheral links.
