# **DM383 DaVinci™ Digital Media Processor Silicon Revisions 1.1, 1.0**

## **Silicon Errata**

Literature Number: SPRZ403

October 2013

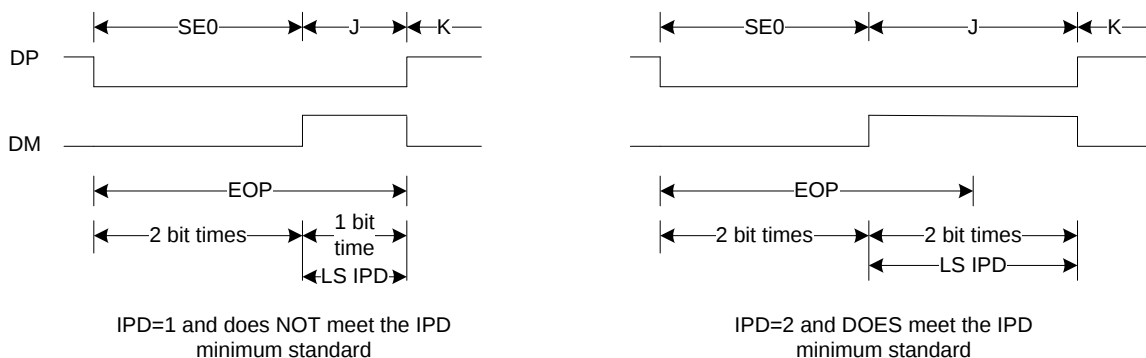
The problem is due to the length of the IPD between the Receiver-to-Transmitter (Rx-to-Tx) transactions. The Host IPD between Rx-to-Tx transactions for LS transactions should range from 2 to 6.5 LS bit times. It has been verified that the controller's LS IPD for Rx-to-Tx is only 1. This is shown in the following figure.

IPDs are measured from the SE0-to-J transition at the end of EOP to the J-to-K transition that starts the next packet.

The impact is that this specific mouse will not work with the processor's USB port.
