## ***F28M36x Concerto™ MCUs Silicon Errata Silicon Revisions F, E, B, A, 0***

This document describes the silicon updates to the functional specifications for the F28M36x microcontrollers (MCUs).

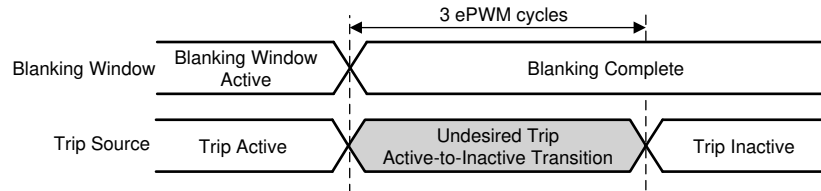
**Figure 3. Undesired Trip Event and Blanking Window Expiration**

The blanking window is typically used to mask any PWM trip events during transitions which would be false trips to the system. If an ePWM trip event remains active for less than three ePWM clocks after the end of the blanking window cycles, there can be an undesired glitch at the ePWM output.

Figure 3 illustrates the time period which could result in an undesired ePWM output.

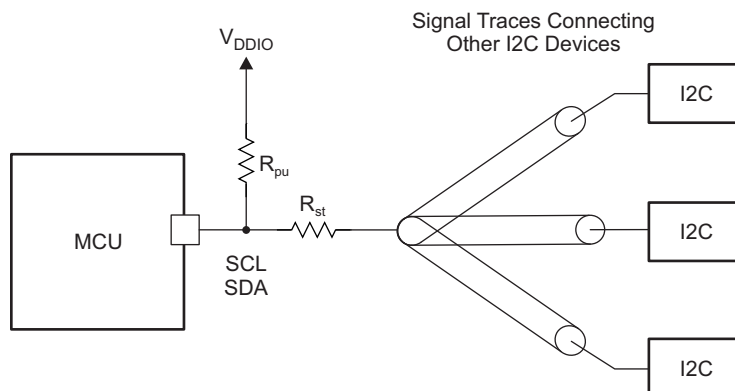
**Figure 8. Placement of Series Termination Resistor and Pullup Resistor**

The SDA and SCL outputs are implemented with push-pull 3-state output buffers rather than open-drain output buffers as required by I2C. While it is possible for the push-pull 3-state output buffers to behave as open-drain outputs, an internal timing skew issue causes the outputs to drive a logic-high for a duration of 0–5 ns before the outputs are disabled. The unexpected high-level pulse will only occur when the SCL or SDA outputs transition from a driven low state to a high-impedance state and there is sufficient internal timing skew on the respective I2C output.

This short high-level pulse injects energy in the I2C signals traces, which causes the I2C signals to sustain a period of ringing as a result of multiple transmission line reflections. This ringing should not cause an issue on the SDA signal because it only occurs at times when SDA is expected to be changing logic levels and the ringing will have time to damp before data is latched by the receiving device. The ringing may have enough amplitude to cross the SCL input buffer switching threshold several times during the first few nanoseconds of this ringing period, which may cause clock glitches. This ringing should not cause a problem if the amplitude is damped within the first 50 ns because I2C devices are required to filter their SCL inputs to remove clock glitches. Therefore, it is important to design the PCB signal traces to limit the duration of the ringing to less than 50 ns. One possible solution is to insert series termination resistors near the SCL and SDA terminals to attenuate transmission line reflections.

This issue may also cause the SDA output to be in contention with the slave SDA output for the duration of the unexpected high-level pulse when the slave begins its ACK cycle. This occurs because the slave may already be driving SDA low before the unexpected high-level pulse occurs. The glitch that occurs on SDA as a result of this short period of contention does not cause any I2C protocol issue but the peak current applies unwanted stress to both I2C devices and potentially increases power supply noise. Therefore, a series termination resistor located near the respective SDA terminal is required to limit the current during the short period of contention.

Insert series termination resistors on the SCL and SDA signals and locate them near the SCL and SDA terminals. The SCL and SDA pullup resistors should also be located near the SCL and SDA terminals. The placement of the series termination resistor and pullup resistor should be connected as shown in [Figure 8](#).
