dsPIC33EPXXXGP50X, dsPIC33EPXXXMC20X/50X and PIC24EPXXXGP/MC20X

dsPIC33EPXXXGP50X, dsPIC33EPXXXMC20X/50X and PIC24EPXXXGP/MC20X Family Silicon Errata and Data Sheet Clarification

The dsPIC33EPXXXGP50X, dsPIC33EPXXXMC20X/50X and PIC24EPXXXGP/MC20X family devices that you have received conform functionally to the current Device Data Sheet (DS70000657J), except for the anomalies described in this document.

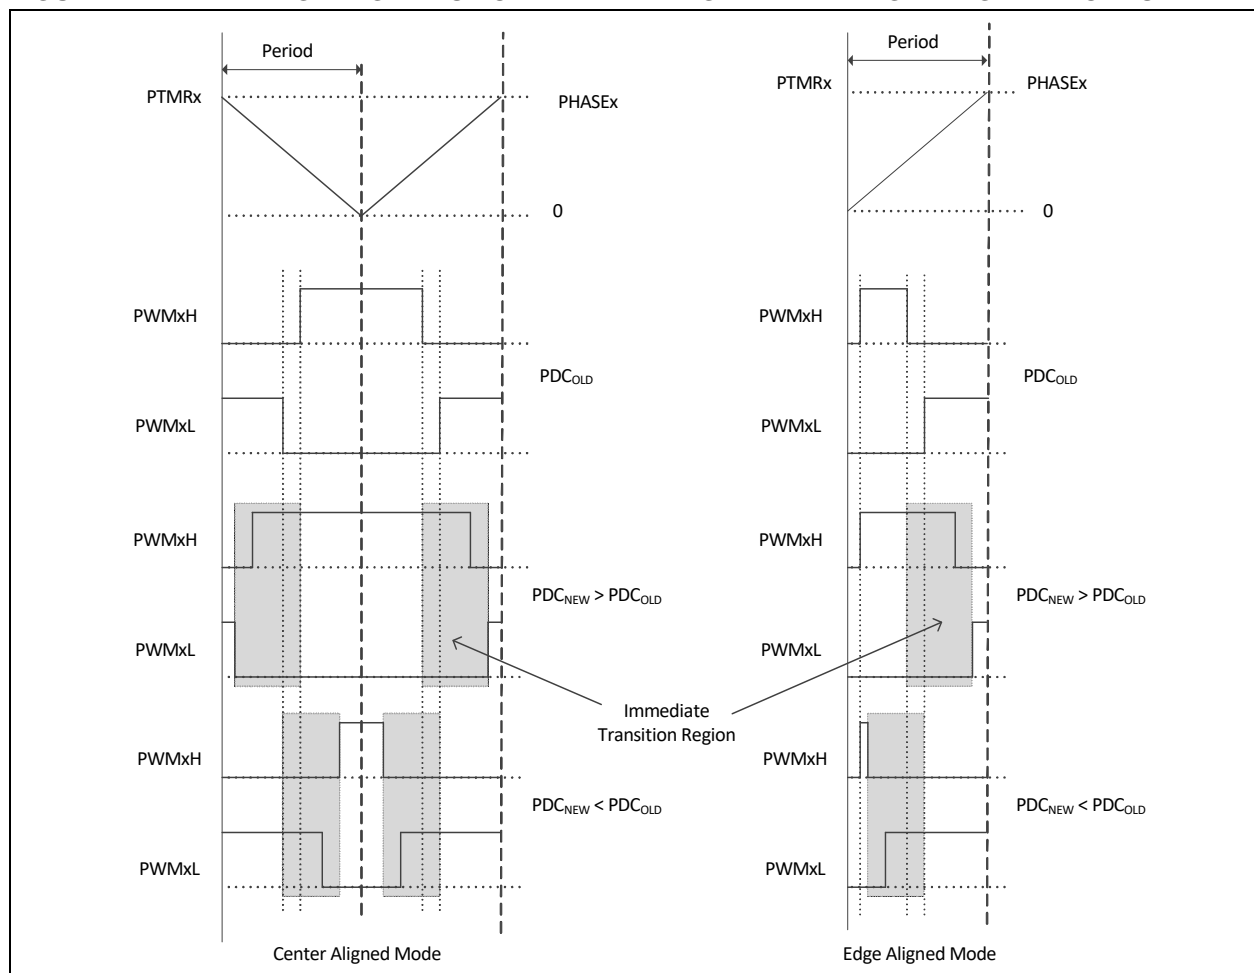
FIGURE 1: TIMING DIAGRAMS FOR CENTER-ALIGNED AND EDGE-ALIGNED MODES

The PWM generator may not assert dead time on the edges of transitions. This has been observed when all of the following conditions are present:

In [Figure 1](#), if the duty cycle write occurred in the shaded box, then PWMxH and PWMxL will make an immediate transition without dead time.

None.

However, in most applications the duty cycle update timing can be controlled using the TRIGx trigger, or Special Event Trigger, such that the above mentioned conditions are avoided altogether.

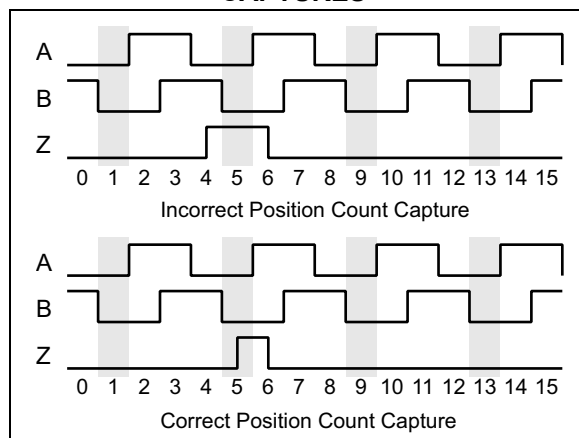
FIGURE 3: CORRECT AND INCORRECT POSITION COUNT CAPTURES

This is only observed when the leading edge of the index pulse occurs prior to the leading edge of the index match event. When the index pulse starts after the leading edge of the index match event, the position count is captured correctly.

Figure 3 shows how this occurs. In these cases, Encoder Signals A, B and (index) Z are shown, with the module being configured for index match when A and B are '0'. The effects of a correct and incorrect capture are shown side by side (shaded area indicates the index match event); the position count is shown along the bottom.

There are two different work arounds depending on the encoder type.

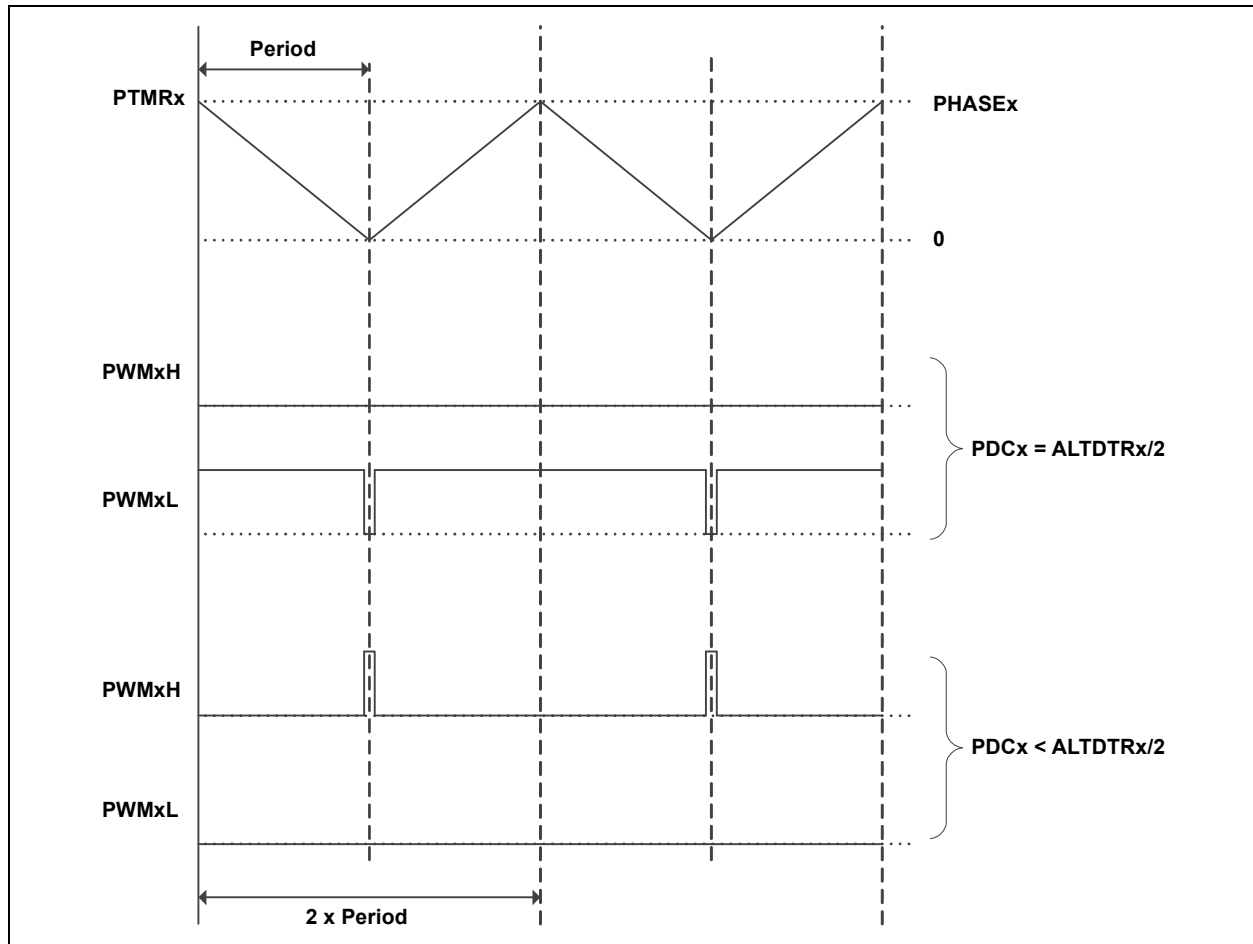
FIGURE 4: PWM GENERATOR TIMING DIAGRAM

In Center-Aligned Complementary mode with Independent Time Base, if the value in the PDCx register is less than one-half the value in the ALTDTRx register, the PWM generator will force the PWMxL to low, and on the PWMxH, generate pulses of width less than twice the dead time, as shown in Figure 4.

Include a software routine to ensure that the duty cycle value written to the PDCx register is always at least one-half of the value in ALTDTRx. [Example 3](#) shows one method, with PDCtemp representing the variable which has the value to be written to the PDCx register. Alternatively, for duty cycle values less than half the desired dead-time value, zero out the ALTDTRx register or dynamically reduce the value in the ALTDTRx register, such that ALTDTRx is always equal to 2 * PDCx, as shown in [Example 4](#).

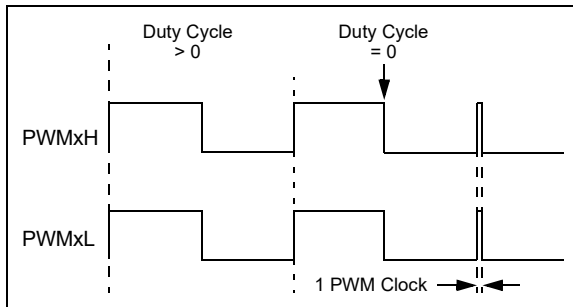
FIGURE 6:

In certain output modes, the PWMx module produces a pulse glitch of one PWM clock in width (Figure 6). This has been observed only when all of the following are true:

The pulse glitch has been observed to occur at the beginning of the following PWM boundary period.

If the application requires a duty cycle of zero, two possible work arounds are available.

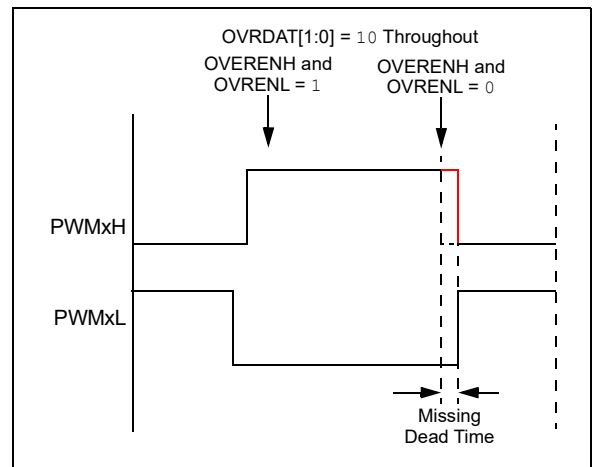
FIGURE 7:

This has been observed in both Center-Aligned and Edge-Aligned modes.

None.

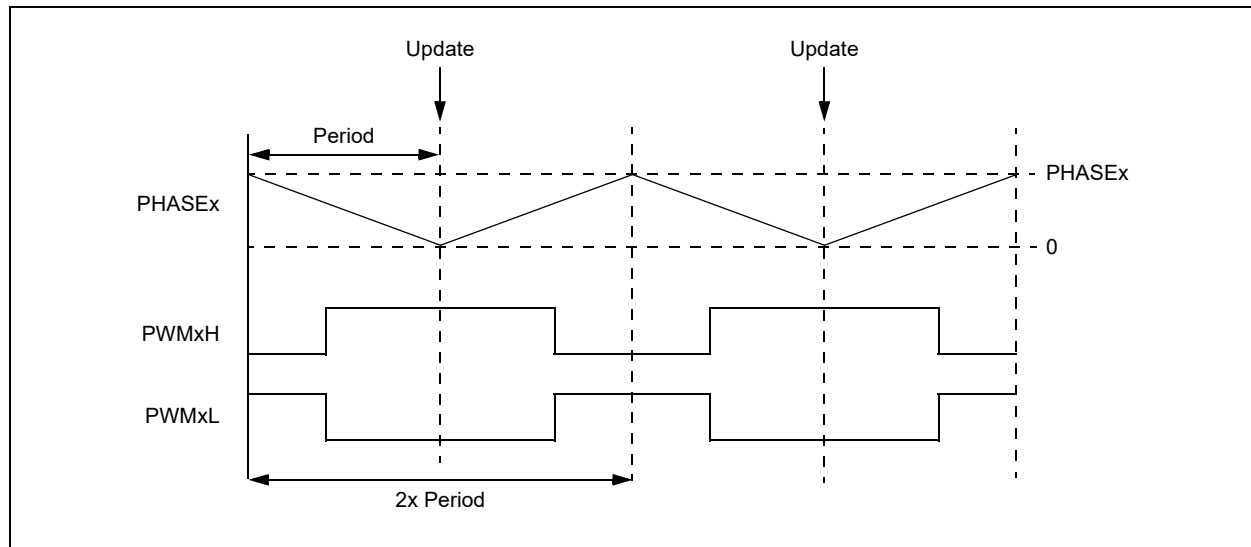
FIGURE 8:

In Center-Aligned Complementary mode with Independent Time Base, the expected dead time between transitions of the PWMxH and PWMxL outputs may not be asserted when SWAP is disabled under the following conditions:

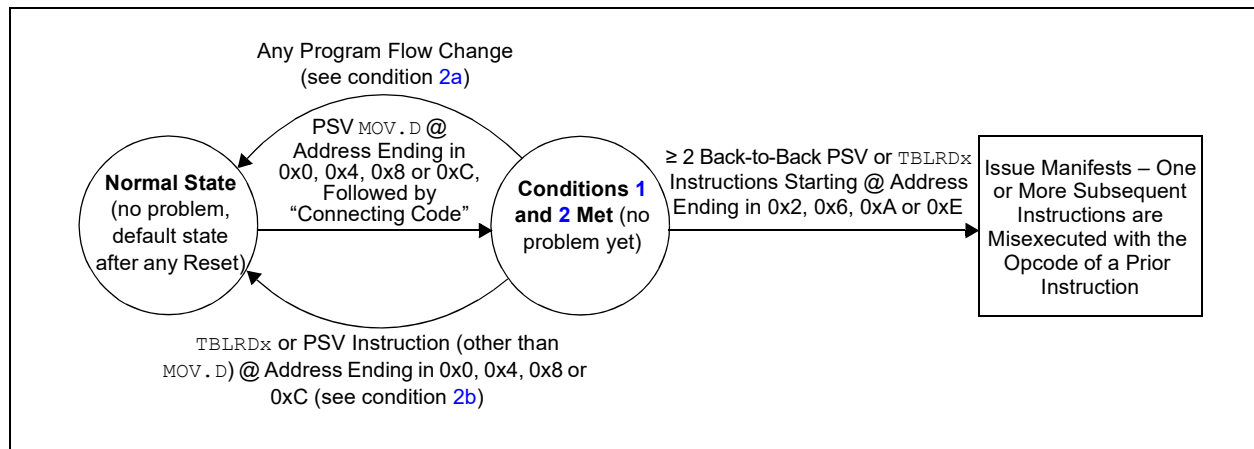
FIGURE 9: SIMPLIFIED BEHAVIOR

When two or more data Flash read instructions (via Program Space Visibility (PSV) read or table read) are executed back-to-back, one or more subsequent instructions can be misexecuted when all of the conditions in [Table 6](#) occur.

[Figure 9](#) provides an example of the effective behavior.

The issue can be avoided by ensuring any one or more of the requirements are not met. For example:

1. All instances of PSV `MOV.D` can be replaced with two PSV `MOV` instructions instead. Non-PSV `MOV.D` instructions acting on RAM/SFRs do not need to be modified; or
2. If not already present, a program flow change instruction (such as `BRA $+2`) can be inserted above back-to-back data Flash read sequences; or
3. Back-to-back data Flash read instruction sequences can be broken up by inserting a non-Flash read instruction (such as a `NOB`) in between the Flash read instructions; or
4. The alignment of the code can be shifted to avoid the required opcode location addresses.
