Applicability

This document applies to the part numbers of STM32L475xx devices listed in [Table 1](#) and their variants shown in [Table 2](#).

[Section 1](#) gives a summary and [Section 2](#) a description of workarounds for device limitations, with respect to the device datasheet and reference manual RM0351.

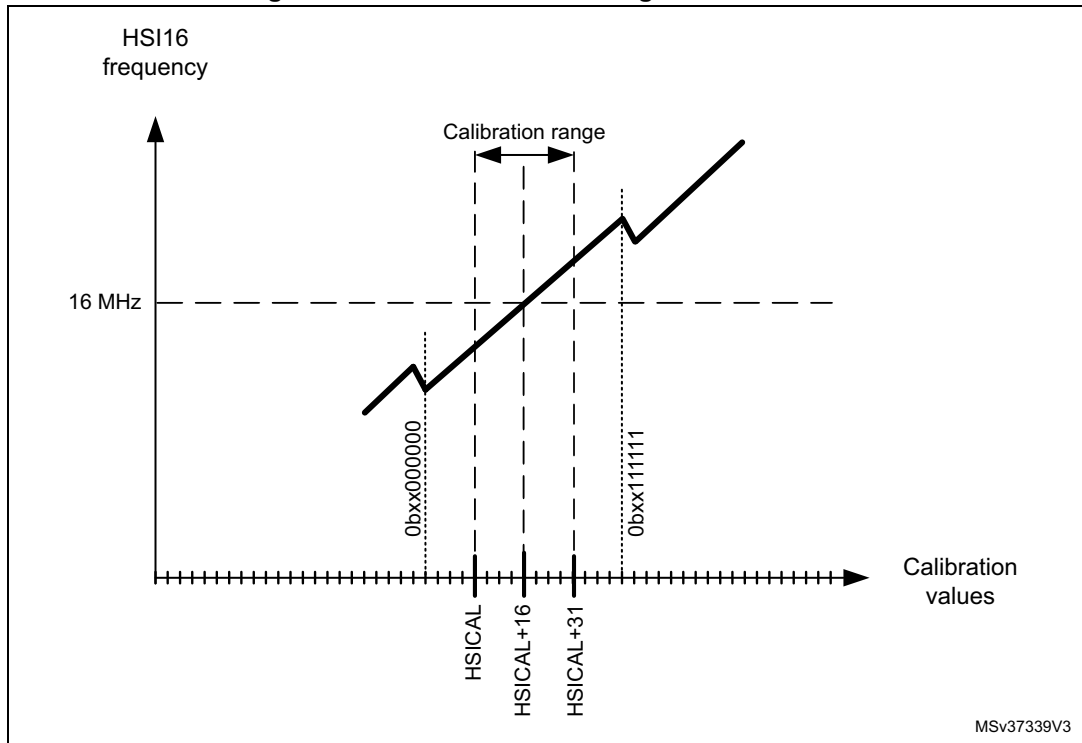
Figure 1. HSI oscillator trimming characteristics

Consequently, the user trim correction must not jump over the codes multiple of 64, which can limit the user correction either in positive or in negative direction.
