*RM44x Microcontroller*

**Initial Silicon Revision (Silicon Revision 0)**

# Silicon Errata

Literature Number: SPNZ209D  
July 2014–Revised May 2016

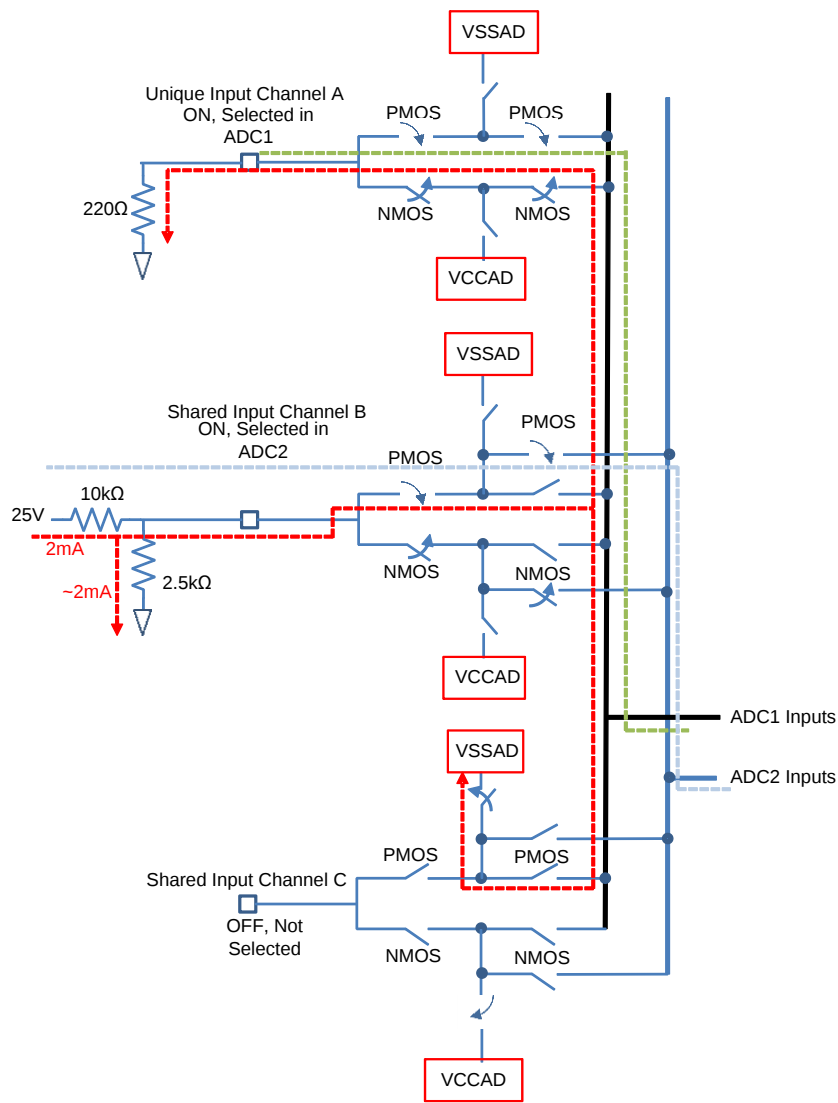
**Figure 3. Example ADC1/ADC2 Channel Connection**

Figure 3 shows an example where a ADC1 is sampling input channel A which is unique to ADC1, and ADC2 is sampling input channel B, which is a shared-input channel. This is shown by the dashed green and light blue current paths.

Another current path is shown in dashed dark red. This is a current injected into channel B as the input level on terminal B is greater than  $V_{CCAD} - 0.3V$ . This is a parasitic current that passes through the "open" PMOS switch, and a part of this current flows to ground through the external 220 ohm resistor connected to input channel A. This causes an offset in the conversion result of channel A being sampled by ADC1.

| <b>Conditions</b> | <p>This issue occurs if:</p> <ol style="list-style-type: none"> <li>1. Input voltage on a shared input channel being sampled by one ADC is (<math>V_{CCAD} - 0.3V</math>) or higher, and</li> <li>2. The second ADC samples another channel such that there is some overlap between the sampling windows of the two ADCs</li> </ol> |

| <b>Workaround(s)</b> | <p>There are two options to minimize the impact of this issue:</p> <ol style="list-style-type: none"> <li>1. Configure the two ADC modules such that their sampling periods do not overlap, or</li> <li>2. Limit the shared analog input upper limit to be lower than (<math>V_{CCAD} - 0.3V</math>). The PMOS leakage is reduced exponentially if the input is lower than <math>V_{CCAD} - 0.3V</math>.</li> </ol> |
