# **TMS320DM816x DaVinci™ Digital Media Processors**

## **Silicon Revisions 2.1, 2.0, 1.1, 1.0**

# **Silicon Errata**

Literature Number: SPRZ329F  
November 2010–Revised March 2015

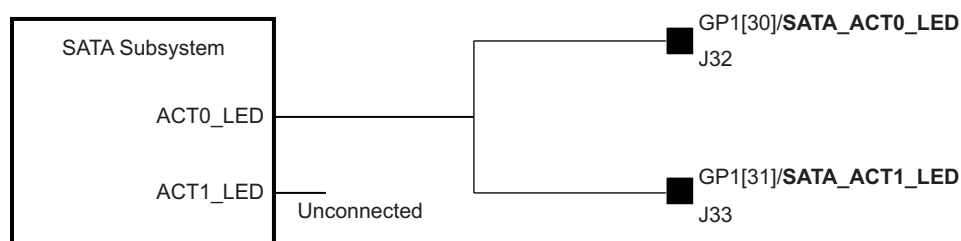
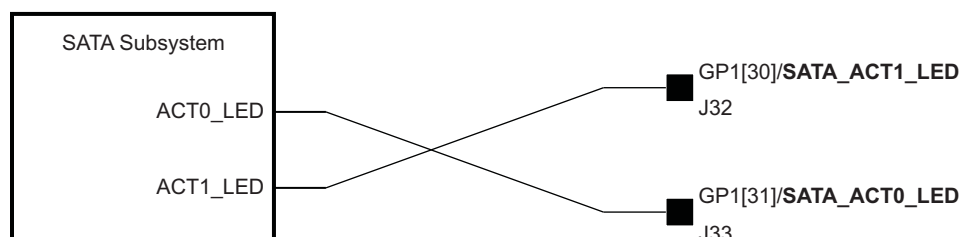
**Figure 4. SATA Activity LED Connectivity**

This issue is corrected on revision 2.0, but with the output pins reversed. SATA\_ACT1\_LED is mapped to pin J32 and SATA\_ACT0\_LED to pin J33 (see [Figure 4](#)).
