### Silicon identification

This errata sheet applies to the revision A, Z, Y and X of STMicroelectronics STM32L053x6/8 microcontrollers.

The STM32L053x6/8 devices feature an ARM® 32-bit Cortex®-M0+ core.

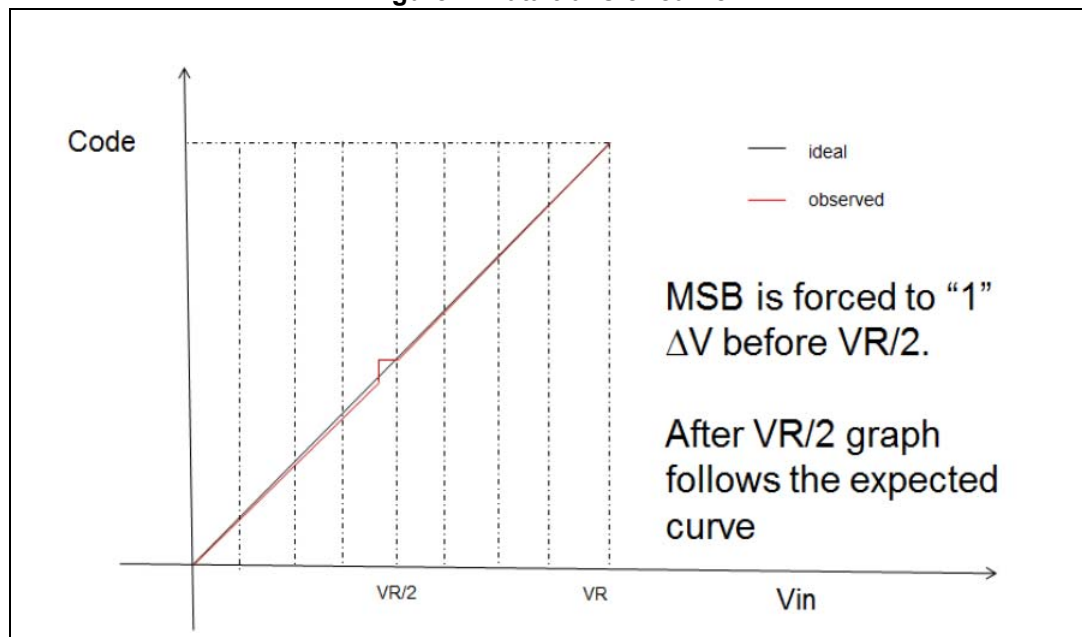
Figure 1. Data transfer curve

When  $V_{REF+}$  is lower than  $V_{DDA}$ , and only in this case, the data MSB is forced to '1' just before  $V_{IN}$  reaches  $V_{REF+}/2$ . As a result, the data transfer curve shows a discrepancy around  $V_{REF+}/2$  (see [Figure 1](#)).

*Note:* The transfer curve behaves as expected when  $V_{IN}$  is strictly lower or higher than  $V_{REF+}/2$ .
