dsPIC33EPXXXGM3XX/6XX/7XX Family Silicon Errata and Data Sheet Clarification

The dsPIC33EPXXXGM3XX/6XX/7XX family devices that you have received conform functionally to the current Device Data Sheet (DS70000689D), except for the anomalies described in this document.

Note: This document summarizes all silicon errata issues from all revisions of silicon, previous as well as current. Only the issues indicated in the last column of [Table 2](#) apply to the current silicon revision (**A3**).

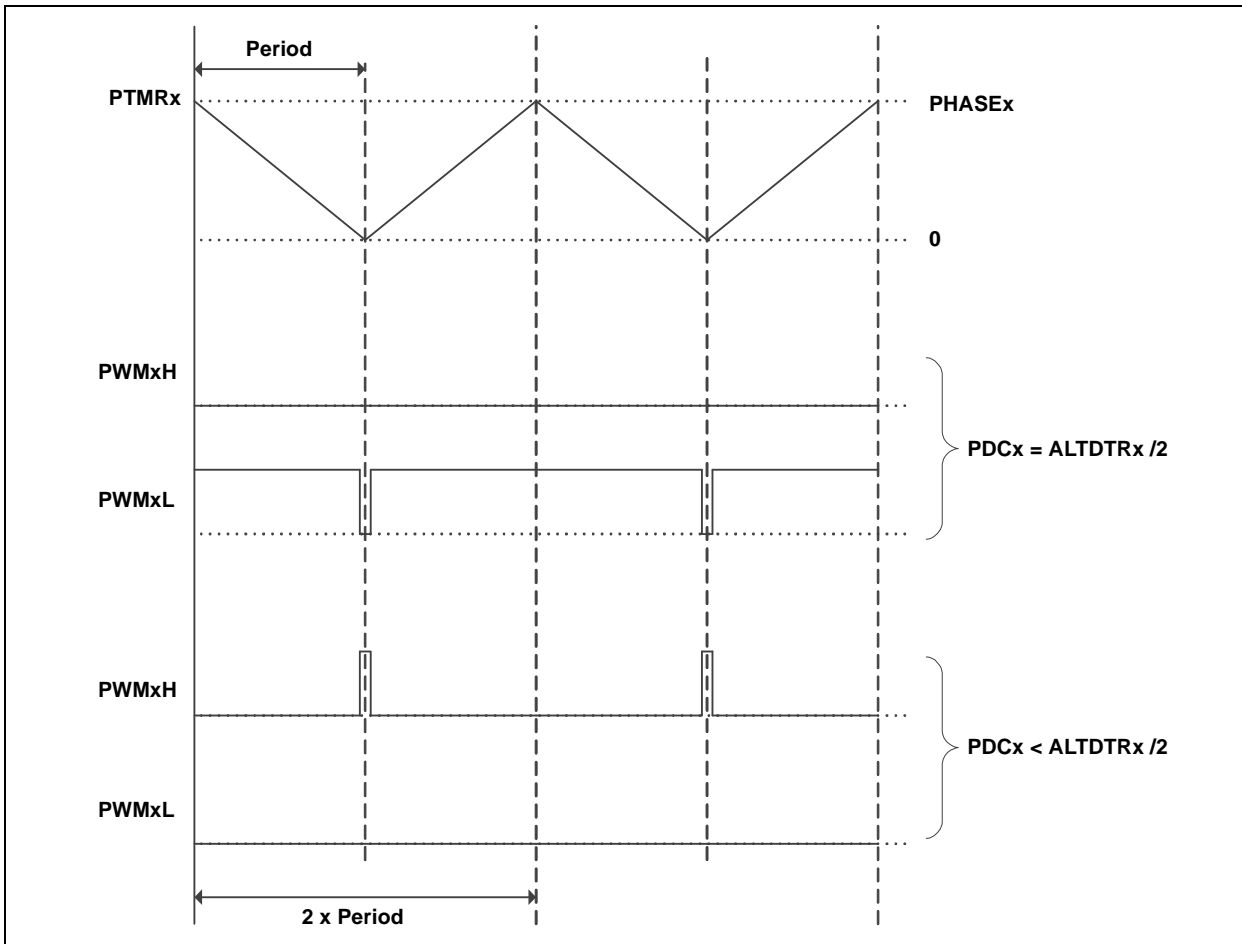
FIGURE 2: PWM GENERATOR TIMING DIAGRAM

In Center-Aligned Complementary mode with Independent Time Base, if the value in the PDCx register is less than one-half the value in the ALTDTRx register, the PWM generator will force the PWMxL to low, and on the PWMxH, generates pulses of a width less than twice the dead time, as shown in Figure 2.

Include a software routine to ensure that the duty cycle value written to the PDCx register is at least one-half of the value in ALTDTRx. Example 1 shows one method, with PDCtemp representing the variable which has the value to be written to the PDCx register. Alternatively, for duty cycle values less than half the desired dead-time value, zero out the ALTDTRx register or dynamically reduce the value in the ALTDTRx register, such that ALTDTRx is always equal to 2 * PDCx, as shown in Example 2.

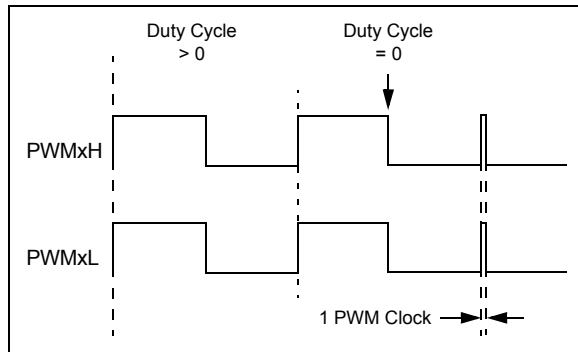
FIGURE 3:

In certain output modes, the PWMx module produces a pulse glitch of one PWM clock in width (Figure 3). This has been observed only when all of the following are true:

The pulse glitch has been observed to occur at the beginning of the following PWM boundary period.

If the application requires a duty cycle of zero, two possible work arounds are available.

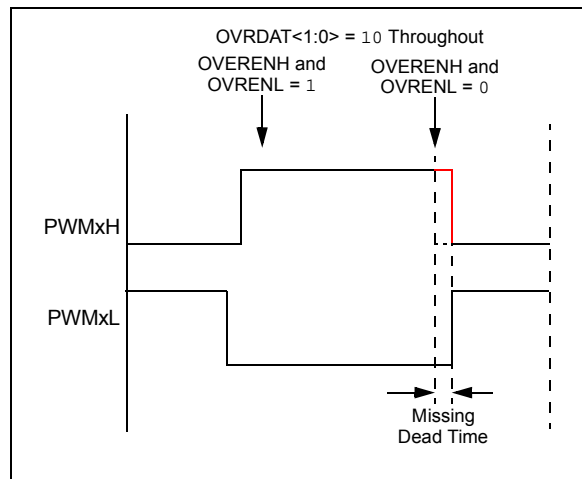
FIGURE 4:

This has been observed in both Center-Aligned and Edge-Aligned modes.

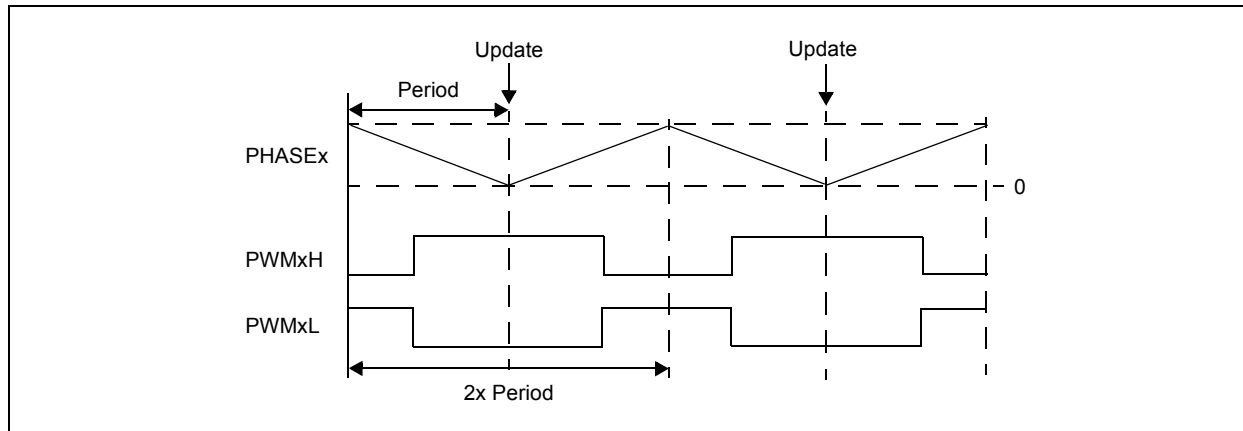
FIGURE 5:

In Center-Aligned Complementary mode with Independent Time Base, updates to the PHASEx register take effect in the middle of a Center-Aligned PWM cycle, as shown in Figure 5. This occurs only when the Immediate Update feature is disabled (IUE = 0). If Immediate Update is enabled (IUE = 1), the PHASEx register updates will take effect immediately.

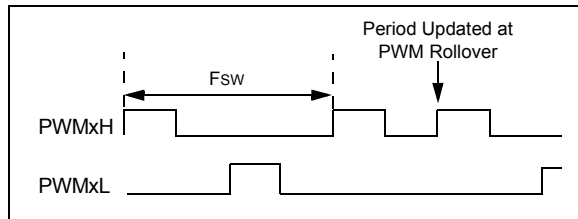
FIGURE 6:

When the PWM module is configured for Push-Pull mode (IOCONx<11:10> = 10) with the Enable Immediate Period Update bit enabled (PTCON <10> = 1), a write to the Period register that coincides with the period rollover event may cause the push-pull output logic to produce back-to-back pulses on the PWMx pins (Figure 6).

Ensure that the update to the PWM Period register occurs away from the PWM rollover event by setting the EIPU bit (PTCON<10> = 1). Use either the PWM Special Event Trigger (SEVTCMP) or the PWM Primary Trigger (TRIGx) to generate a PWM Interrupt Service Routine (ISR) near the start of the PWM cycle. This ISR will ensure that period writes do not occur near the PWM period rollover event.

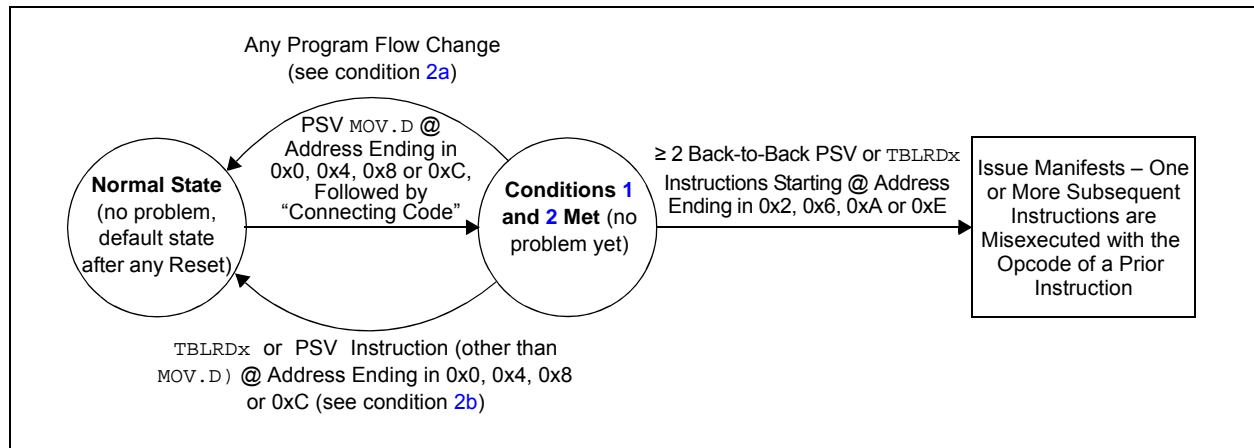
FIGURE 7: SIMPLIFIED BEHAVIOR

When two or more data Flash read instructions (via Program Space Visibility (PSV) read or table read) are executed back-to-back, one or more subsequent instructions can be misexecuted when all of the conditions in [Table 6](#) occur.

[Figure 7](#) provides an example of the effective behavior.

1. All instances of PSV `MOV.D` can be replaced with two PSV `MOV` instructions instead. Non-PSV `MOV.D` instructions acting on RAM/SFRs do not need to be modified; or
2. If not already present, a program flow change instruction (such as `BRA $+2`) can be inserted above back-to-back data Flash read sequences; or
3. Back-to-back data Flash read instruction sequences can be broken up by inserting a non-Flash read instruction (such as a `NOP`), in between the Flash read instructions; or
4. The alignment of the code can be shifted to avoid the required opcode location addresses.
