# **TMS320F28044 Digital Signal Processor Silicon Revision 0**

## **1 Introduction**

This document describes the silicon updates to the functional specifications for the TMS320F28044 digital signal processor (DSP).

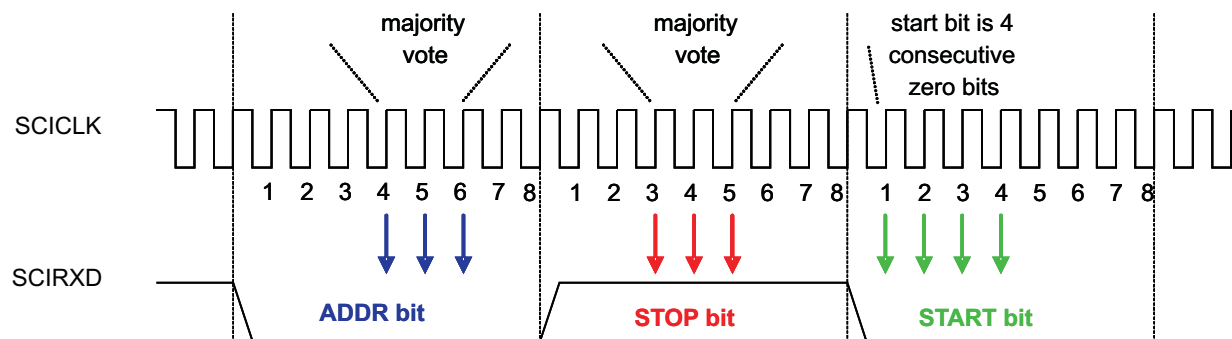
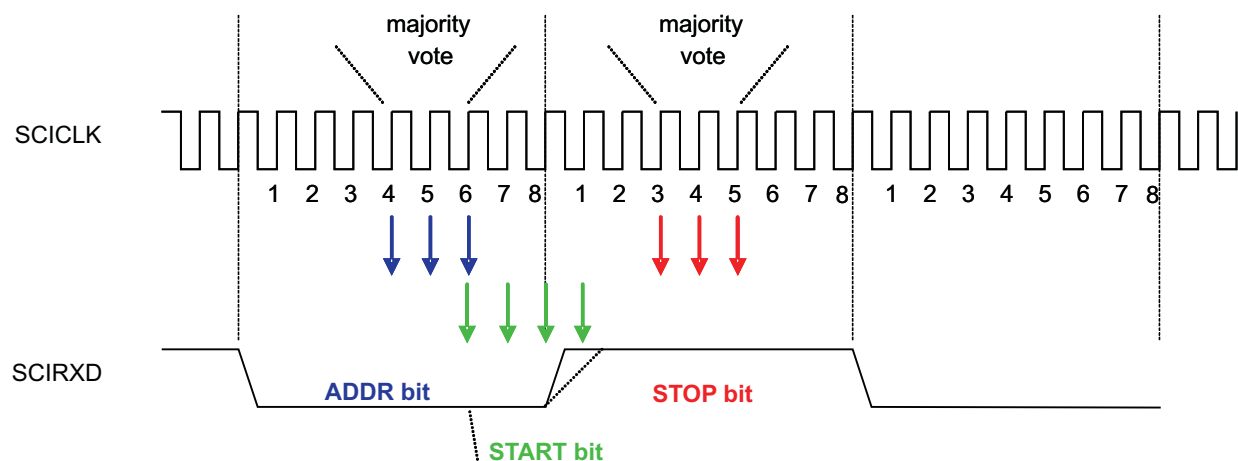
**Figure 3. Difference Between Expected and Erroneous Operation of START Bit**

SCI does not look for STOP bit after the ADDR bit. Instead, SCI starts looking for the start bit beginning on sub-sample 6 of the ADDR bit. Slow rise-time from ADDR to STOP bit can cause the false START bit to occur since the 4th sub-sample for the start bit may be sensed low.

*Expected Operation:*

*Erroneous Operation:*

Program the baud rate of the SCI to be slightly slower than the actual. This will cause the 4th sub-sample of the false START bit to be delayed in time, and therefore occur more towards the middle of the STOP bit (away from the signal transition region). The amount of baud slowing needed depends on the rise-time of the signal in the system. Alternatively, IDLE mode of the SCI module may be used, if applicable.
