*TMS570LS09/07xx Microcontroller*

**Silicon Revision A**

# **Silicon Errata**

Literature Number: SPNZ230B  
July 2015–Revised May 2016

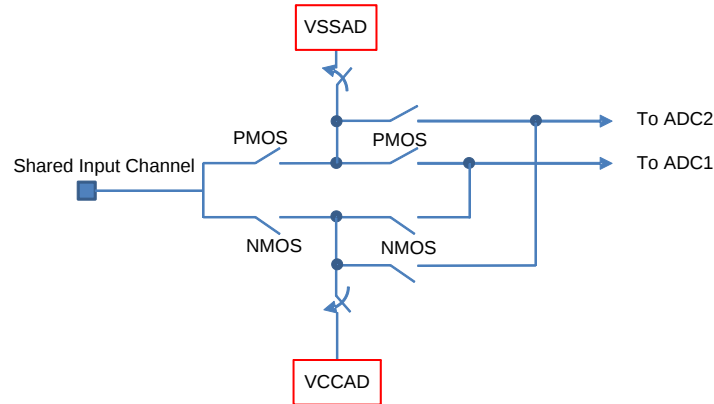
**Figure 2. Shared Input Channel in "Open" State**

**Issue** This microcontroller (MCU) has two Analog-to-Digital Converters (ADCs). Some of the input channels are unique to ADC1 while some are shared between ADC1 and ADC2. [Figure 2](#) shows a block diagram of an input channel shared between ADC1 and ADC2.

The PMOS and NMOS switches are open indicating that this shared input channel is not currently being sampled either by ADC1 or by ADC2. Also, there are switches to VCCAD and VSSAD that are closed. If any current is injected into this analog input, any leakage through the open PMOS switch will be shunted to VSSAD. These switches to VSSAD and VCCAD are opened as soon as this shared input channel is being sampled by either ADC1 or ADC2.
