# ES\_LPC11U6x

## Errata sheet LPC11U6x

Rev. 1.4 — 7 March 2018

Errata sheet

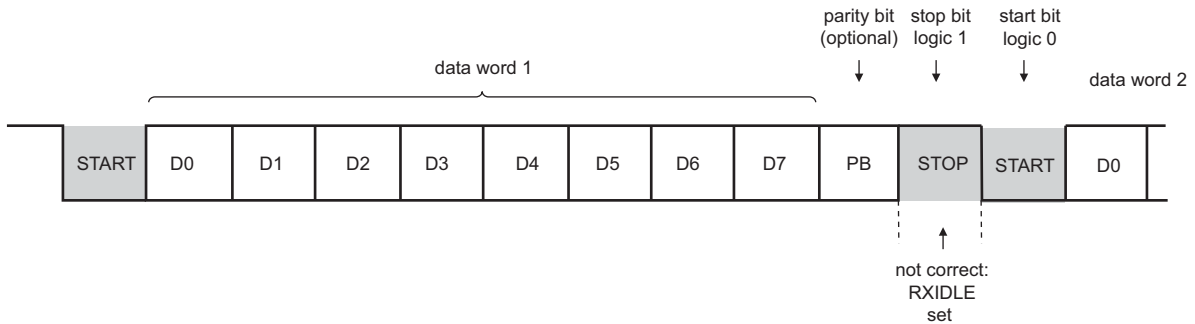
The RXIDLE bit is incorrectly set for a fraction of the clock cycle between the reception of the last data bit and the reception of the start bit of the next word, that is while the stop bit is received. RXIDLE is cleared at the beginning of the start bit.

**Fig 1. Incorrect setting of RXIDLE during UART receive**

When writing code that checks for the setting of any of the status bits RXIDLE, TXIDLE, TXDISSTAT, check the value of the status bit in the STAT register:

- If status bit = 1, add a delay of one UART bit time (if STOPLEN = 0, one stop bit) or two bit times (if STOPLEN = 1, two stop bits) and check the value of the status bit again:
  - If status bit = 1, the receiver is idle.
  - If status bit = 0, the receiver is receiving data.
- If the status bit = 0, the receiver is receiving data.

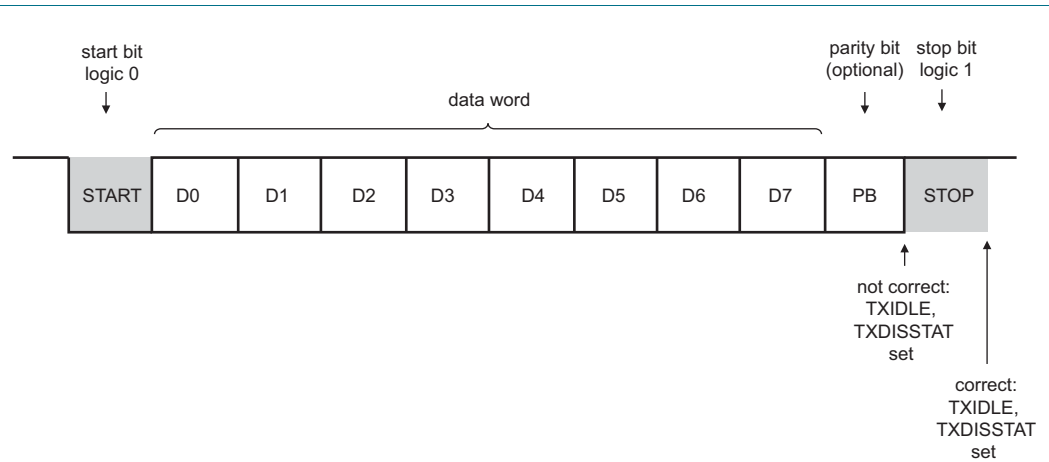
Both, TXIDLE and TXDISSTAT are set incorrectly between the last data bit and the stop bit while the transfer is still ongoing.

**Fig 2. Incorrect setting of TXIDLE and TXDISSTAT during UART transmit**
