PIC32MK General Purpose and Motor Control (GP/MC) Silicon Errata and Data Sheet Clarification

The PIC32MK General Purpose and Motor Control (GP/MC) family of devices that you have received conform functionally to the current Device Data Sheet (DS60001402F), except for the anomalies described in this document.

The silicon issues discussed in the following pages are for silicon revisions with the Device and Revision IDs listed in [Table 1](#). The silicon issues are summarized in [Table 2](#).

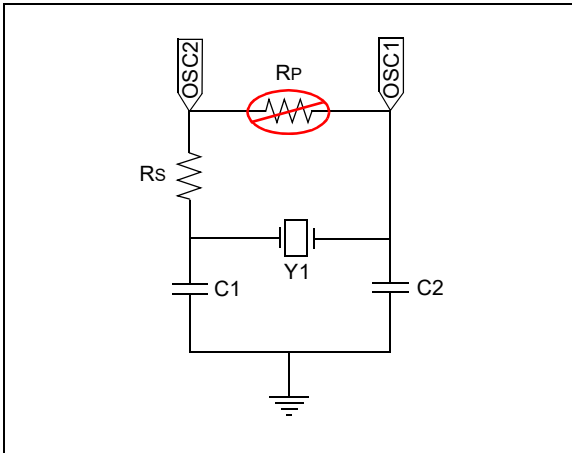
FIGURE 1: POSC CRYSTAL CIRCUIT

1. Module: Primary Oscillator

The POSC supports only specific crystal operation, as provided in [Table 1](#).

The Primary Oscillator (POSC) has been characterized to operate at 8 MHz and 12 MHz when the circuit shown in [Figure 1](#) is implemented and the operating conditions provided in [Table 1](#) are met.

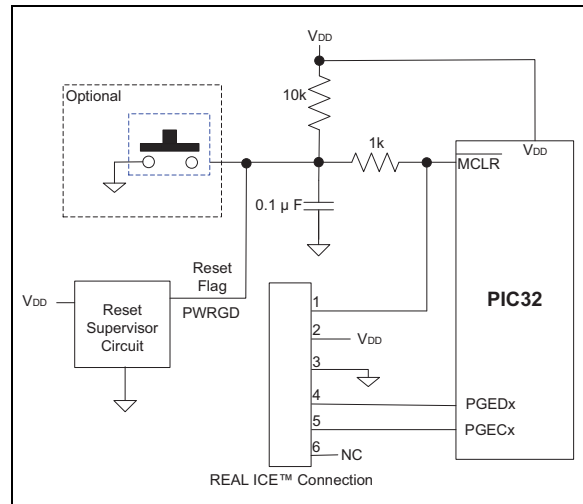
FIGURE 2: RESET SUPERVISOR CIRCUIT

On a BOR event, $V_{POR} < V_{DD} < V_{BOR}$, a Reset is not generated when the BOR threshold is reached. System clocks will stop with all I/O pins functions frozen in their present state until either V_{DD} falls to V_{POR} or V_{DD} returns to above V_{BOR} . The user must assess if this V_{DD} brown-out condition and the resulting frozen I/O pin state has an adverse effect on their application (UART, PWM, I/O, OC, etc.).

Note: For Motor Control applications utilizing the PWM module, **only Work around 1 is recommended.**
