Applicability

This document applies to the STM32F058C8/R8 devices and their variants shown in [Table 1](#).

[Section 1](#) gives a summary and [Section 2](#) a description of device limitations and documentation errata, with respect to the device datasheet and reference manual RM0091.

Table 1. Device variants

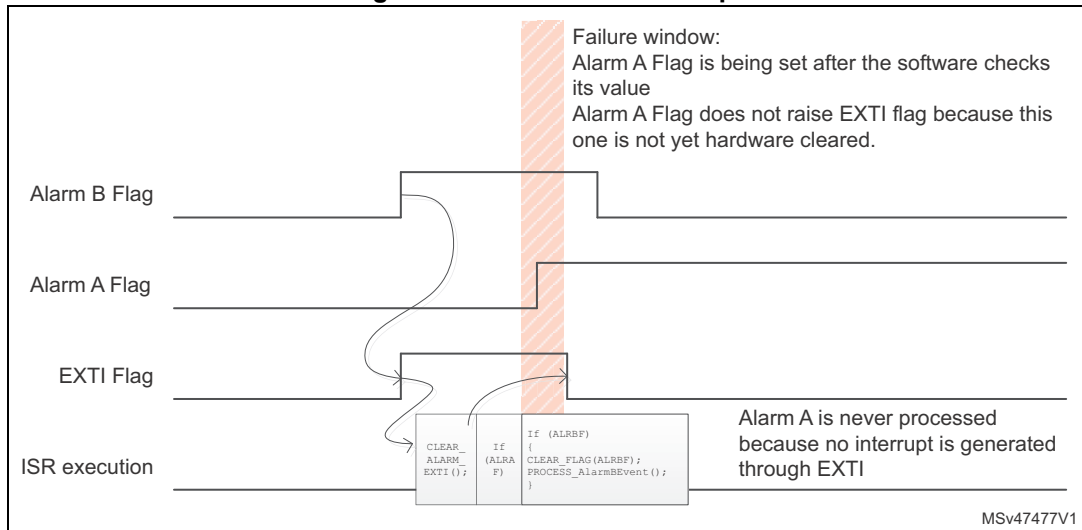
Figure 1. Masked RTC interrupt

The following code example and figure illustrate the failure mechanism: The Alarm A event is lost (fails to generate interrupt) as it occurs in the failure window, that is, after checking the Alarm A event flag but before the effective clear of the EXTI interrupt flag by hardware. The effective clear of the EXTI interrupt flag is delayed with respect to the software instruction to clear it.

Workaround

In the interrupt service routine, apply three consecutive event flag checks - source one, source two, and source one again, as in the following code example:

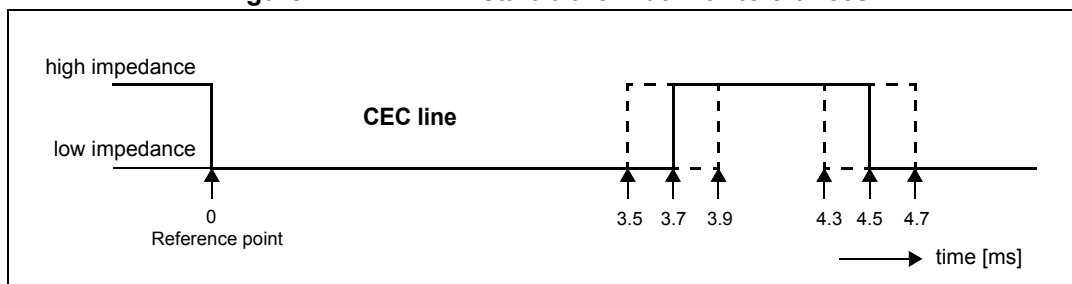
Figure 2. HDMI-CEC start bit format with tolerances

This failure is unlikely to happen as the CEC start bit corruption by another device can only occur if that device does not respect the CEC communication protocol.

The start bit timing standard tolerances are shown in [Figure 2](#). The start bit is initiated by the device by driving the CEC line low (reference point). After 3.7 ms, the device releases the CEC line and starts checking its level. The following conditions must be met for the start bit to be valid:

If one of these conditions is not met, the transmission is aborted and never automatically retried. No error flag is set and the TXSOM (Tx Start Of Message) bit is not cleared.

Workaround

The only way to detect this error is for the application software to start a timeout when setting the TXSOM bit, restart it upon ARBLST or any RX event (as the transmission can be delayed by interleaved reception), and stop it upon TXBR (proof that the start bit was transmitted successfully) or TXEND event, or upon any TX error (which clears TXSOM). If the timeout expires (because none of those events occurred), the application software must restart the HDMI-CEC peripheral and retransmit the message.
