# Chip Errata for the MPC8272 PowerQUICC II Family

This document describes all known silicon errata for the MPC8272 PowerQUICC II family of 0.13-μm (HiP7) communications processors. See [Table 2](#) for a list of devices.

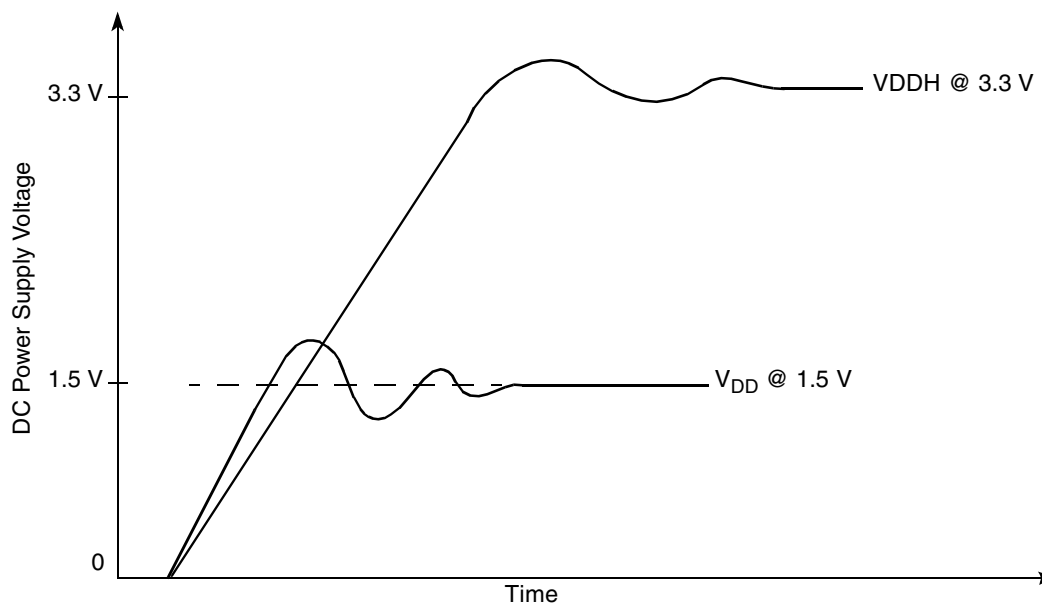
Figure 1. Power Supply Ramping

If core supply voltage (VDD) is below recommended operating conditions while I/O supply voltage (VDDH) is high during a power-on reset sequence, I/O pins (including those designated input only) might drive a value instead of being Hi-Z. This could confuse connected devices and, in turn, cause the PowerQUICC II device to behave improperly. Affected pins include such interfaces as the communication parallel I/O, reset, address and data bus pins, and JTAG pins. The value a pin may drive is random. As soon as core voltage has stabilized at its nominal level within recommended operating conditions, all pins will behave normally and the PowerQUICC II will continue to function properly.

It is recommended that VDD/VCCSYN be raised before or simultaneously with VDDH during the power-on reset sequence; that is, while  $VDDH \leq$  recommended operating condition for VDD/VCCSYN during ramp of all voltages, it should be ensured that  $VDD/VCCSYN \geq VDDH$  at all times. Refer to [Figure 1](#).

If the power supply design cannot be altered as recommended, then any logic connected to the PowerQUICC II which may react or be affected in an undesirable manner by unexpected low or high signal values during power ramp up should be appropriately secured in the design. Using

SDRAM as an example, it is usually sufficient to connect the CKE input to  $\overline{\text{PORESET}}$ . The practice of tying CKE high may not be safe and may lead to an unrecoverable system state.

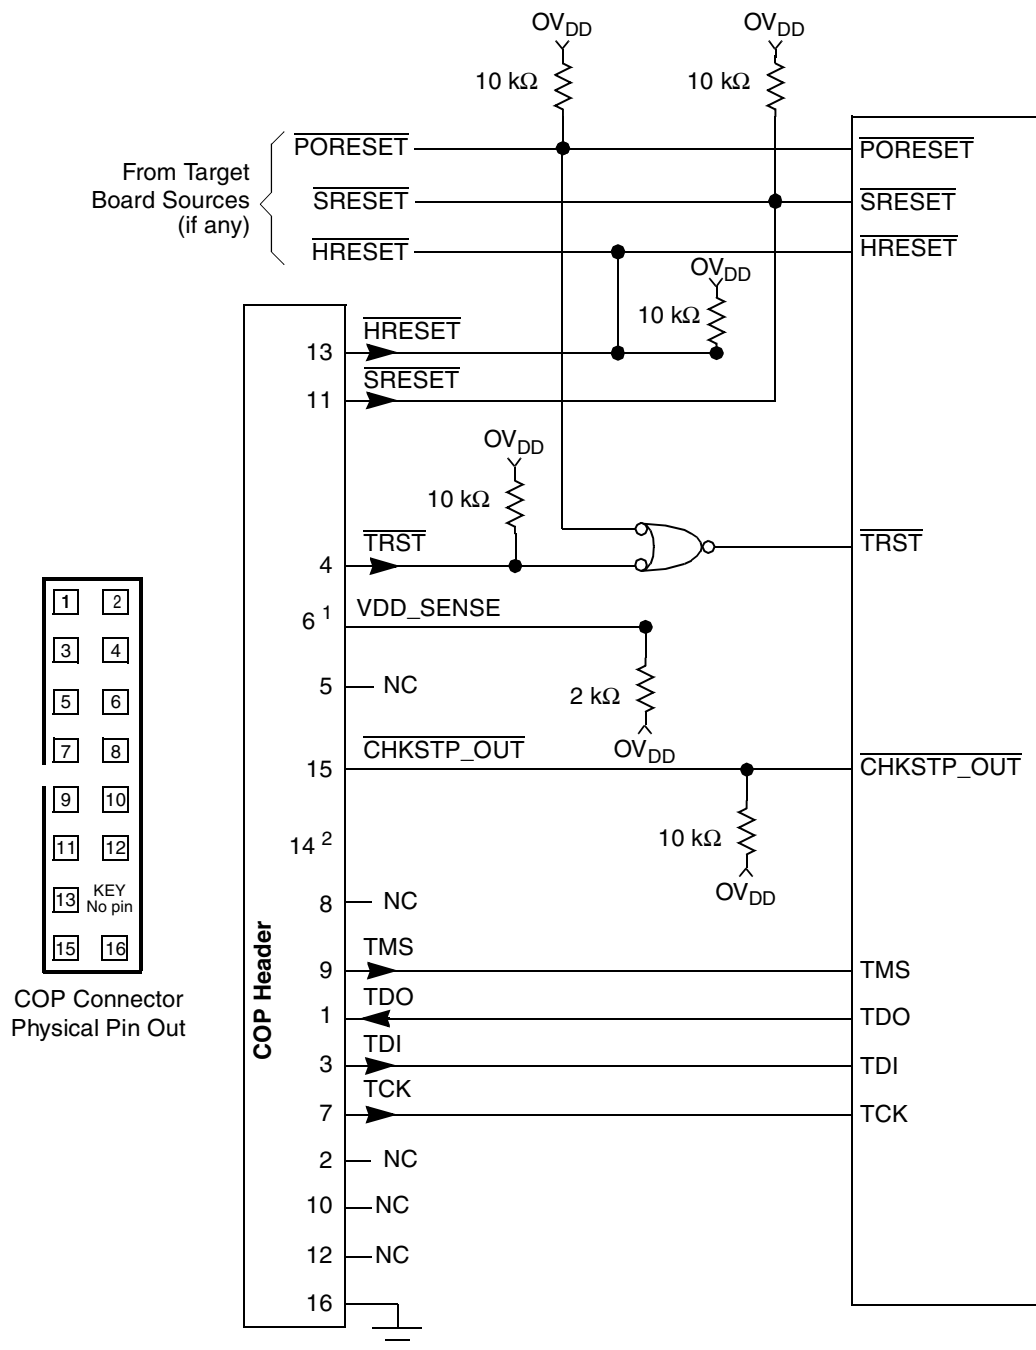
**Figure 2. COP Connections to PowerQUICC II Processors**

$\overline{\text{PORESET}}$  does not reset the CPU JTAG machine and, therefore,  $\overline{\text{TRST}}$  must be asserted during  $\overline{\text{PORESET}}$  in order for the CPU to work correctly.

For boards that require debugging capability, implement an external circuit as shown in [Figure 2](#).

1. Some systems require power to be fed from the application board into the debugger repeater card via the COP header. The resistor value for VDD\_SENSE is around 20 Ω.
2. Key location; pin 14 is not physically present on the COP header.

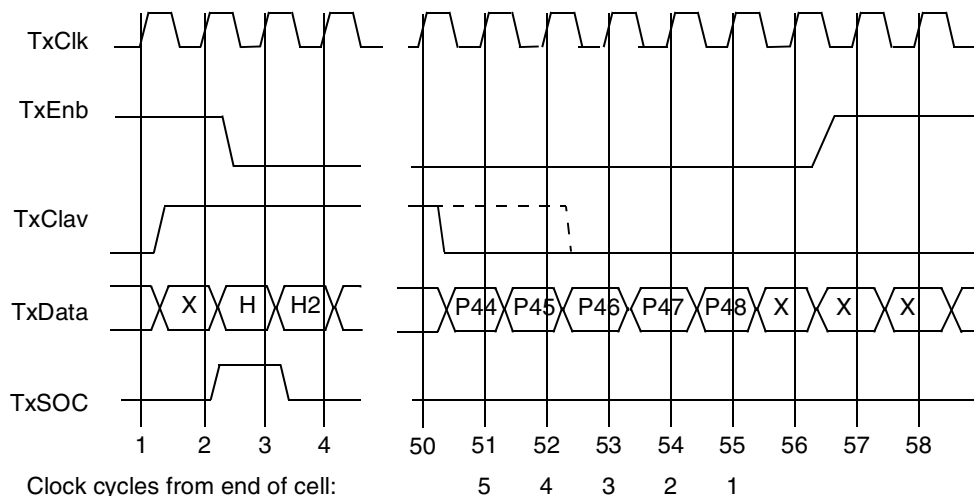
FCC ATM receive UTOPIA slave mode. When the RxFIFO is full, RxClav is negated 2 cycles before the end of the cell transfer instead of 4. A master that polls RxClav or pauses 3 or 4 cycles before the end of the cell transfer may sample a false RxClav and an overrun condition may occur. The dashed line in the timing diagram below depicts the actual RxClav negation (2 cycles before the end of the cell transfer instead of 4 cycles). The signals in the timing diagram shown in [Figure 3](#) are with respect to the master, hence, Tx interface is shown.

- Master should not poll RxClav or pause cell transfer at 4 cycles before the end of cell transfer. Master should poll 2 cycles before the end of the current cell or later. This can be achieved by introducing a cell-to-cell polling (and transfer) delay, which is equal or larger then one cell transfer time. If this can be achieved, the impact on performance is minimal.
- Configuring ATM only on FCC1 and setting FPSMR[TPRI] ensures highest priority to FCC1 Rx. In addition, for CPM utilization lower then 80% (as reported by the CPM performance tool based on UTOPIA maximal bus rate) the CPM performance is enough to guarantee that the RxFIFO does not fill up.
