## CC430F5135 Device Erratasheet

The revision of the device can be identified by the revision letter on the [Package Markings](#) or by the [HW\\_ID](#) located inside the TLV structure of the device

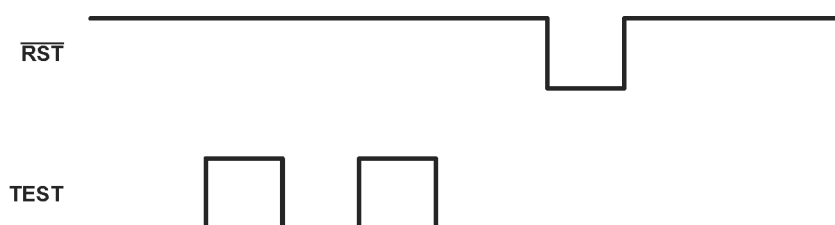
| <b>Description</b> | The methods used to exit the BSL per MSP430 Programming Via the Bootstrap Loader ( <a href="#">SLAU319</a> ) are invalid. |

| <b>Workaround</b> | <p>To exit the BSL one of the following methods must be used.</p> <ul style="list-style-type: none"> <li>- A Power cycle</li> </ul> <p>or</p> <ul style="list-style-type: none"> <li>- Toggle the TEST pin twice when nRST is high and after 50us pull nRST low.</li> </ul> |

Note: This toggling of TEST pins is not subject to timing constraints. The appropriate level transitions on TEST pin, followed by a RST pulse after 50us, are sufficient to trigger an exit from BSL mode.
