## **CC1020 Errata Note 001, rev. 1.0**

**Improved ESD protection requires changes in matching network and register values for optimum performance.**

**CC1020 Errata Note 003, rev. 2.0**

**CC1020 Errata Note 004, rev. 1.0**

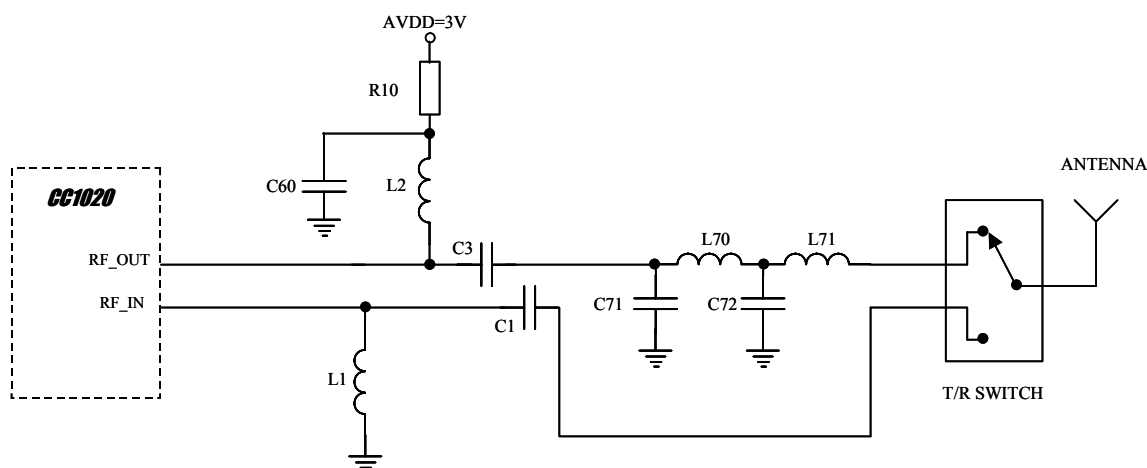
**Figure 1: Schematic diagram of the input/output matching network**

When using high output power settings with the CC1020EMX-433 v1.0 the recommended maximum voltage level on the RF\_OUT pin (pin 21) is exceeded. This may cause a drop in output power over time, particularly if the transmit duty cycle is high. Power drop has only been observed on the 402 – 470 MHz version of the reference design (i.e. the CC1020EMX-433 v1.0) as the 804 – 940 MHz version has a considerably lower voltage swing during transmit.

By lowering the load impedance “seen” by the CC1020 power amplifier, the output power drop is avoided. The series resistor R10 is added to reduce the DC voltage at the RF\_OUT pin. Finally, for the CC1020EMX-433 the filter topology has been changed from a  $\pi$ -type filter to a T-type filter in order to achieve a better combination of reflection factors for the harmonics. This change applies to the 433 MHz frequency only. Altogether, these changes, which are implemented in the new CC1020EMX reference design v2.0, remedy the output power drop problem. The new solution increases the current consumption in transmit mode by typically 3 mA at maximum output power.

Copy the CC1020EMX reference design v1.1 (4-layer), v2.0 (2-layer) or newer.

A schematic diagram of the input/output matching networks for the CC1020EMX reference design v2.0 is shown in *Figure 1*.

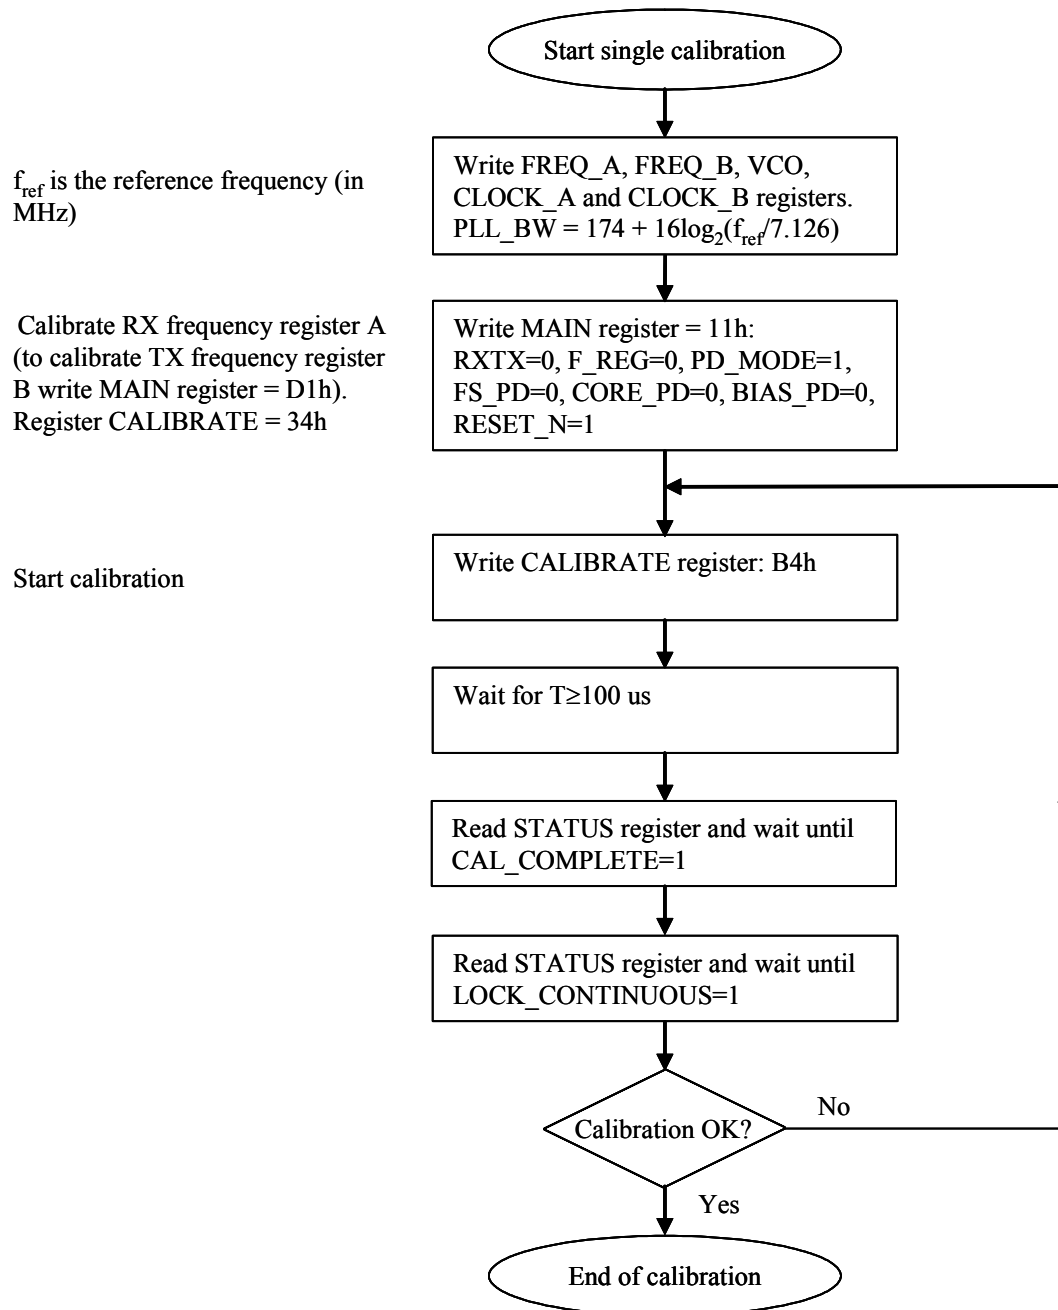
**Figure 1: Recommended PLL calibration procedure**

When using a 14.7456 MHz crystal frequency the CC1020 calibration (monitored by steps 2 and 3) typically lasts 27 ms. However, it has been observed that the CAL\_COMPLETE indicator in the STATUS register is unreliable during the first 100  $\mu$ s after initiating the calibration. As a result step 2 might indicate calibration complete too early, i.e. before the actual calibration has actually completed. In such a situation step 3 (LOCK monitoring) is executed during instead of after calibration. In order to avoid this inconsistency, a waiting period of at least 100  $\mu$ s between calibration start and the start of the polling should be applied using one of the following methods:

In less than 10 ppm of all PLL calibrations performed it was observed that CC1020 did not achieve LOCK even when introducing a 100  $\mu$ s wait period before polling of [STATUS.CAL\_COMPLETE] was initiated. The reason for no LOCK still occurring, even when calibrating the PLL with this small wait period, is due to the PLL calibration procedure making an erroneous frequency measurement causing the PLL calibration algorithm to choose a wrong capacitor array setting producing a no LOCK situation. For this reason it is important to control that the PLL calibration achieves LOCK and recalibrate if it does not.

For those users who have not already implemented a recalibration procedure in software it is strongly recommended to avoid polling [STATUS.CAL\_COMPLETE] until 100  $\mu$ s has elapsed following calibration start, then monitor LOCK after calibration complete and, if LOCK is not achieved, recalibrate until LOCK is successfully achieved. The recommended calibration procedure, including recalibration, is provided in figure 1.
