## MSP430F5634 Device Erratasheet

## 7 Detailed Bug Description

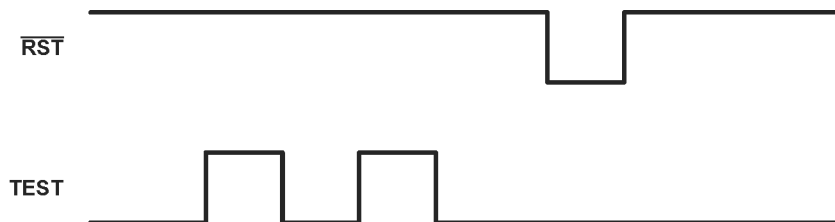
| <b>Description</b> | The methods used to exit the BSL per MSP430 Programming Via the Bootstrap Loader ( <a href="#">SLAU319</a> ) are invalid. |

Note: This toggling of TEST pins is not subject to timing constraints. The appropriate level transitions on TEST pin, followed by a RST pulse after 50us, are sufficient to trigger an exit from BSL mode.

| <b>Workaround</b> | <p>To exit the BSL one of the following methods must be used.</p> <ul style="list-style-type: none"> <li>- A Power cycle</li> </ul> <p>or</p> <ul style="list-style-type: none"> <li>- Toggle the TEST pin twice when nRST is high and after 50us pull nRST low.</li> </ul> |
