## Applicability

This document applies to the part numbers of STM32F042x4/x6 devices listed in [Table 1](#) and their variants shown in [Table 2](#).

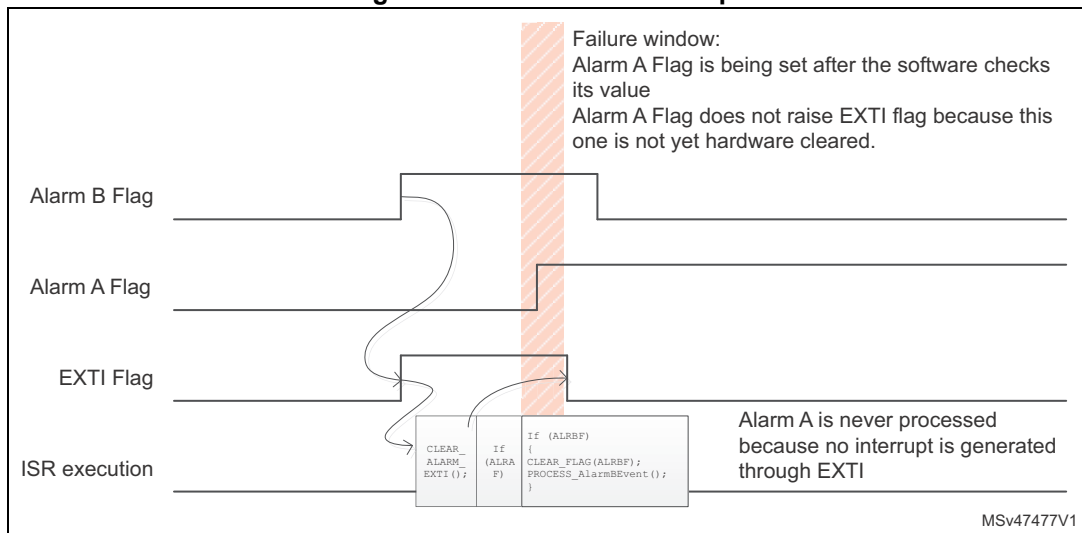
**Figure 1. Masked RTC interrupt**

## 2.7.4 RTC interrupt can be masked by another RTC interrupt

The following code example and figure illustrate the failure mechanism: The Alarm A event is lost (fails to generate interrupt) as it occurs in the failure window, that is, after checking the Alarm A event flag but before the effective clear of the EXTI interrupt flag by hardware. The effective clear of the EXTI interrupt flag is delayed with respect to the software instruction to clear it.

**Workaround**

In the interrupt service routine, apply three consecutive event flag checks - source one, source two, and source one again, as in the following code example:

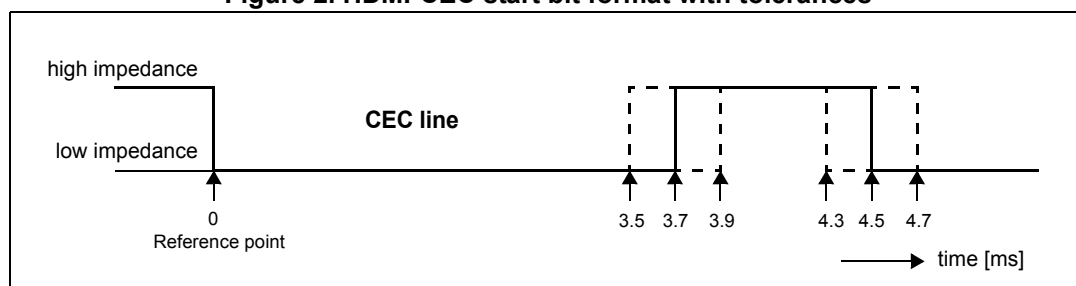
**Figure 2. HDMI-CEC start bit format with tolerances**

This failure is unlikely to happen as the CEC start bit corruption by another device can only occur if that device does not respect the CEC communication protocol.

The start bit timing standard tolerances are shown in [Figure 2](#). The start bit is initiated by the device by driving the CEC line low (reference point). After 3.7 ms, the device releases the CEC line and starts checking its level. The following conditions must be met for the start bit to be valid:

If one of these conditions is not met, the transmission is aborted and never automatically retried. No error flag is set and the TXSOM (Tx Start Of Message) bit is not cleared.

### Workaround

The only way to detect this error is for the application software to start a timeout when setting the TXSOM bit, restart it upon ARBLST or any RX event (as the transmission can be delayed by interleaved reception), and stop it upon TXBR (proof that the start bit was transmitted successfully) or TXEND event, or upon any TX error (which clears TXSOM). If the timeout expires (because none of those events occurred), the application software must restart the HDMI-CEC peripheral and retransmit the message.
