STM32F100xC, STM32F100xD and STM32F100xE
high-density value line device limitations

Silicon identification

This errata sheet applies to the revision A of the STMicroelectronics high-density value line products.

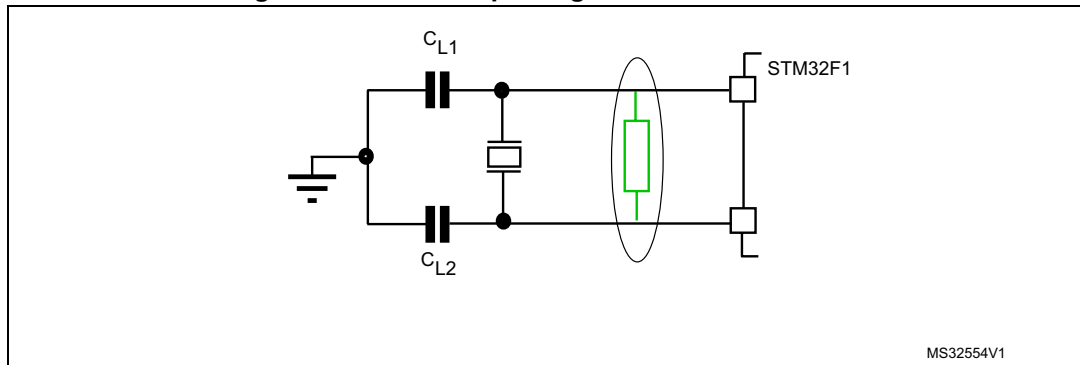
Figure 1. LSE start-up using an additional resistor

The LSE (low speed external) oscillator system is designed to minimize the overall power consumption of the STM32F1 microcontroller. It is extremely important to take specific care in the design of the PCB to ensure this low power oscillator starts in harsh conditions. In some PCB designs without coating, an induced low leakage may prevent the LSE to start-up, regardless of the 32.768 KHz crystal used. This phenomenon is amplified in humid environments that create frost on the OSC32_IN/OSC32_OUT tracks. This unwanted behavior may happen only at the first back-up domain power-on of the device.

It is recommended to mount an additional parallel feedback resistor (from 16 MΩ to 22 MΩ) on board to help the oscillation start-up in all cases (see [Figure 1](#)). For more details on compatible crystals and hardware techniques on PCB, refer to AN2867 “Oscillator design guide for STM8AF/AL/S, STM32 MCUs and MPUs”, available on www.st.com.
