## dsPIC33EPXXXGS70X/80X Family Silicon Errata and Data Sheet Clarification

The dsPIC33EPXXXGS70X/80X family devices that you have received conform functionally to the current Device Data Sheet (DS70005258C), except for the anomalies described in this document.

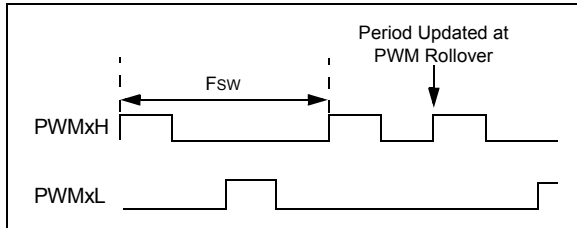
FIGURE 1:

When the PWM module is configured for Push-Pull mode (IOCONx[11:10] = 0b10) with the Enable Immediate Period Update bit enabled (PTCON [10] = 1), a write to the Period register that coincides with the period rollover event may cause the push-pull output logic to produce back-to-back pulses on the PWMx pins (see Figure 1).

Ensure that the update to the PWM Period register occurs away from the PWM rollover event by setting the EIPU bit (PTCON[10] = 1). Use either the PWM Special Event Trigger (SEVTCMP) or the PWM Primary Trigger (TRIGx) to generate a PWM Interrupt Service Routine (ISR) near the start of the PWM cycle. This ISR will ensure that period writes do not occur near the PWM period rollover event.

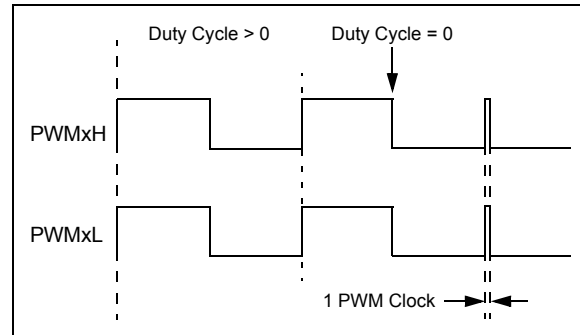
FIGURE 2: EXAMPLE FOR REDUNDANT OUTPUT MODE

In the Redundant Output mode (IOCONx[11:10] = 0b01) and Push-Pull Output mode (IOCONx[11:10] = 0b10), with the Immediate Update Enable bit disabled (PWMCONx[0] = 0), when the Duty Cycle register is updated from a non-zero value to zero, a glitch pulse of a width equal to 1 PWM clock will appear at the next PWM period boundary, as shown in Figure 2 (for the Redundant Output mode). The Duty Cycle register refers to the PDCx register if PWMCONx[8] = 0 or the MDC register if PWMCONx[8] = 1.

If the application requires a zero duty cycle output, there are two possible work around methods:

1. Use the PWM override feature to override the PWM output to a low state instead of writing to the Duty Cycle register. In order to switch back to a non-zero duty cycle output, turn off the PWM override. The override-on and override-off events must be timed close to the PWM period boundary if the IOCONx register has been configured with IOCONx[0] = 0 (i.e., output overrides through the OVRDAT[1:0] bits occur on the next CPU clock boundary).
2. Enable the Immediate Update Enable bit (PWMCONx[0] = 1) while configuring the PWMx module (i.e., before enabling the PWMx module, PTCON[15] = 1). With the Immediate Update enabled, writes to the Duty Cycle register can have an immediate effect on the PWM output. Therefore, the duty cycle write operations must be timed close to the PWM period boundary in order to avoid distortions in the PWM output.

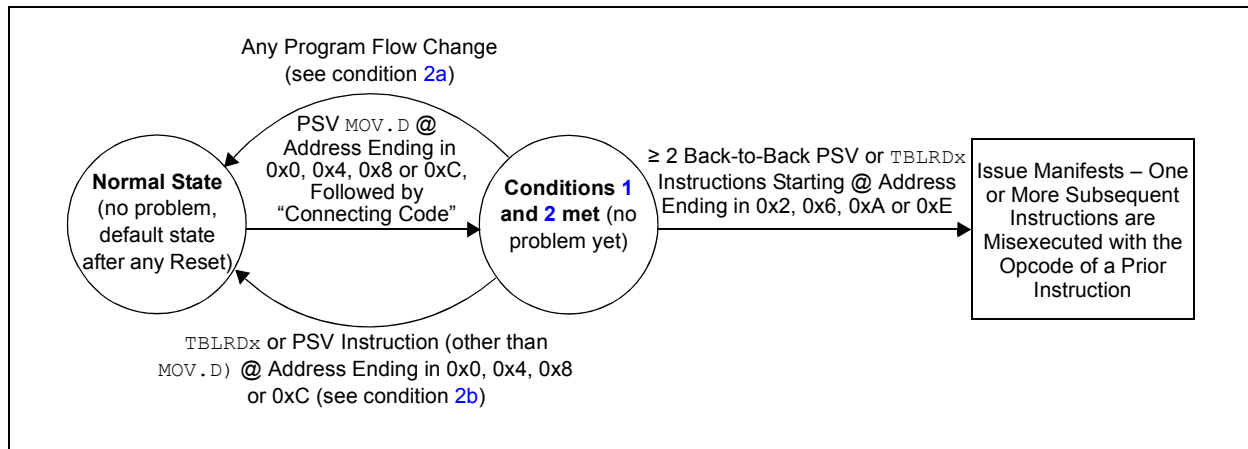
**FIGURE 3: SIMPLIFIED BEHAVIOR**

When two or more data Flash read instructions (via Program Space Visibility (PSV) read or Table Read) are executed back-to-back, one or more subsequent instructions can be misexecuted when all of the conditions in [Table 4](#) occur.

1. A PSV <code>MOV.D</code> instruction is executed, with opcode at address ending in 0x0, 0x4, 0x8 or 0xC; and
2. Some “connecting code” is executed (following the <code>MOV.D</code> of condition 1), with the properties: <ul style="list-style-type: none"> <li>a) The connecting code does not include any program flow changes, including: taken branch instructions (including all versions of <code>BRA</code>, <code>CPBEQ</code>, <code>CPBGT</code>, <code>CPBLT</code>, <code>CPBNE</code>), <code>CALL</code>, <code>CALL.L</code>, <code>GOTO</code>, <code>GOTO.L</code>, <code>RCALL</code>, <code>RETLW</code>, <code>RETURN</code>, vectoring to an ISR, returning from an interrupt (<code>RETFIE</code>) and certain debug operations, such as break and one-step; and</li> <li>b) The connecting code does not include a <code>TBLRDx</code> or non-<code>MOV.D</code> PSV instruction, located at a Flash memory address ending in 0x0, 0x4, 0x8 or 0xC; and</li> <li>c) The connecting code is at least two instruction words in length; and</li> <li>d) The connecting code does not end with a <code>REPEAT</code> instruction, with count &gt; 0; and</li> </ul>

3. $\geq 2$ back-to-back PSV or <code>TBLRDx</code> instructions are executed (following the code of condition 2), where the first of the back-to-back instructions is located at an address ending in 0x2, 0x6, 0xA or 0xE.

The issue can be avoided by ensuring any one or more of the requirements are not met. For example:

1. All instances of PSV `MOV.D` can be replaced with two PSV `MOV` instructions instead. Non-PSV `MOV.D` instructions acting on RAM/SFRs do not need to be modified; or
2. If not already present, a program flow change instruction (such as `BRA $+2`) can be inserted above back-to-back data Flash read sequences; or
3. Back-to-back data Flash read instruction sequences can be broken up by inserting a non-Flash read instruction (such as a `NOP`), in between the Flash read instructions; or
4. The alignment of the code can be shifted to avoid the required opcode location addresses.
