# **AM1802 ARM Microprocessor Silicon Revisions 2.3, 2.1 and 2.0**

## **Silicon Errata**

Literature Number: SPRZ340H  
November 2010–Revised September 2014

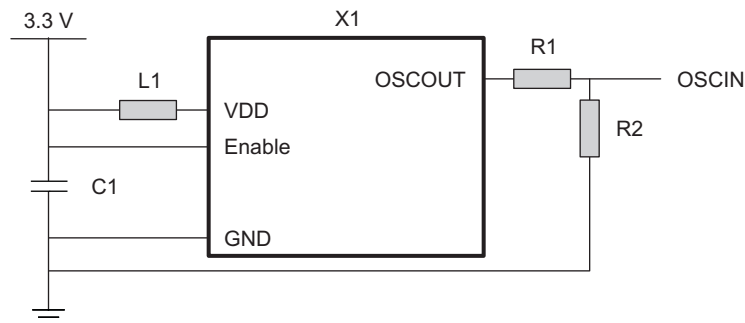
**Figure 2. External 3.3V Clock Source**

On all silicon revisions, certain design elements make this device susceptible to radiated noise during an ESD strike, as described in the standard IEC 61000-4-2. Exposure to the electrical noise caused by the ESD can cause soft device failures due to noise coupling on the system clock (OSCIN). ESD events within the IEC spec range do not cause permanent device damage and full functionality is recoverable with a device reset. The sensitivity to this noise issue is primarily due to the 1.2V oscillator/clock input implemented on this device. The low voltage range, coupled with slow rise and fall times, provides a lower noise margin than other TI devices with higher voltage internal oscillators (for example, 1.8V or 3.3V oscillators).

If ESD robustness is a concern, it is strongly recommended to avoid using the internal oscillator as a clock source. An external 3.3V clock source with a resistor voltage divider as in [Figure 2](#) can be used to externally generate the required 1.2V input clock. By using an external clock input with fast rise/fall times (less than 5 ns), the noise margin improves significantly, increasing ESD noise resistance.

A Legend: L1 = ferrite bead; C1 = 0.1 uF; R1 = 165 ohm / 5%; R2 = 100 ohm / 5%

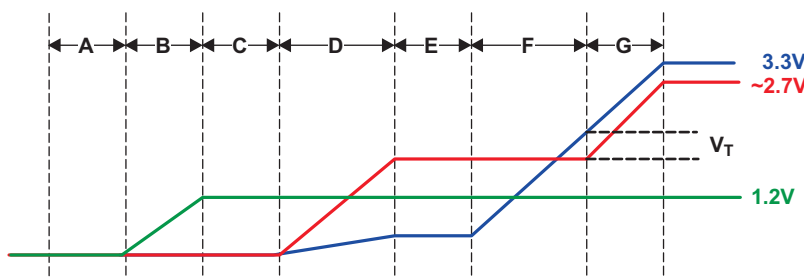
**Figure 4. Faulty power-supply ramp**

The behavior is the same until zone G. When the DVDD3318\_x supply exceeds DVDD18 by a transistor  $V_T$ , the DVDD18 supply begins to be pulled up by the DVDD3318\_x supply and follows the DVDD3318\_x supply by DVDD3318\_x -  $V_T$ . Since the DVDD18 supply is often connected to other 1.8V supplies in the design, these other supplies can be pulled up also.

The condition occurs because the dual-voltage IO buffers have voltage detection circuitry that monitors DVDD3318\_x during reset and determines whether the applied supply voltage is 1.8V or 3.3V. This detection circuitry then configures the IOs to operate at the appropriate voltage. As the DVDD3318\_x supply ramps, there is a small range near DVDD18 +  $V_T$  where the voltage detection circuit finds the state indeterminate and briefly turns on circuitry associated with both voltage options creating a current path between them. This current path can cause the DVDD18 supply to be pulled up. The mechanism for this behavior is explained below:

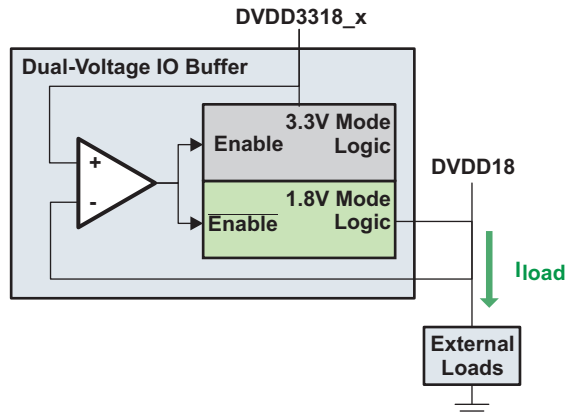
Figure 5. Behavior of the IO buffer during Zone F

As the DVDD3318\_x supply ramps, but is not yet one  $V_T$  above the DVDD18 supply, the comparator enables the 1.8V mode logic section and disables the 3.3V mode logic section. No unexpected current flows between the two sections.

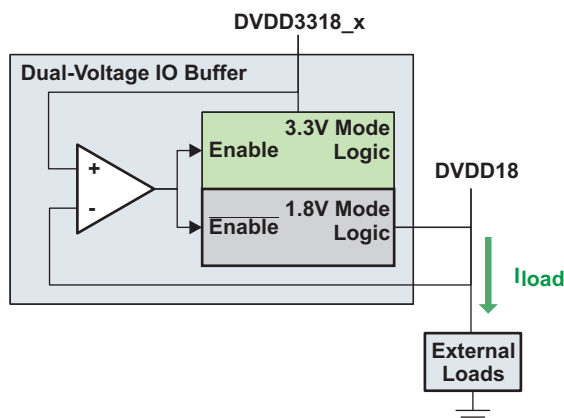
If the load current is high enough or the DVDD18 power supply can oppose the leakage current, then the DVDD18 voltage stays low enough for:

- the comparator to recognize 3.3V mode
- the 1.8V mode logic is turned off
- the leakage stops

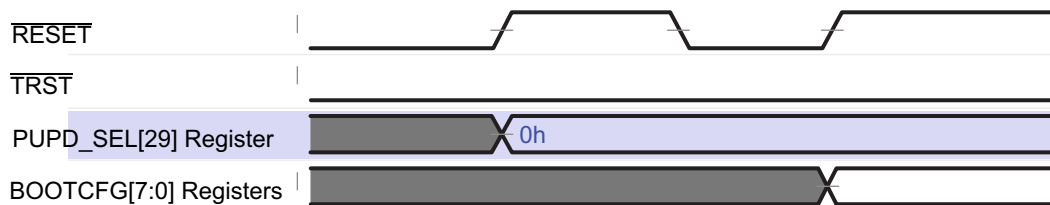
### Initialization of PUPD\_SEL[29] and BOOTCFG[7:0] Registers with Weak or No External Pull Resistors on BOOT[7:0] Pins

Internal pullups being enabled on the BOOT[7:0] pins may result in boot failures. If weak external pulldown resistors are used on the PCB to select the boot mode, they may not be able to overpower the internal pullups. This can result in the wrong boot mode being latched in the BOOTCFG[7:0] register when coming out of Reset.

Once the device is out of Reset, the PUPD\_SEL[29] register is initialized, and the internal pulldown resistors for the BOOT[7:0] pins are all enabled. Issuing a second Power-On Reset ( $\overline{\text{POR}}$ ) results in the intended boot mode being latched, since the pins are internally pulled down as expected.

[Initialization of PUPD\\_SEL\[29\] and BOOTCFG\[7:0\] Registers with Weak or No External Pull Resistors on BOOT\[7:0\] Pins](#) shows the behavior of the PUPD\_SEL[29] register before and after reset. Assuming weak or no external pull resistors are on the BOOT[7:0] pins, the BOOTCFG register will latch the unknown values after the device initially comes out of Reset. Note that,  $\overline{\text{TRST}}$  **must** always be low in order to issue a  $\overline{\text{POR}}$  and latch the boot pin values -- the boot pins are not latched after a Warm Reset.

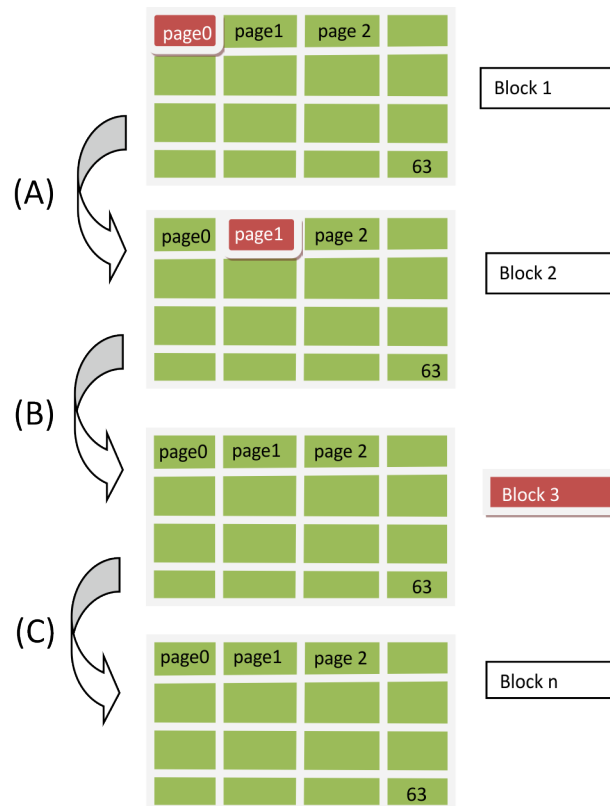
## D800K008 ROM Behavior With Software Patch Applied<sup>(1)</sup>

(1) All pages marked in **green** are good and all pages marked in **red** have "uncorrectable" errors.

This workaround is implemented using a software patch that is loaded in device RAM at boot time and is designed to change the default behavior of the ECC Correct and Read functions in the RBL. The patch binary replaces function pointers to the ECC Correct and Read functions in the ROM function table, (defined in device internal memory), during boot. The patch binary will reside in page0 of the NAND block and so will be applied only after the page0 of a good block has been read.

Once the patch is read, all subsequent page reads in the block will use the new ECC Correct and Read functions. ECC data errors on any page (other than page0) are ignored, any user data error (up to 4 bit errors total) is corrected and the boot process continues. If an uncorrectable error is detected on any page, the block is skipped and the boot process is restarted on the next good block. The behavior of the device boot from the NAND after application of the patch is shown in [D800K008 ROM Behavior With Software Patch Applied<sup>\(1\)</sup>](#).

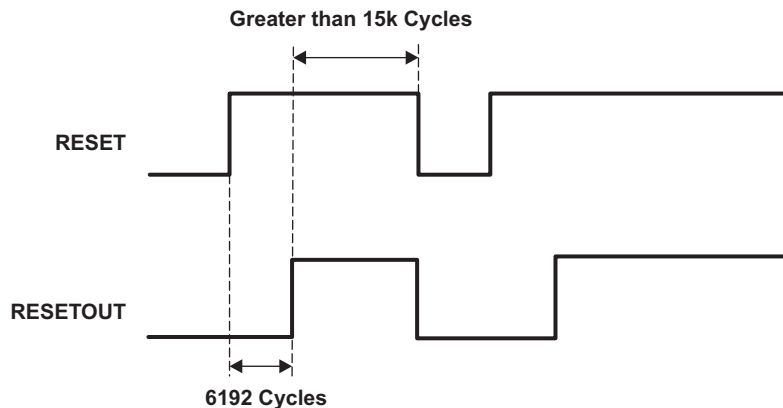
**Figure 8. First POR Reset Timing**

The 15k clock cycle count does not include the 6192 clock cycles required to complete a device POR reset (see [Figure 8](#)). With a 24MHz crystal, the first RESET signal must be asserted high for at least 883us (or approximately 1ms).
