# dsPIC33EPXXX(GP/MC/MU)806/810/814 and PIC24EPXXX(GP/GU)810/814

## dsPIC33EPXXX(GP/MC/MU)806/810/814 and PIC24EPXXX(GP/GU)810/814 Family Silicon Errata and Data Sheet Clarification

The dsPIC33EPXXX(GP/MC/MU)806/810/814 and PIC24EPXXX(GP/GU)810/814 family devices that you have received conform functionally to the current Device Data Sheet (DS70616G), except for the anomalies described in this document.

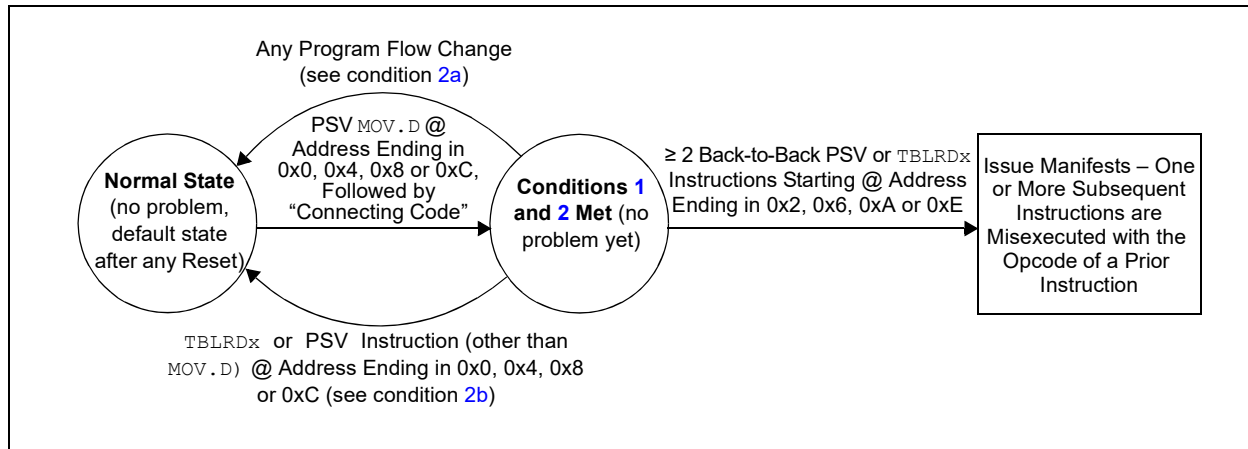
**FIGURE 1: SIMPLIFIED BEHAVIOR**

When two or more data Flash read instructions (via Program Space Visibility (PSV) read or table read) are executed back-to-back, one or more subsequent instructions can be misexecuted when all of the conditions in Table 3 occur.

1.	A PSV <code>MOV.D</code> instruction is executed, with opcode at address ending in 0x0, 0x4, 0x8 or 0xC; and
2.	Some “connecting code” is executed (following the <code>MOV.D</code> of condition 1), with the properties: <ul style="list-style-type: none"> <li>a) The connecting code does not include any program flow changes, including: taken branch instructions (including all versions of <code>BRA</code>, <code>CPBEQ</code>, <code>CPBGT</code>, <code>CPBLT</code>, <code>CPBNE</code>), <code>CALL</code>, <code>CALL.L</code>, <code>GOTO</code>, <code>GOTO.L</code>, <code>RCALL</code>, <code>RETLW</code>, <code>RETURN</code>, vectoring to an ISR, returning from an interrupt (<code>RETFIE</code>) and certain debug operations, such as <code>break</code> and <code>one-step</code>; and</li> <li>b) The connecting code does not include a <code>TBLRDx</code> or non-<code>MOV.D</code> PSV instruction, located at a Flash memory address ending in 0x0, 0x4, 0x8 or 0xC; and</li> <li>c) The connecting code is at least two instruction words in length; and</li> <li>d) The connecting code does not end with a <code>REPEAT</code> instruction, with count &gt; 0; and</li> </ul>

3.	≥ 2 back-to-back PSV or <code>TBLRDx</code> instructions are executed (following the code of condition 2), where the first of the back-to-back instructions is located at an address ending in 0x2, 0x6, 0xA or 0xE.

Figure 1 provides an example of the effective behavior.

The issue can be avoided by ensuring any one or more of the requirements are not met. For example:

1. All instances of PSV `MOV.D` can be replaced with two PSV `MOV` instructions instead. Non-PSV `MOV.D` instructions acting on RAM/SFRs do not need to be modified; or
2. If not already present, a program flow change instruction (such as `BRA $+2`) can be inserted above back-to-back data Flash read sequences; or
3. Back-to-back data Flash read instruction sequences can be broken up by inserting a non-Flash read instruction (such as a `NOB`) in between the Flash read instructions; or
4. The alignment of the code can be shifted to avoid the required opcode location addresses.

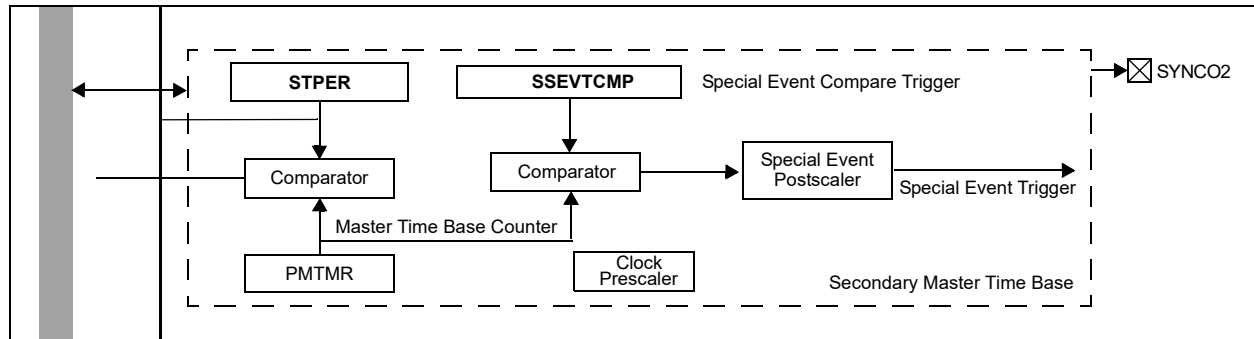
**FIGURE 16-2: HIGH-SPEED PWM MODULE REGISTER INTERCONNECTION DIAGRAM**

In **Figure 16-2: High-Speed PWM Module Register Interconnection Diagram**, the Secondary Master Time Base section has been updated. The updated text is shown in **bold** in [Figure 16-2](#) below.
