## ***TMS320F2807x MCUs***

### ***Silicon Revisions C, B***

This document describes the silicon updates to the functional specifications for the TMS320F2807x microcontrollers (MCUs).

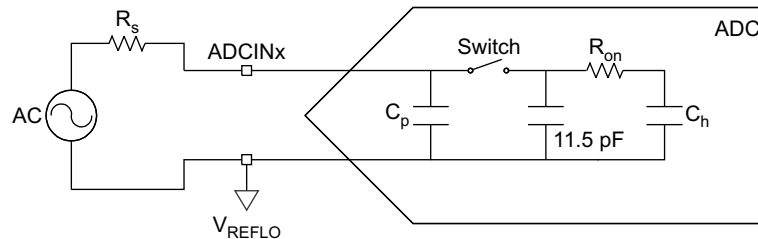
**Figure 3. Single-Ended Input Model**

**Details** The ADC input model should be used to select the sample-and-hold (S+H) duration for each ADC input. For the revisions affected, if the currently converting channel is an even-numbered channel and the previously converted channel was an odd-numbered channel (or vice versa), then the 12-bit input model will not accurately predict ADC input performance. Under these conditions, an additional capacitance should be added to the model. This capacitance has a value of 11.5 pF and should be placed between the S+H switch and  $R_{on}$  as shown in [Figure 3](#).

**Workaround(s)** For the revisions affected, when subsequent conversions switch between channel groups, the S+H duration should be chosen to account for the additional capacitance.

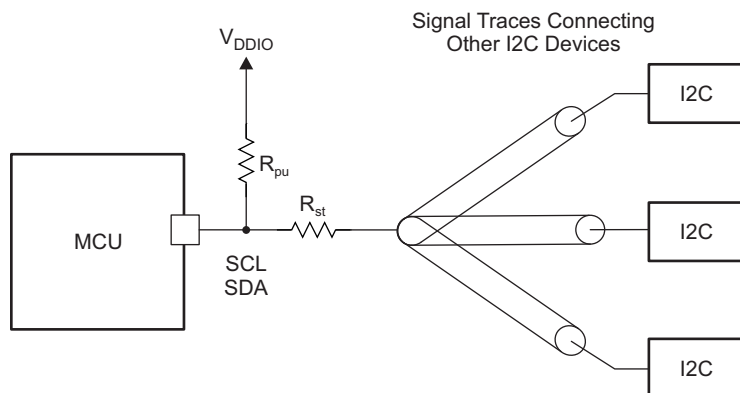
**Figure 7. Placement of Series Termination Resistor and Pullup Resistor**

The SDA and SCL outputs are implemented with push-pull 3-state output buffers rather than open-drain output buffers as required by I2C. While it is possible for the push-pull 3-state output buffers to behave as open-drain outputs, an internal timing skew issue causes the outputs to drive a logic-high for a duration of 0–5 ns before the outputs are disabled. The unexpected high-level pulse will only occur when the SCL or SDA outputs transition from a driven low state to a high-impedance state and there is sufficient internal timing skew on the respective I2C output.

This short high-level pulse injects energy in the I2C signals traces, which causes the I2C signals to sustain a period of ringing as a result of multiple transmission line reflections. This ringing should not cause an issue on the SDA signal because it only occurs at times when SDA is expected to be changing logic levels and the ringing will have time to damp before data is latched by the receiving device. The ringing may have enough amplitude to cross the SCL input buffer switching threshold several times during the first few nanoseconds of this ringing period, which may cause clock glitches. This ringing should not cause a problem if the amplitude is damped within the first 50 ns because I2C devices are required to filter their SCL inputs to remove clock glitches. Therefore, it is important to design the PCB signal traces to limit the duration of the ringing to less than 50 ns. One possible solution is to insert series termination resistors near the SCL and SDA terminals to attenuate transmission line reflections.

Insert series termination resistors on the SCL and SDA signals and locate them near the SCL and SDA terminals. The SCL and SDA pullup resistors should also be located near the SCL and SDA terminals. The placement of the series termination resistor and pullup resistor should be connected as shown in [Figure 7](#).
