## Applicability

This document applies to the STM32F098CC/RC/VC devices and their variants shown in [Table 1](#).

# 1 Summary of device errata

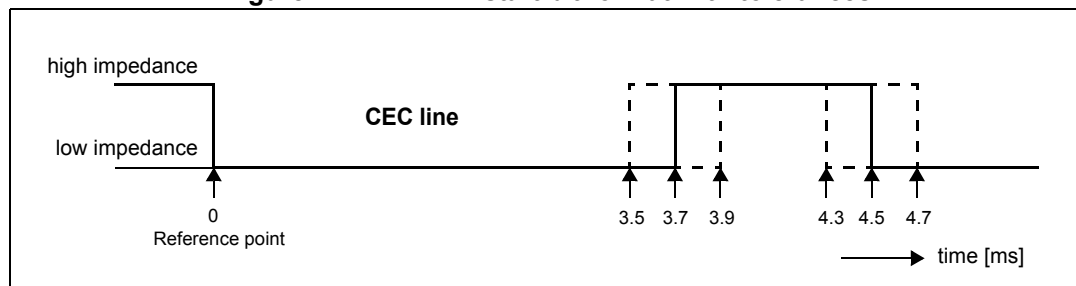
**Figure 2. HDMI-CEC start bit format with tolerances**

This failure is unlikely to happen as the CEC start bit corruption by another device can only occur if that device does not respect the CEC communication protocol.

CEC line and starts checking its level. The following conditions must be met for the start bit to be valid:

If one of these conditions is not met, the transmission is aborted and never automatically retried. No error flag is set and the TXSOM (Tx Start Of Message) bit is not cleared.

**Workaround**

The only way to detect this error is for the application software to start a timeout when setting the TXSOM bit, restart it upon ARBLST or any RX event (as the transmission can be delayed by interleaved reception), and stop it upon TXBR (proof that the start bit was transmitted successfully) or TXEND event, or upon any TX error (which clears TXSOM). If the timeout expires (because none of those events occurred), the application software must restart the HDMI-CEC peripheral and retransmit the message.
