**OMAP-L137  
C6000 DSP+ARM Processor  
Silicon Revisions 3.0, 2.1, 2.0, 1.1, and 1.0**

# **Silicon Errata**

Literature Number: SPRZ291I  
October 2008–Revised June 2014

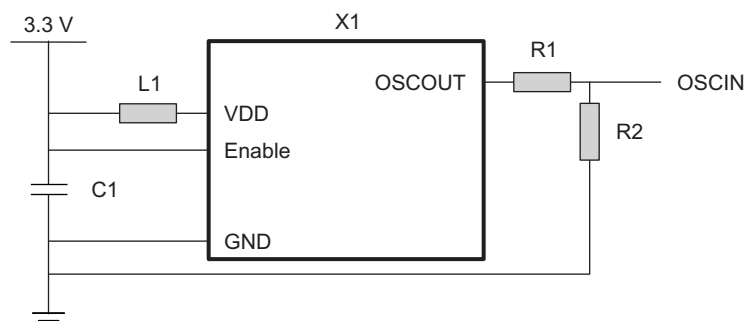
**Figure 1. External 3.3V Clock Source**

On all silicon revisions, certain design elements make this device susceptible to radiated noise during an ESD strike, as described in the standard IEC 61000-4-2. Exposure to the electrical noise caused by the ESD can cause soft device failures due to noise coupling on the system clock (OSCIN). ESD events within the IEC spec range do not cause permanent device damage and full functionality is recoverable with a device reset. The sensitivity to this noise issue is primarily due to the 1.2V oscillator/clock input implemented on this device. The low voltage range, coupled with slow rise and fall times, provides a lower noise margin than other TI devices with higher voltage internal oscillators (for example, 1.8V or 3.3V oscillators).

If ESD robustness is a concern, it is strongly recommended to avoid using the internal oscillator as a clock source. An external 3.3V clock source with a resistor voltage divider as in [Figure 1](#) can be used to externally generate the required 1.2V input clock. By using an external clock input with fast rise/fall times (less than 5 ns), the noise margin improves significantly, increasing ESD noise resistance.

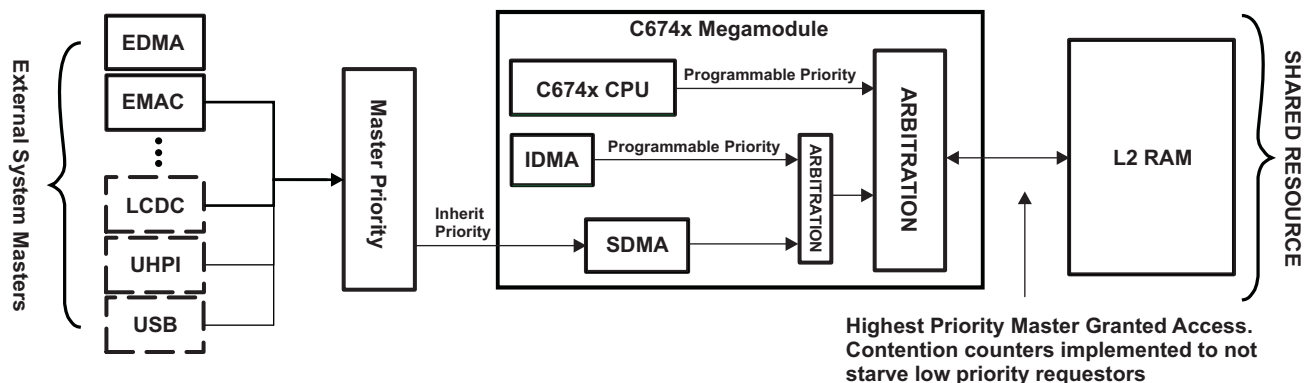
**Figure 2. Priority Arbitration Scheme for L2 RAM**

Ideally, the BWM arbitration will grant equal L2 bandwidth between equal priority DMA and CPU requests. Instead, when equal priority DMA and CPU requests arrive at the BWM, bandwidth is always granted in favor of the CPU over DMA. In the case of successive CPU requests, it is possible for the CPU to block all DMA requests until CPU traffic subsides. Additionally, some command logic in the BWM uses priority level 7, which can also result in SDMA stalls when the CPU is also programmed to priority level 7. [Figure 2](#) shows a high level diagram of the arbitration scheme used for L2 RAM requests.

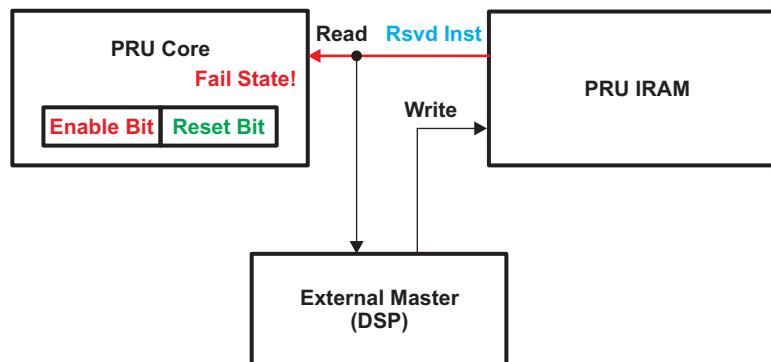
**Figure 5. Boot Failure on Power-On**

When the device is first powered-on, the read bus from the PRU IRAM is not initialized and will contain random values (see Figure 5). Under unpredictable circumstances, the random value on the read bus may resemble a reserved instruction which can be interpreted by the PRU when the core is reset and not enabled.

If the PRU core executes this reserved instruction, it will not be able to properly execute the first functional op-code in the PRU IRAM when the core is later enabled. In this fail state, the PRU will never acknowledge to the DSP that the reset vector table was successfully initialized and the DSP will be stuck in a polling loop waiting for the PRU to complete its task.

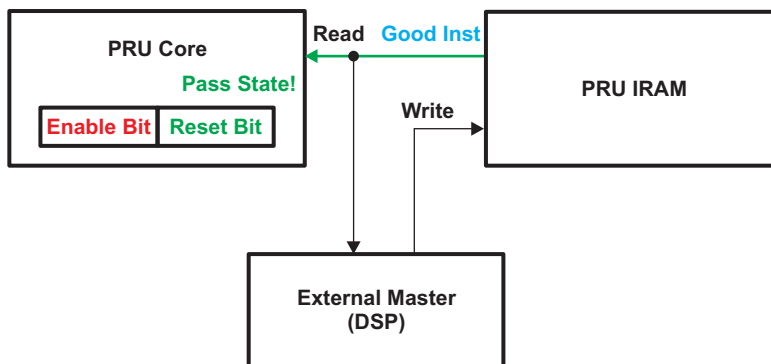
**Figure 6. Secondary Reset**

Although the PRU core execution is stuck, the PRU IRAM read bus is now initialized with a non-reserved instruction that was fetched from the IRAM by the PRU core (see

**Figure 6).** If a secondary reset is provided to the device (either POR or WARM), the PRU will be able to execute its functional instructions as expected.

Note that in order to recover from this fail state with a secondary reset, the DSP must be allowed to execute its boot ROM up to the point where the PRU has fetched a known instruction from the PRU IRAM. The approximate count of 15k cycles into the boot ROM is sufficient.

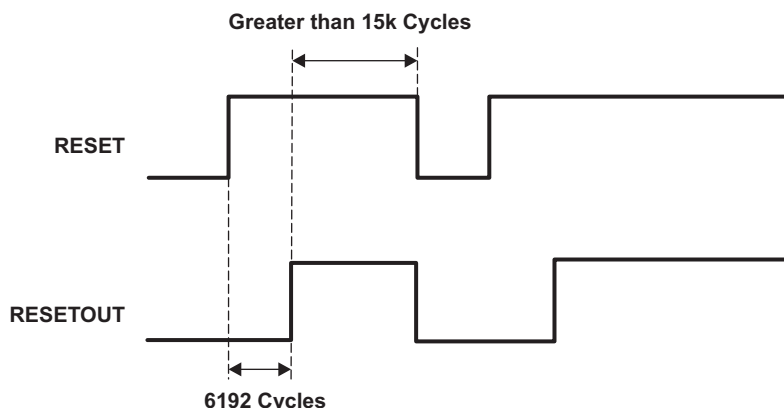
**Figure 7. First POR Reset Timing**

The 15k clock cycle count does not include the 6192 clock cycles required to complete a device POR reset (see [Figure 7](#)). With a 24MHz crystal, the first RESET signal must be asserted high for at least 883us (or approximately 1ms).

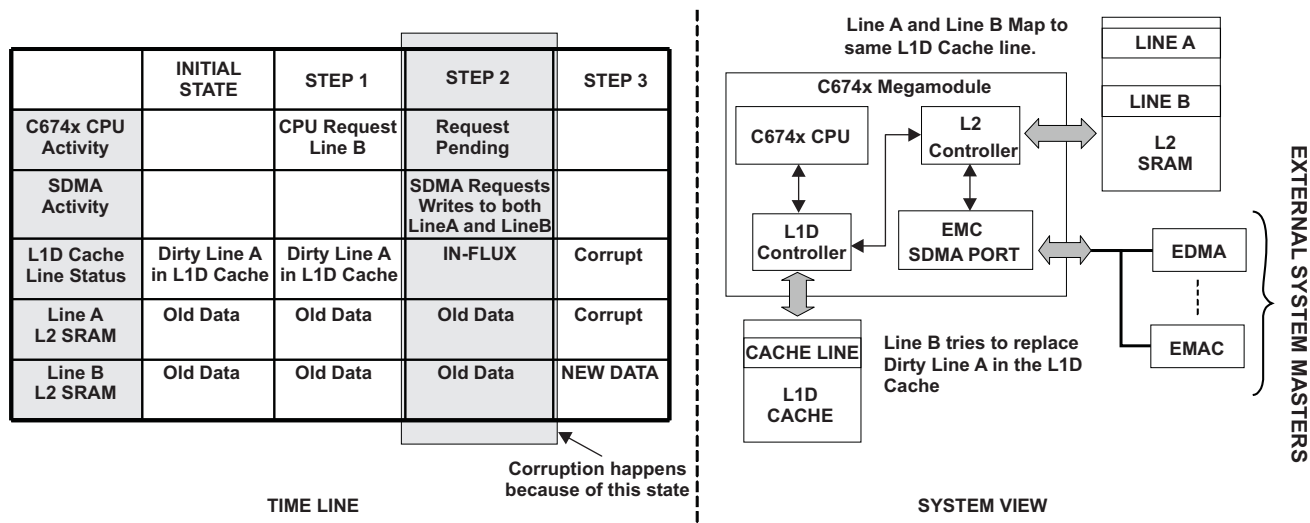
Figure 13. Example of L1D Cache and L2 RAM Corruption

An L1D cache-line corruption event occurs when all of the following conditions are met:

1. L1D cache evicts a dirty line (Line A) while allocating a new line (Line B) in the same set/way (cache Lines A and B consist of 64-bytes each). In order for this to happen, the following will have taken place:
  - (a) Line A was previously read by CPU because L1D is a read-allocate cache,
  - (b) Line A is dirty because its value was modified by CPU, and
  - (c) Line B is read by CPU
2. Both Line A and Line B are associated with L2 RAM, and
3. While the original L1D victim write-back from condition (1) is in progress, the SDMA performs both:
  - (a) a read or write operation to Line A in L2 RAM and
  - (b) a write operation to Line B in L2 RAM.

If all of the above conditions are met, the L2 RAM data associated with the Line A victim writeback will become corrupt. Additionally, the Line B data originating from the SDMA write will also become corrupt in L1D cache. [Figure 13](#) shows an example scenario of L1D cache and L2 RAM corruption.

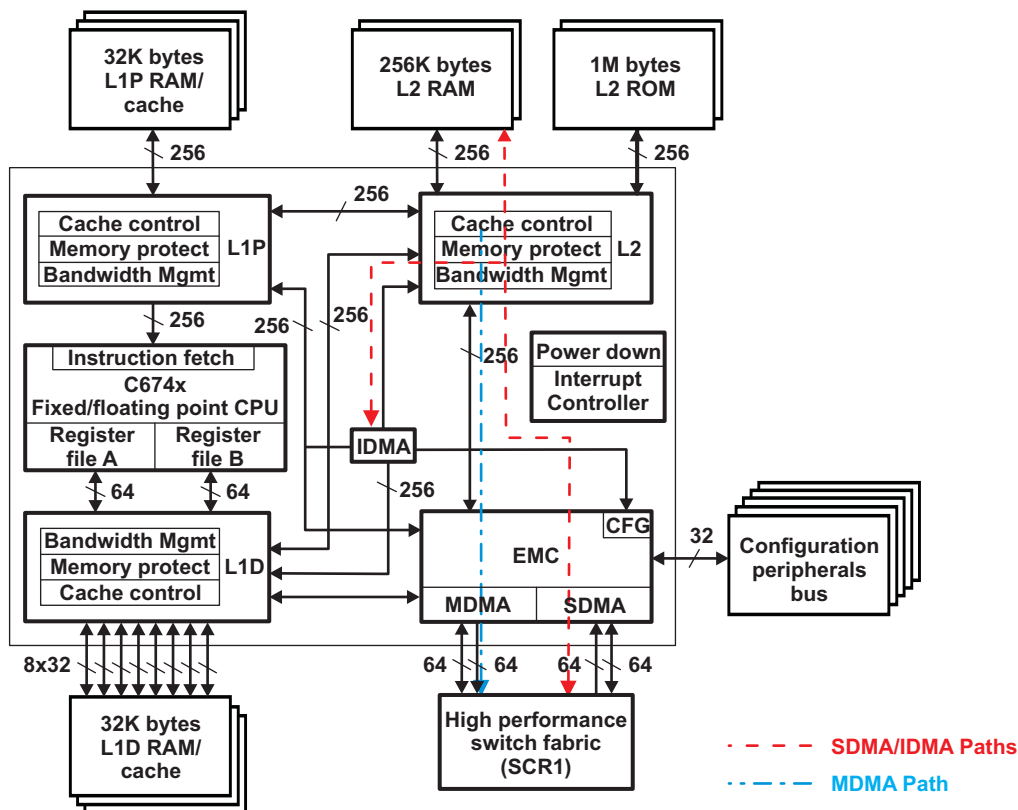
### Figure 14. C674x Megamodule

Ideally, the MDMA (dashed-dotted line in [Figure 14](#)) and SDMA/IDMA paths (dashed lines in [Figure 14](#)) operate independently with minimal interference. Normally MDMA accesses may stall for extended periods of time due to expected system level delays (for example, bandwidth limitations). However, when using L2 as RAM, SDMA and IDMA accesses to L2/L1 may experience unexpected stalling in addition to the normal stalls seen by the MDMA interface. For latency-sensitive traffic, the SDMA stall can result in missing real-time deadlines. In a more severe case, the SDMA stall can produce a deadlock condition in the device. An IDMA stall cannot produce a deadlock condition.

**Note:** SDMA/IDMA accesses to L1P/D will not experience an unexpected stall if there are no SDMA/IDMA accesses to L2. Unexpected SDMA/IDMA stalls to L1 happen only when they are pipelined behind L2 accesses. Additionally, the deadlock scenario will be avoided if there are no SDMA accesses to L2.

The duration of the SDMA/IDMA stalls depend on the quantity/characteristics of the L1/L2 cache and the MDMA traffic in the system. Therefore, it is difficult to predict if stalling will occur and for how long.

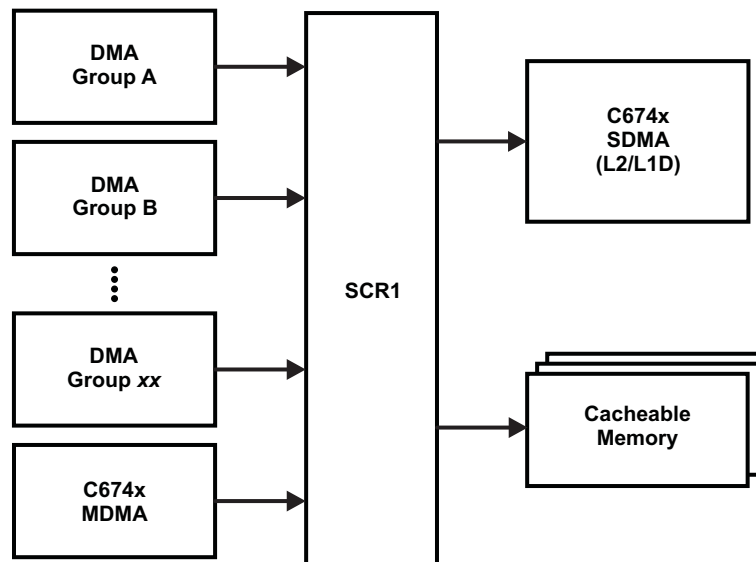
**Figure 15. SCR1 System Interconnect**

Step 2: The DSP's SDMA asserts itself as not ready and is unable to accept the write data from Step 1, and a cache line writeback is initiated from DSP memory to the same cacheable memory from Step 1. The cache line writeback command also passes through SCR1.

With the above scenario, it is possible for SCR1 to order the write commands from Step 1 in front of the write commands from Step 2. Due to the MDMA/SDMA blocking behavior, the SDMA commands from Step 2 will be waiting for the MDMA traffic from Step 1 to finish, resulting in a deadlock situation at SCR1. Figure 15 is provided for illustrative purposes and is incomplete because of simplification.

Entirely eliminate IDMA/SDMA stalling and potential for a deadlock condition using one of the following two methods:
