## STM32L432KB/KC and STM32L442KC device errata

This document applies to the part numbers of STM32L432KB/KC and STM32L442KC devices and the device variants as stated in this page.

It gives a summary and a description of the device errata, with respect to the device datasheet and reference manual RM394.

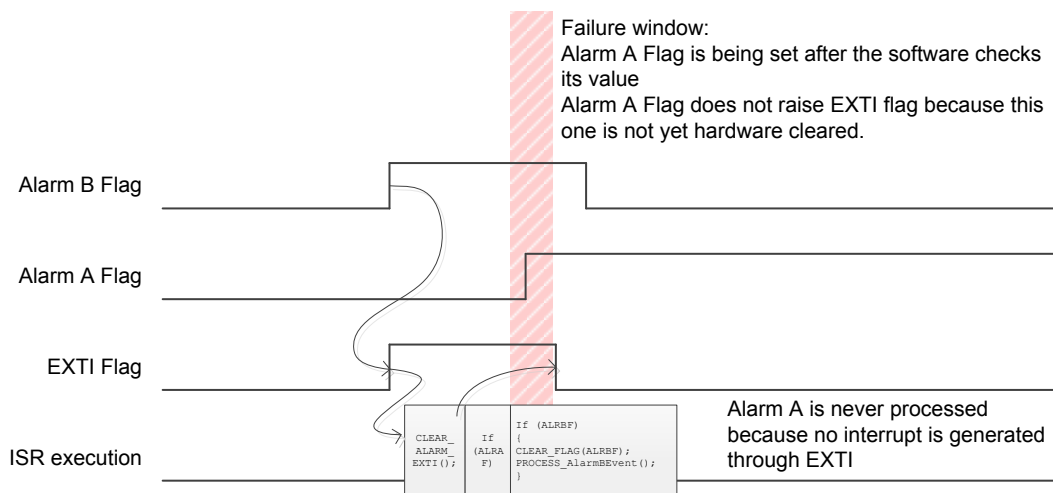
Figure 1. Masked RTC interrupt

The following code example and figure illustrate the failure mechanism: The Alarm A event is lost (fails to generate interrupt) as it occurs in the failure window, that is, after checking the Alarm A event flag but before the effective clear of the EXTI interrupt flag by hardware. The effective clear of the EXTI interrupt flag is delayed with respect to the software instruction to clear it.

In the interrupt service routine, apply three consecutive event flag checks - source one, source two, and source one again, as in the following code example:
