## MSP430FG439 Device Erratasheet

### 1 Functional Errata Revision History

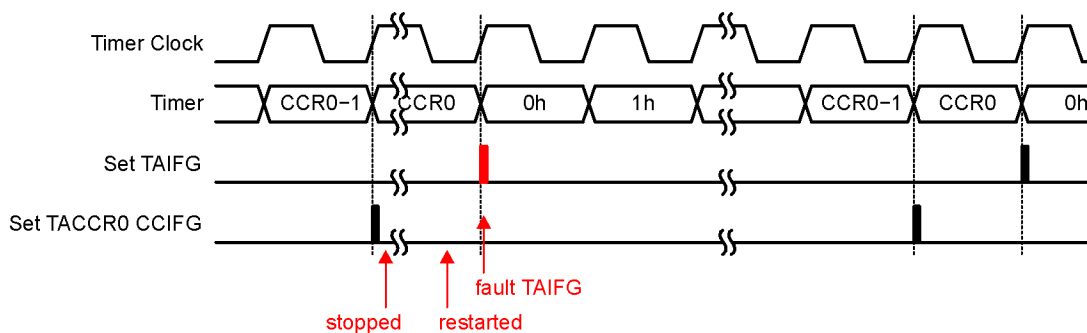
## TA21 *TIMER\_A Module*

**Function** TAIFG Flag is erroneously set after Timer A restarts in Up Mode

**Description** In Up Mode, the TAIFG flag should only be set when the timer counts from TACCR0 to zero. However, if the Timer A is stopped at TAR = TACCR0, then cleared (TAR=0) by setting the TACLRL bit, and finally restarted in Up Mode, the next rising edge of the TACLK will erroneously set the TAIFG flag.

**Workaround** None.
