**TMS320C6414, TMS320C6415,
and TMS320C6416
Digital Signal Processors
Silicon Errata**

Silicon Revisions 1.0, 1.01, 1.02, 1.03, 1.1, 2.0

SPRZ011T
October 2001
Revised August 2007

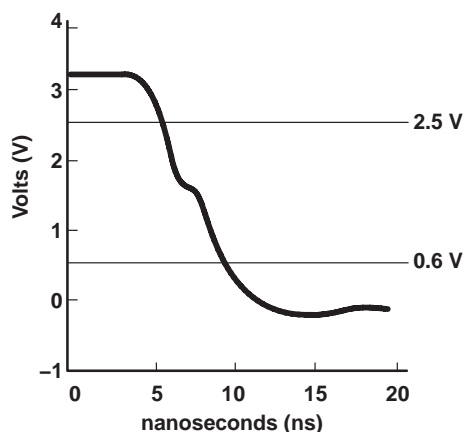
Figure 2. Bad TCK Transition

A TCK edge that can cause this problem might look similar to the one shown in Figure 2. A TCK edge that does not cause the problem will look similar to the one shown in Figure 3. The key difference between the two figures is that Figure 3 has a clean and sharp transition whereas Figure 2 has a “knee” in the transition zone. Problematic TCK signals may not have a knee that is as pronounced as the one in Figure 2. Due to the TCK signal amplification inside the chip, any perturbation of the signal can create erroneous clock edges.

As a result of the faster edge transition, there is increased ringing in Figure 3. As long as the ringing does not cross logic input thresholds (0.6 V for falling edges, and 2.5 V for rising edges), this ringing is acceptable.

When examining a TCK signal for this issue, either in board simulation or on an actual board, it is very important to probe the TCK line as close to the DSP input pin as possible. In simulation, it should not be difficult to probe right at the DSP input. For most physical boards, this means using the via for the TCK pad on the back side of the board. Similarly, ground for the probe should come from one of the nearby ground pad vias to minimize EMI noise picked up by the probe.

*EMU: Emulation Prone to Failure Under Certain Situations (Continued)***Workaround:**

As the problem may be caused by one or more of the above factors, one or more of the steps outlined below may be necessary to fix it:

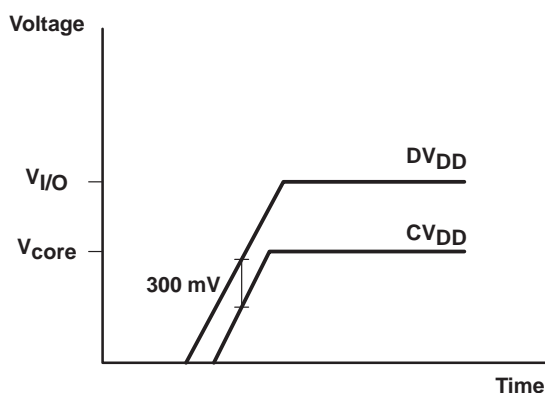
Figure 5. Core and I/O Power-On Ramps

Details: The TMS320C64x device uses electronically blowable fuses for certain memory and device configuration purposes, which may be damaged if the device is not held in reset during and after the power-on ramp. In addition, since the reset signal must propagate through the I/O buffers to the core logic, the I/O supply must be powered on enough to allow the reset signal to propagate through before the core supply reaches a voltage where fuse damage can occur (1.0 V). However, if the I/O supply reaches a voltage where the I/O buffers are operational before the core is powered on enough to force all outputs to the high-impedance state, board-level bus contention may result.

Workaround: To protect the fuses and prevent bus contention, a reset supervisor must be used in conjunction with a controlled power-on ramp sequence. A reset supervisor such as the Texas Instruments' TPS3110 ensures that $\overline{\text{RESET}}$ is asserted low or put in a high-impedance mode so that it may be pulled down for the entire power-on ramp. The I/O rail must start to ramp before or at the same time as the core rail, and the core rail must be no more than 300 mV behind at any time until the core rail has reached its operating voltage. Ramping the power in this manner ensures that the device's input buffers allow the $\overline{\text{RESET}}$ signal to propagate to the core (which is necessary to prevent fuse damage) while providing a valid signal to the device's output buffers before they can drive (which is necessary to prevent bus contention). Power supplies such as the Power Trends™ PT6932 sequence the power ramp in this manner. See Figure 5 and Figure 6 for the core and I/O power-on ramps and a recommended reset supervisor circuit example.
