# **TMS320C6652/54/55/57**

#### **Silicon Revision 1.0**

## **Silicon Errata**

Literature Number: SPRZ381C  
April 2012–Revised May 2016

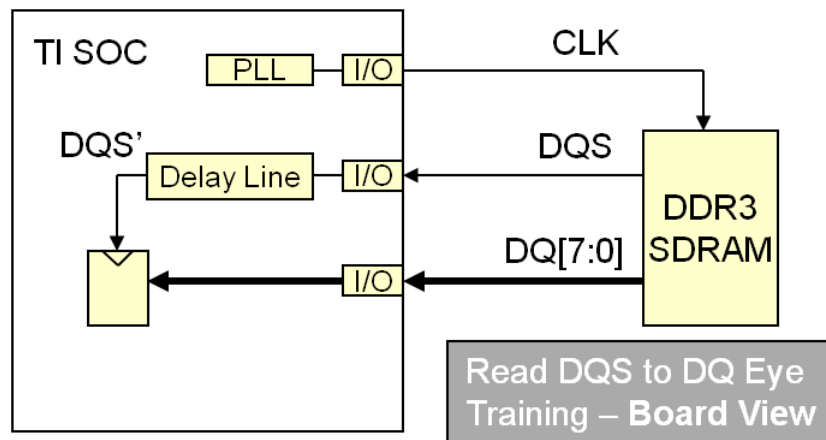
**Figure 2. Read DQS to DQ Eye Training - Board View**

The leveling feature with the problem is the Read Data Eye Training. Depending on the jitter seen on the DQ and DQS signals, this leveling feature will fail to converge on a good data eye, resulting in corrupted DSP to DDR3 SDRAM reads.

The intended purpose of the Read Data Eye Training feature is to align the DQS sampling transitions in the middle of the DQ data eye within individual byte lanes of the DDR3 memory interface. As seen in [Figure 2](#), the DQS signal can be delayed relative to the DQ signal within the DDR3 PHY.

- Workaround 1:** The DDR3 PHY in the device has the ability to complete auto-leveling of the write leveling values and the read DQS gate training values separate from the read data eye training. Then a fixed value is used as the read data eye sample point. This solution is functional on standard DDR3 fly-by layouts and is referred to as Partial Automatic Leveling. It has been validated for robust operation at DDR3-1333 when connected to either a UDIMM or with a discrete SDRAM implementation.

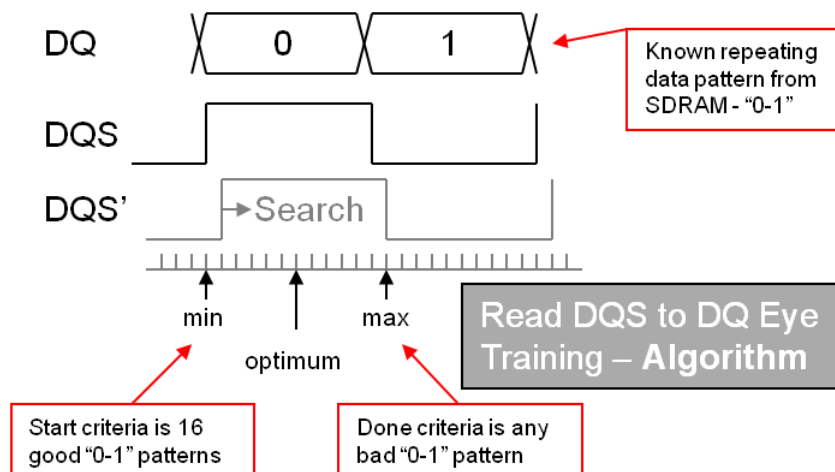
Figure 3. Read DQS to DQ Eye Training - Algorithm

As shown in Figure 3, the Read Data Eye Training algorithm should correctly detect the extents of the DQ data eye. The SDRAM are put into a DQS to DQ eye training mode and read back an alternating 0, 1 pattern.

The DDR3 PHY uses this pattern to detect good or bad data being sampled by the DQS transitions. The DDR3 PHY searches by delaying DQS relative to DQ until these constraints are found.

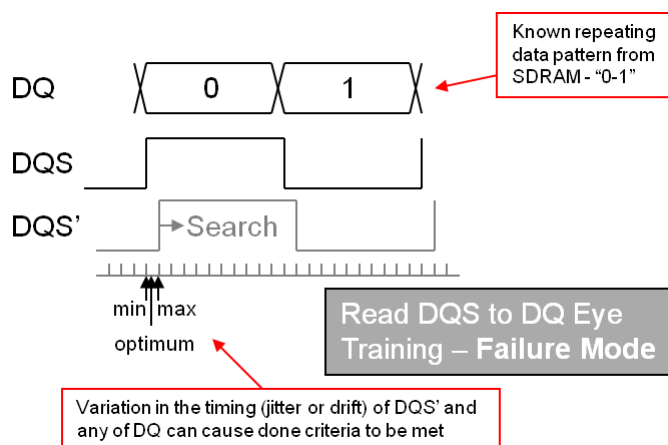
Figure 4. Read DQS to DQ Eye Training - Failure Mode

However, if too much jitter is present on the DQ or DQS signals, the search can converge to a false edge as shown in Figure 4.

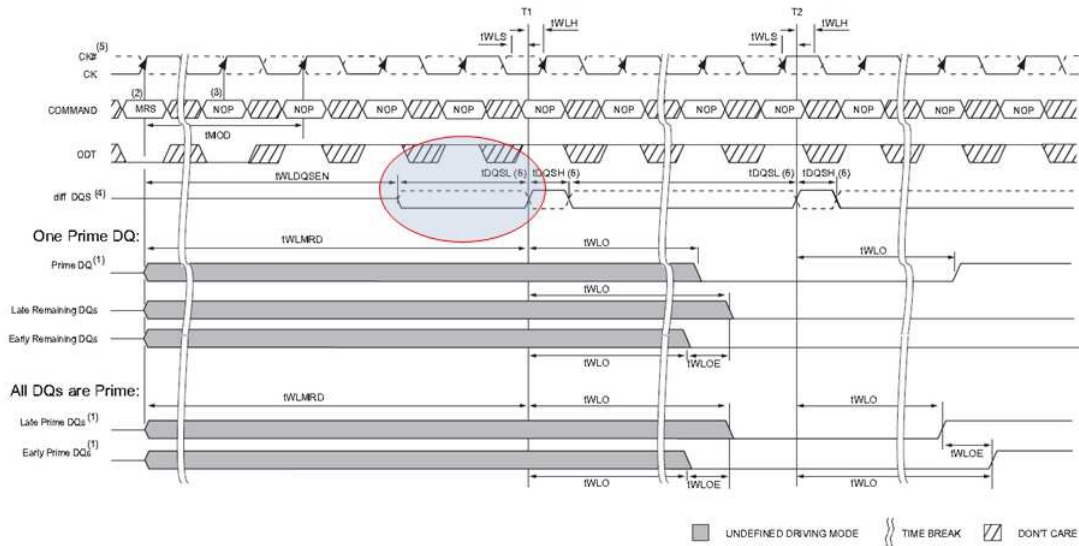
**Figure 5. Timing Details of Writing Leveling Sequence**

As shown in Figure 5, the DDR3 JEDEC standard requires that the DQS strobe be sent with a preamble (DQS=0) for at least tDQSL during write leveling, prior to the first rising edge of the DQS strobe (DQS=1). It was observed in simulations that the first DQS strobe is sent immediately following the high impedance state of the DQS line and without a preamble. This Z->1 transition on the DQS line may allow incremental write leveling to fail. Note that this issue impacts only the incremental write leveling feature of the DDR3 Memory controller. No issue is expected with automatic write leveling.

At this time, incremental write leveling is not supported on this device and we recommend that the incremental write leveling intervals in RDWR\_LVL\_CTRL and RDWR\_LVL\_RMP\_CTRL be programmed to 0 to disable this feature.

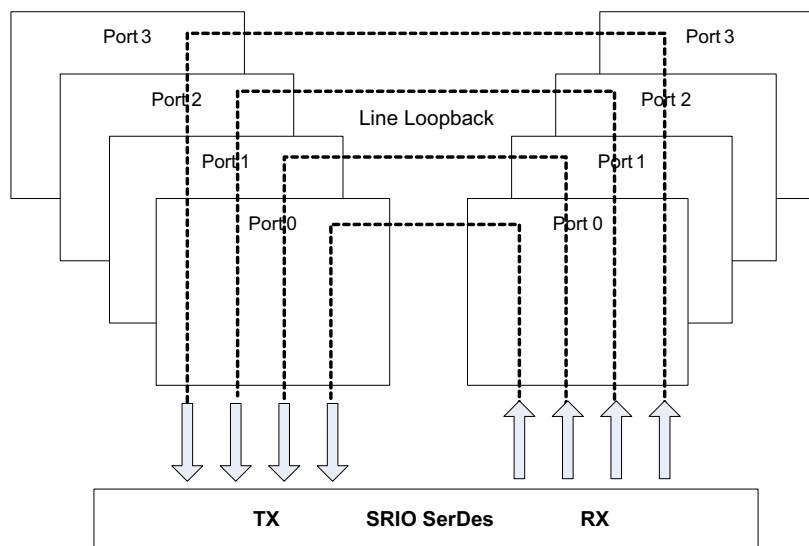
**Figure 6. SRIO SerDes in Loopback Mode**

The SRIO physical layer is configured in line-loopback mode on a per-port basis, by setting the LLB\_EN bit in PLM\_SP(n)\_IMP\_SPEC\_CTL register. In line-loopback mode, the data from the SerDes receiver is looped back to the SerDes transmitter. [Figure 6](#) shows the line loopback from SerDes RX to SerDes TX:

The port does not provide any clock compensation when line loopback is enabled. The transmit clock must be externally synchronized with the receive clock. There is only a small FIFO that can compensate for PLL jitter or wander. Hence, correct operation of line loopback requires that the link partners use the same reference clock for the SRIO physical layer, in order to avoid overruns or underruns due to clock frequency mismatch between the link partners. As a result, line loopback mode is generally restricted to validation and qualification of board signal integrity in a lab environment.

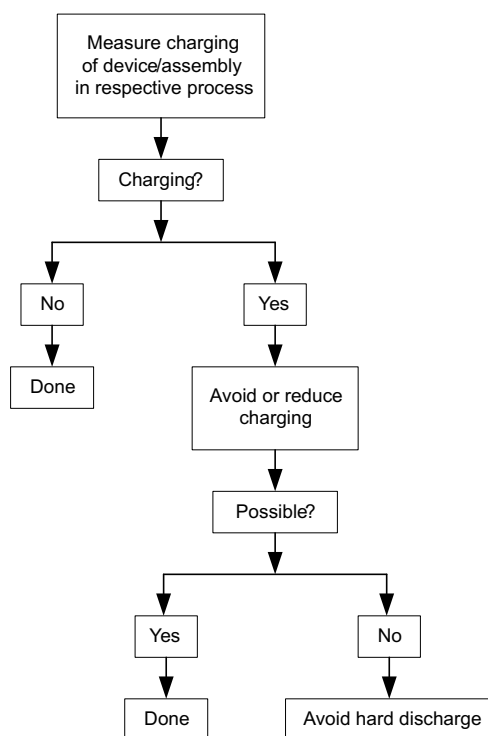
**Figure 7. Basic Flow for Analyzing CDM Risk**

Due to the sensitive nature of the SerDes high-speed pins, exceeding component ESD CDM stress pulses of 150 V on the functional pins listed below may cause permanent changes to the output swing and the de-emphasis behavior associated with these pins.

While there is no strict workaround for this issue, there are several ways to analyze the risk with regards to CDM. [Figure 7](#) shows the basic flow for analyzing this risk:

Using generally accepted good practices during the assembly process can help to minimize the likelihood of a hard discharge. These practices include:

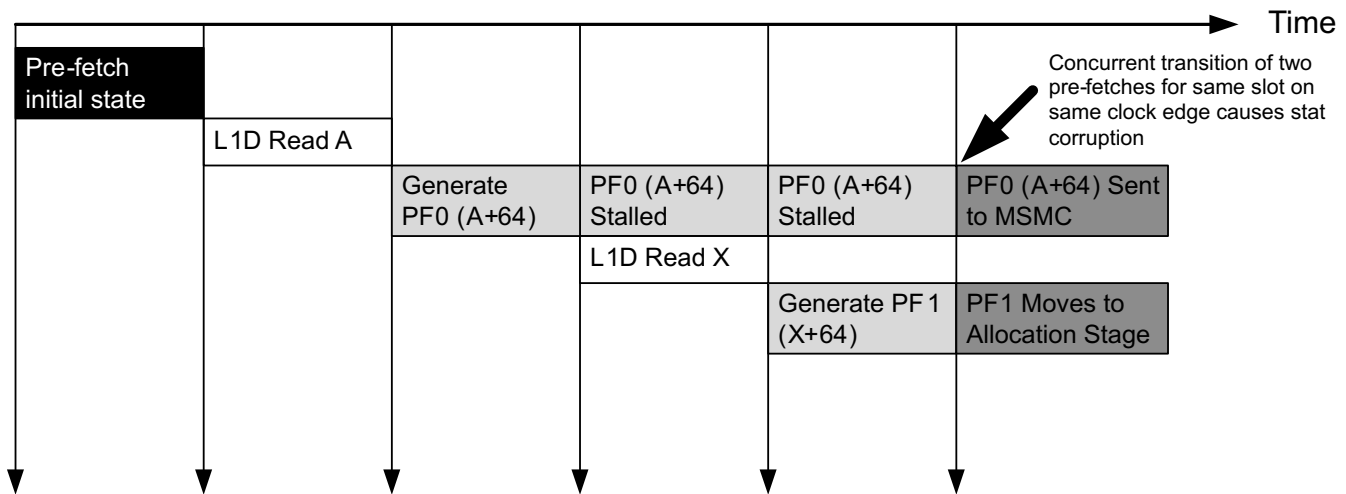
**Figure 9. Sequence diagram**

The fault lies in the 'sorting' hardware which can lead to the first pre-fetch not being marked stale under certain boundary conditions (see pathological sequence below). The subsequent fetch access when the pre-fetch access wasn't marked stale will access the stale data that has been cleared (but not yet marked as stale.) This results in the read exception and/or incorrect data being fetched. Thus, the issue occurs only when the re-fetch feature is triggered and only L1D accesses use the re-fetch feature.

8. Instead of PF0 being marked stale and thrown away when returned, both PF0 and PF1 are marked valid and outstanding.
9. This leads to two valid outstanding pre-fetches for the same data buffer slot which is an invalid state and can result in unexpected behavior for a subsequent pre-fetchable data access to address X+64.

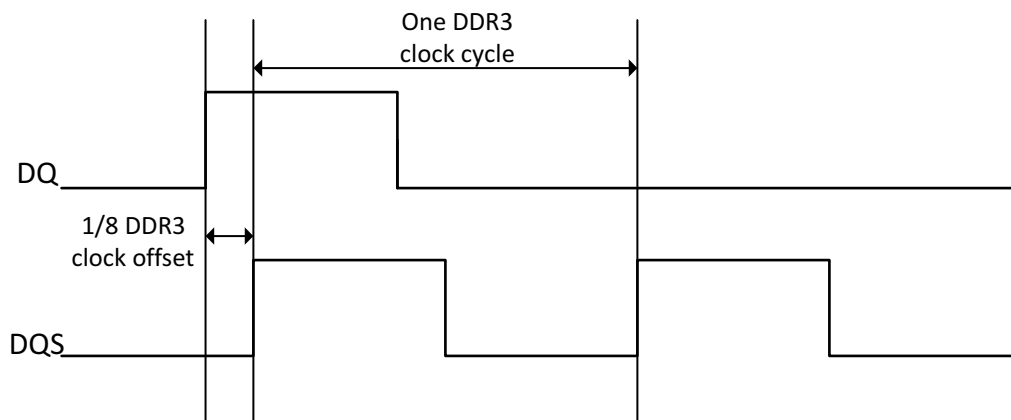
**Figure 10. DQ to DQS offset with default incorrect value (0x20) for DATA\_REG\_PHY\_DQ\_OFFSET in DDR3\_CONFIG\_REG\_1**

**Problem Summary:** On C665x devices, the default value of the DATA\_REG\_PHY\_DQ\_OFFSET field in the DDR3\_CONFIG\_REG\_1 register causes DQ and DQS to be offset incorrectly during writes.

//Correct DQS-DQ write timing offset
DDR3_CONFIG_REG_1 = 0x01000000;

//Do a PHY reset. Toggle DDR_PHY_CTRL_1 bit 15 0->1->0
DDR_DDRPHYC &= ~(0x00008000);
DDR_DDRPHYC |= (0x00008000);
DDR_DDRPHYC &= ~(0x00008000);
```
