STM32F071x8/xB device limitations**Applicability**

This document applies to the part numbers of STM32F071x8/xB devices listed in [Table 1](#) and their variants shown in [Table 2](#).

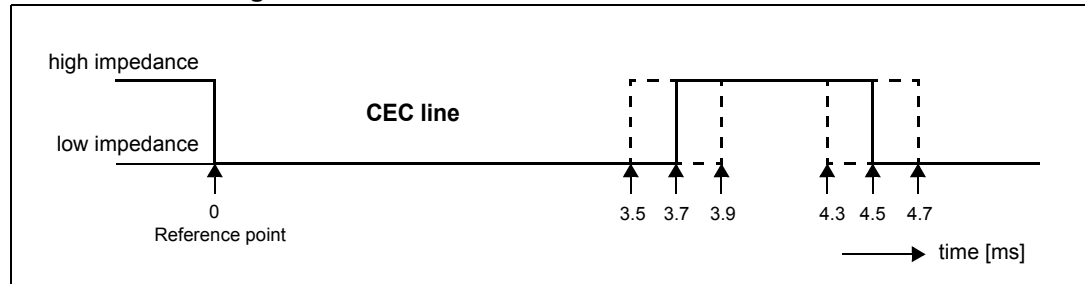
Figure 1. HDMI-CEC start bit format with tolerances

CEC line and starts checking its level. The following conditions must be met for the start bit to be valid:

If one of these conditions is not met, the transmission is aborted and never automatically retried. No error flag is set and the TXSOM (Tx Start Of Message) bit is not cleared.

The only way to detect this error is for the application software to start a timeout when setting the TXSOM bit, restart it upon ARBLST or any RX event (as the transmission can be delayed by interleaved reception), and stop it upon TXBR (proof that the start bit was transmitted successfully) or TXEND event, or upon any TX error (which clears TXSOM). If the timeout expires (because none of those events occurred), the application software must restart the HDMI-CEC peripheral and retransmit the message.
