*RM46x Microcontroller*

**Silicon Revision B**

# **Silicon Errata**

Literature Number: SPNZ200F  
February 2013–Revised May 2016

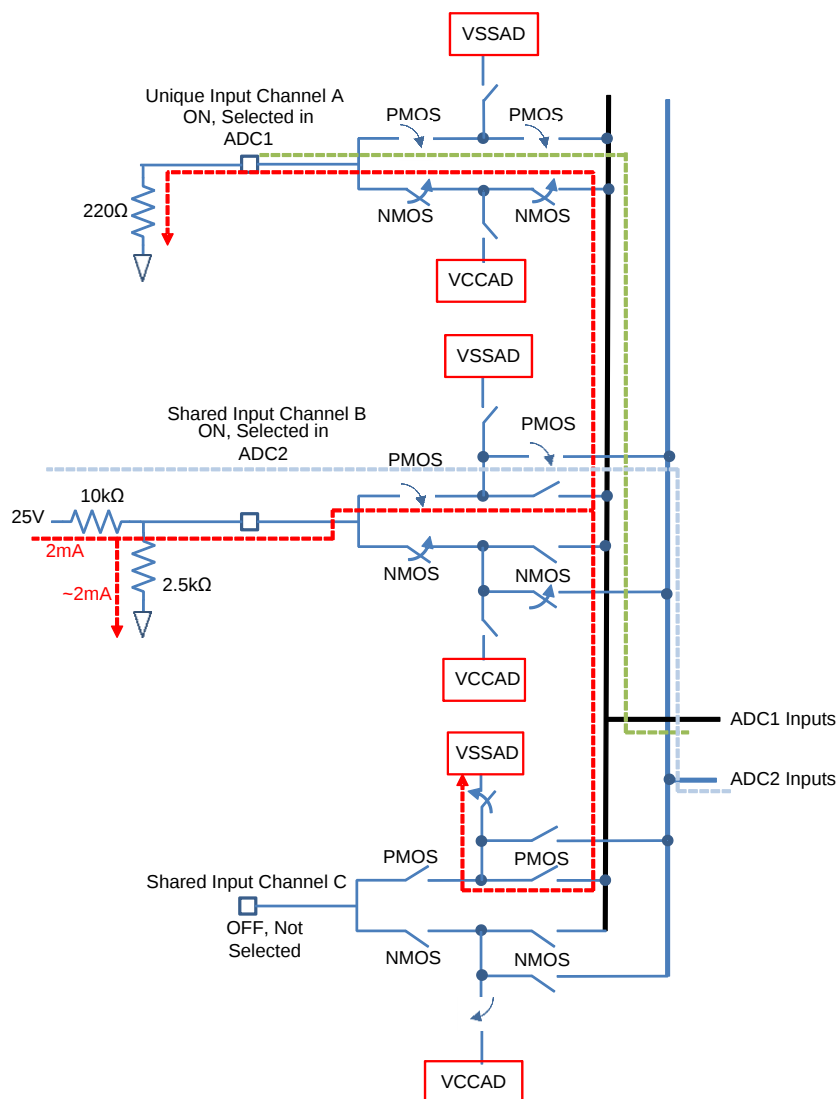
**Figure 3. Example ADC1/ADC2 Channel Connection**

Figure 3 shows an example where a ADC1 is sampling input channel A which is unique to ADC1, and ADC2 is sampling input channel B, which is a shared-input channel. This is shown by the dashed green and light blue current paths.

Another current path is shown in dashed dark red. This is a current injected into channel B as the input level on terminal B is greater than  $V_{CCAD} - 0.3V$ . This is a parasitic current that passes through the "open" PMOS switch, and a part of this current flows to ground through the external 220 ohm resistor connected to input channel A. This causes an offset in the conversion result of channel A being sampled by ADC1.

1. Configure the two ADC modules such that their sampling periods do not overlap, or
2. Limit the shared analog input upper limit to be lower than ( $V_{CCAD} - 0.3V$ ). The PMOS leakage is reduced exponentially if the input is lower than  $V_{CCAD} - 0.3V$ .
