## Applicability

This document applies to the part numbers of STM32F038x6 devices listed in [Table 1](#) and their variants shown in [Table 2](#).

[Section 1](#) gives a summary and [Section 2](#) a description of device limitations and documentation errata, with respect to the device datasheet and reference manual RM0091.

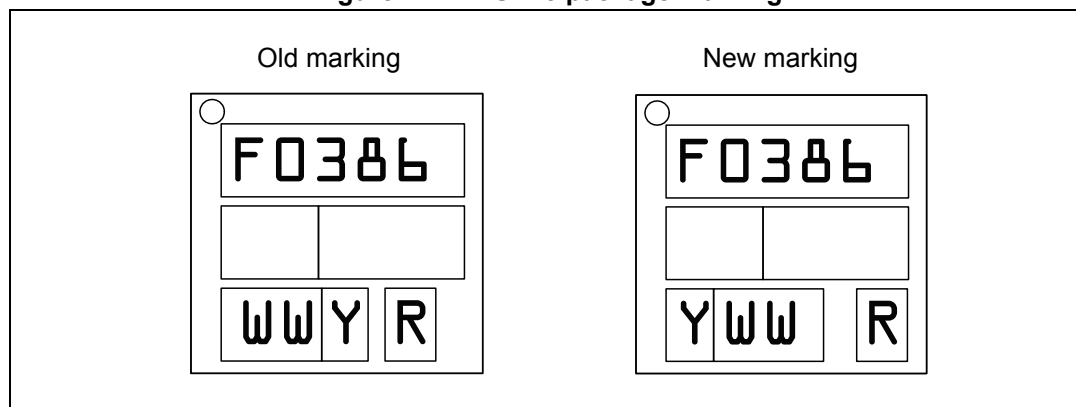
**Figure 2. WLCSP25 package marking**

From week 9, 2017 on, the marking on the WLCSP25 package is modified to show the date in the format YWW. [Figure 2](#) illustrates the difference between the old and the new product marking. The figure in the product datasheet was also updated to better reflect the dimensions and layout of the marking on the package.
