## MSP430BT5190 Device Erratasheet

### 1 Functional Errata Revision History

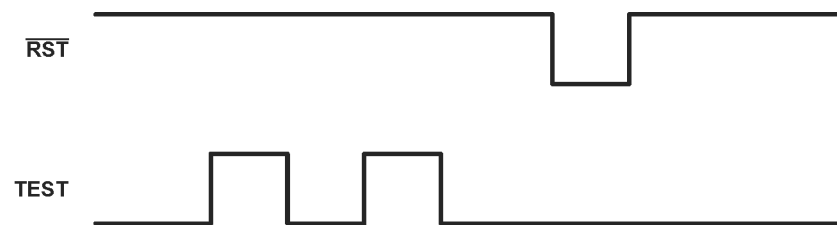
- A Power cycle

- or
- Toggle the TEST pin twice when nRST is high and after 50us pull nRST low.

Note: This toggling of TEST pins is not subject to timing constraints. The appropriate level transitions on TEST pin, followed by a RST pulse after 50us, are sufficient to trigger an exit from BSL mode.

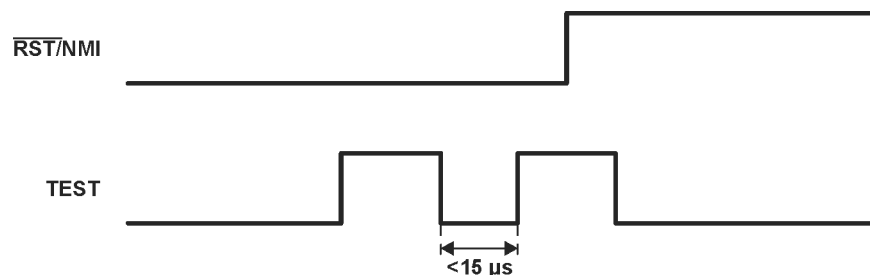
| <b>Function</b> | BSL entry sequence is subject to specific timing requirements |
| <b>Description</b> | <p>The BSL entry sequence requires that the low phase of the TEST/SBWTCK pin does not exceed 15us. This timing requirement is faster than most PC serial ports can provide, as shown in the following picture. If this requirement is not met, the entry sequence fails and the SYSBSLIND is not set.</p> |

| <b>Workaround</b> | An external hardware solution is recommended to provide the appropriate BSL entry sequence. See <a href="http://processors.wiki.ti.com/index.php/BSL_(MSP430)">http://processors.wiki.ti.com/index.php/BSL_(MSP430)</a> for recommendations on available BSL hardware. |
