CEC1702

Silicon Errata and Data Sheet Clarification

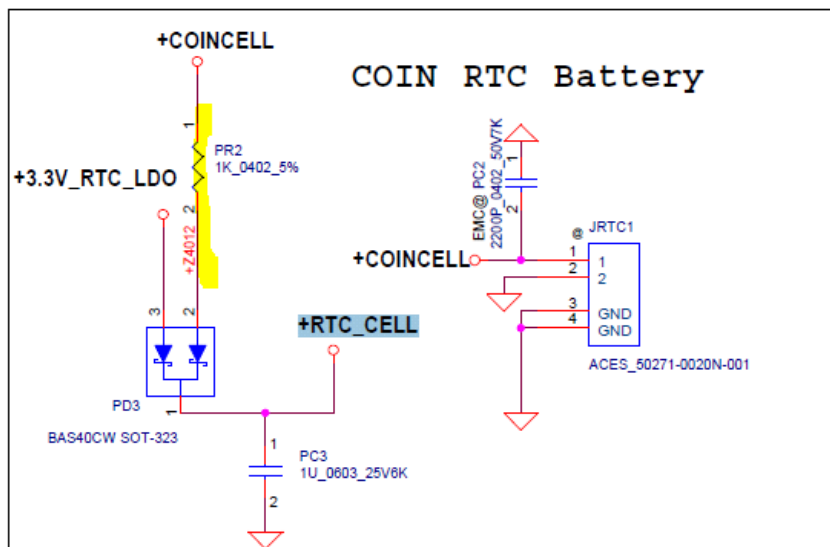
FIGURE 1: HIGH IBAT CURRENT DURING COIN CELL INSERTION

There could be a high I_{BAT} current on new coin cell insertion. During initial VBAT power rising, the VBAT circuit can enter a high current state causing a voltage drop across the 1K UL resistor.

END USER IMPLICATIONS

- Under these conditions, the VBAT power on can stall in this high current state, with the VBAT on device pin between 0.7 and 1.2V.

When inserting the coin-cell follow the below procedure

Insert the coin cell and then apply VTR (i.e +3VALW). This enables VBAT low-power operation. A high I_{BAT} will not return on subsequent VTR power cycles.

Referring to the RTC Battery circuit shown in [Figure 1](#), applying VTR via the +3.3V_RTC_LDO signal, powers RTC_Cell (which is connected to VBAT) directly (without a series 1k resistor and hence no IR drop from the applied VTR), raising VBAT (RTC_Cell) to greater than 2.0 volts. This takes VBAT out of the “high current” region discussed above enabling normal VBAT low power operation.
