**OMAP5912**  
**Applications Processor**  
**Silicon Errata**

SPRZ209K  
December 2003 – Revised December 2007

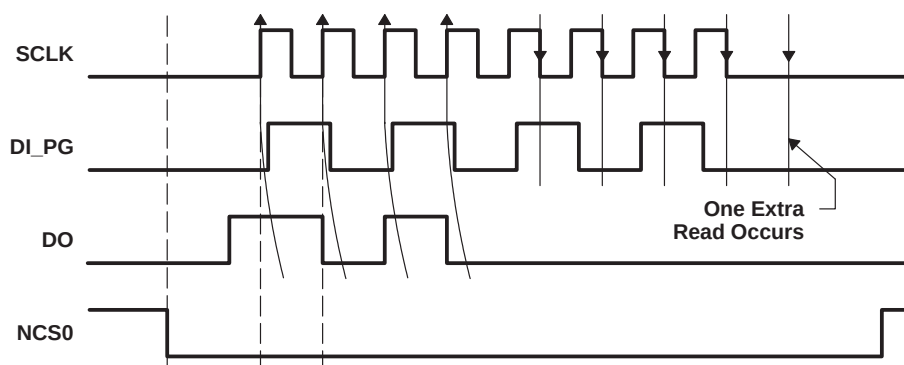
**Figure 5. Write (4 Bits) on Rising/Read (4 Bits) on Falling (TX = 0xA, RX and 0x1F = 0x14)**

**Advisory  
UWIRE\_1***MICROWIRE Interface RX Data Failures Possible***Revision(s) Affected:** All revisions**Details:** See the table below and Figure 5 and Figure 6.

| | <b>CSx_EDGE_RD = 0<br/>CSx_EDGE_WR = 0</b> | <b>CSx_EDGE_RD = 1<br/>CSx_EDGE_WR = 1</b> | <b>CSx_EDGE_RD = 0<br/>CSx_EDGE_WR = 1</b> | <b>CSx_EDGE_RD = 1<br/>CSx_EDGE_WR = 0</b> |
|---|---|---|---|---|
| <b>SCLK Inverted</b> | <p>Data read on rising edge of SCLK. Data write on rising edge of SCLK.</p> <p>Delay of 2 SCLK cycles between last bit transmitted on rising edge and first bit captured on rising edge.</p> <p>No issue.</p> | <p>Data read on falling edge of SCLK. Data write on falling edge of SCLK.</p> <p>Delay of 2 SCLK cycles between last bit transmitted on falling edge and first bit captured on falling edge.</p> <p>No issue.</p> | <p>Data read on rising edge of SCLK. Data write on falling edge of SCLK.</p> <p>Delay of 1.5 SCLK cycles between last bit transmitted on falling edge and first bit captured on rising edge.</p> <p><b>Issue found:</b><br/>One extra bit is captured.</p> <p><b>Workaround:</b><br/>Ignore Bit 0 of the receive data register (shift right one bit). Note that this workaround does not work for a 16-bit data configuration (1 bit is lost).</p> | <p>Data read on falling edge of SCLK. Data write on rising edge of SCLK.</p> <p>Delay of 2.5 SCLK cycles between last bit transmitted on rising edge and first bit captured on falling edge.</p> <p><b>Issue found:</b><br/>First bit captured will start 2.5 SCLK cycles after the last bit sent instead of 1.5 SCLK as defined in the specifications.</p> <p><b>Workaround:</b><br/>Do not use this configuration.</p> |

**Workaround:**

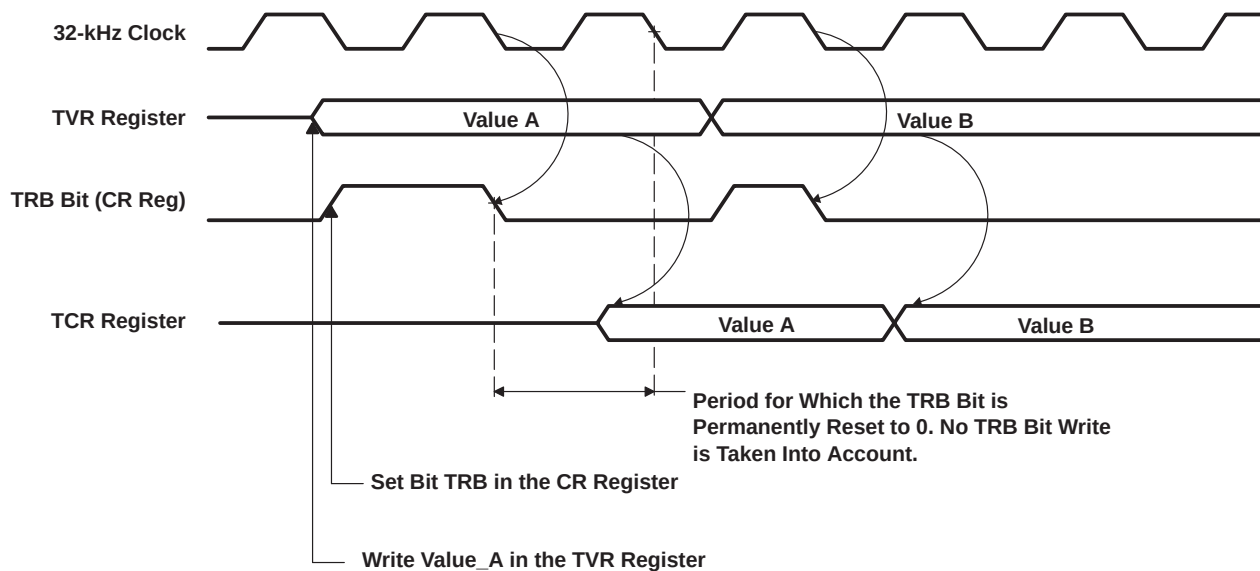
**Figure 11. TRB Timing Diagram**

**Details:** The Timer32K Reload Bit (TRB) is used to load the TCR register with the value contained in the TVR register. Once the TCR is loaded, the TRB bit should be automatically reset to '0'. The user should be able to use the TRB bit (by polling) to know when to load a new value in the TVR.

However (see Figure 11), the TRB bit is reset to zero by the falling edge of 32-kHz clock only after a maximum of  $1.5 \times 32\text{-kHz}$  clock period (or minimum  $0.5 \times 32\text{-kHz}$  clock period) after the TRB bit is set. The TCR register is loaded after a maximum of  $2 \times 32\text{-kHz}$  clock periods (or minimum of  $1 \times 32\text{-kHz}$  clock period) on the rising edge of the 32-kHz clock. After the TRB is reset, there is a one 32-kHz clock period where a new TRB setting will not be taken into account by the module. If the user programs the TVR and updates the TRB bit within this 32-kHz clock period, the new TVR will not be loaded correctly into the TCR.

**Workaround:** To load a new value into the TCR, poll the TRB bit. When the TRB is equal to '0' (signaling that the previous value has been loaded), the user has to wait for an additional one 32-kHz clock period, before loading a new value in the TVR and setting the TRB bit to '1'.

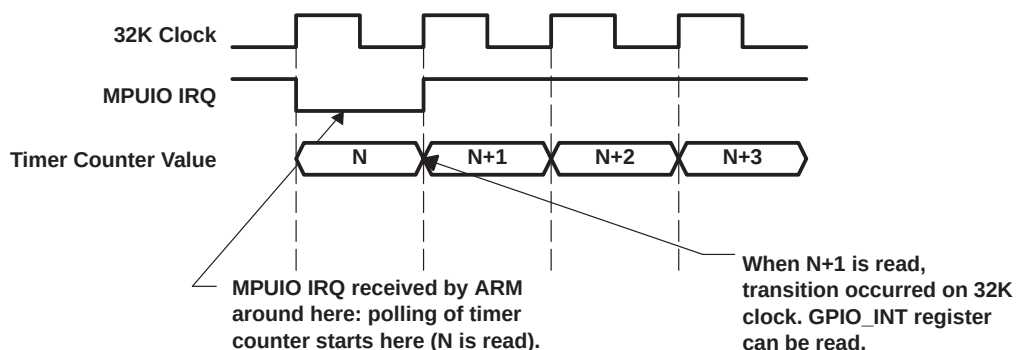
**Figure 12. Polling the Timer 32k Timer**

**Details:** The reset of the MPUIO GPIO interrupt is done asynchronously when a GPIO\_INT register read occurs. The release of this reset is done synchronously with the ARM\_XOR\_CLK when the 32-kHz clock is high. A read of the GPIO\_INT register while the 32-kHz clock is low or transitioning can result in a deadlock to the state machine that will cause all further interrupts subject to the MPUIO pin to be ignored.

**Workaround:** After receiving the MPUIO GPIO\_INT, the MPU should observe the 32-kHz clock and then read the GPIO\_INT register only just after a rising edge on the 32-kHz clock. There are different ways to detect a rising edge on the 32-kHz clock:

- Poll the timer 32k counter until there is an increment (see Figure 12, which describes the procedure)

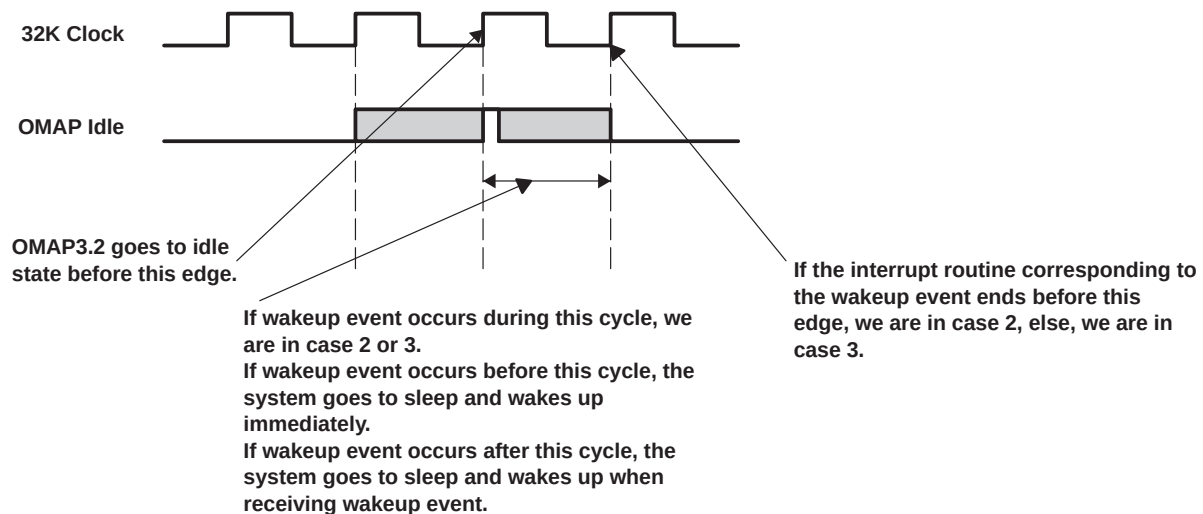
**Figure 14. IDLECT1.WKUP\_MODE = 1 Possible Effects**

1. No noticeable problem. The system wakes up correctly.
2. The OMAP3.2 clock is shut down while the ARM is awake (possibly in the middle of an instruction fetch). The wakeup event is caught, and corresponding interrupt routine has time to complete before the ARM clock is shut down. The system will go to sleep and resume normal operation on the next wakeup event (first wakeup event will be treated at this time). Depending on the time when OMAP3.2 clock was shut down, instruction/data corruption is possible.
3. The OMAP3.2 clock is shut down while the ARM is awake (possibly in the middle of an instruction fetch). The wakeup event is caught, but corresponding interrupt routine does not have time to complete before ARM clock is shut down. The system will resume normal operation. Depending on the time when OMAP3.2 clock was shut down, instruction/data corruption is possible.

Figure 14 summarizes briefly the conditions under which case 1, 2, and 3 may happen.

**Workaround:** The IDLECT1.WKUP\_MODE bit should always be 0 in all OMAP5912 devices.

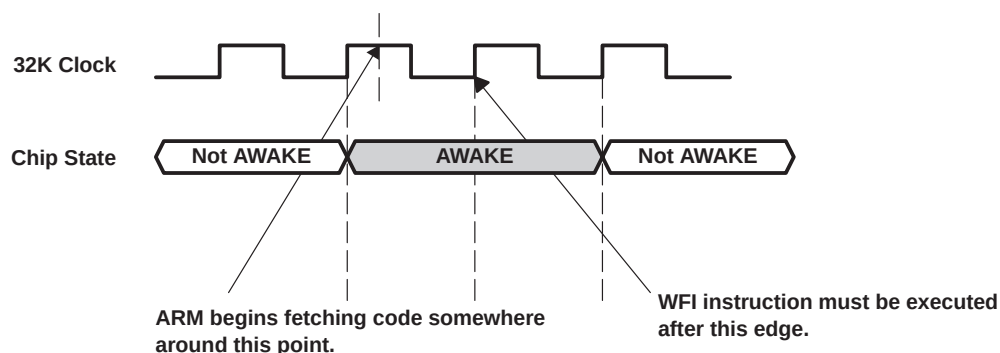
**Figure 15. Minimum AWAKE Window Needed for Proper Operation**

**Advisory  
ULPD\_4***System May Hang if Idle/Awake Sequence Period is Too Short***Revision(s) Affected:** All revisions

**Details:** When the system goes out of deep or big sleep, at least one 32K clock rising edge must occur before the WFI instruction is executed again. If this does not occur, the ULPD will stay in the awake state, and OMAP5912 will remain in idle mode. This will cause the system to hang. The only way to restore the system is to perform power-on reset or MPU reset.

**Workaround:** The Minimum AWAKE window is needed for proper operation. Software needs to make sure that one 32K clock rising edge occurs between wake up of the device and next WFI instruction execution. This can be done by monitoring 32K counter value.

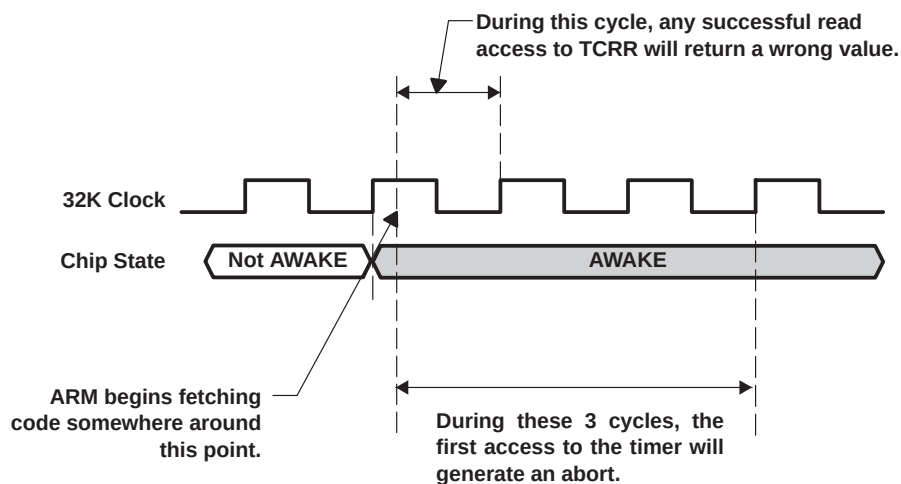
**Figure 16. DM Timer Access Timings After Wake Up From Deep Sleep (Functional Clock is 32K Clock)****Workaround:**

**Details:** The following sequence of events may cause a fail on a dual-mode timer's first access:

If the dual-mode timer functional clock is configured to be a 32-kHz clock, then this time can be significantly longer than the time it takes for the MPU to do an access to the dual-mode timer. In which case, if one of the first operations software performs after wakeup is an access to dual-mode timer, then the access is very likely to fail.

There are two possible workarounds:

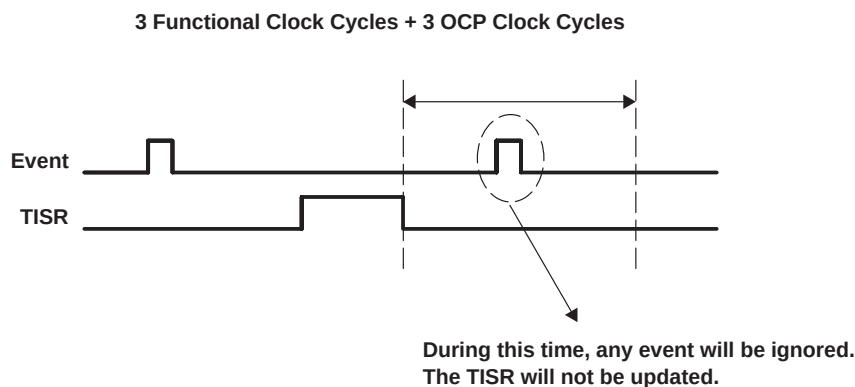
**Figure 17. DM Timer Event Ignored Window**

After the interrupt gets acknowledged by the TISR and after 3 functional clock cycles + 3 OCP clock cycles, any event of the same type other than the one initially processed, will be ignored, and the corresponding interrupt will be not generated (see Figure 17).

This problem does not occur if the event has a different type: it will be kept in the TISR.

**Workaround:** There is no workaround.
