dsPIC33CH128MP508 Family Silicon Errata and Data Sheet Clarification

The dsPIC33CH128MP508 family devices that you have received conform functionally to the current Device Data Sheet (DS70005319D), except for the anomalies described in this document.

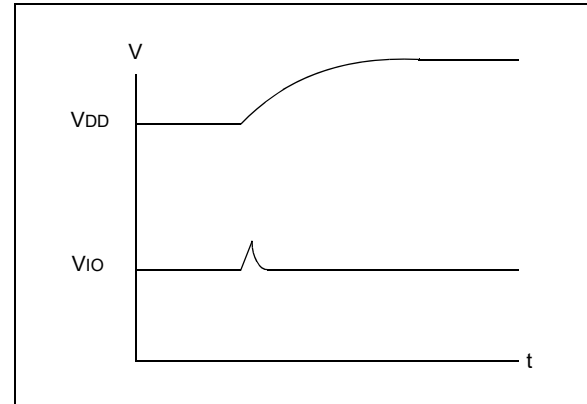
FIGURE 1: I/O RAMP

During a fast device power-up, when the V_{DD} ramp is less than 4 mS, the I/O pins may drive up to 100 μ A current for a duration of up to 10 μ S (Figure 1).

Example applications affected may include complementary power switches, where a transient current shoot-through might occur.

1. Slow down the V_{DD} ramp time (greater than 4 mS for V_{DD} to ramp 0V to 3.3V).
2. Ensure the circuitry that is connected to the pins can endure this pulse.

High-voltage applications with complementary switches should power the high-voltage 200 μ Sec later than powering the dsPIC[®] device to avoid the current shoot-through. This behavior is specific to each device and not affected by aging.
