## STM32L433xx/443xx device errata

This document applies to the part numbers of STM32L433xx/443xx devices and the device variants as stated in this page.

It gives a summary and a description of the device errata, with respect to the device datasheet and reference manual RM394.

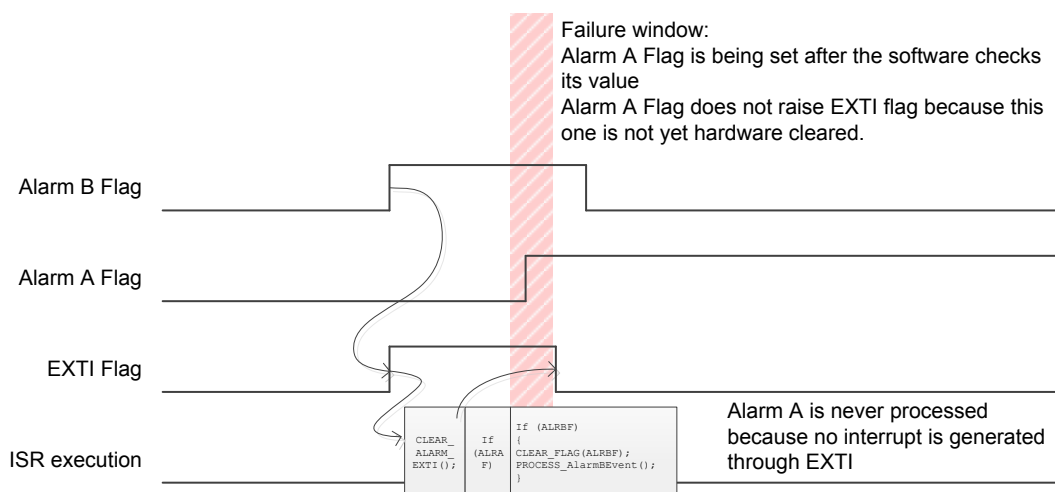
Figure 1. Masked RTC interrupt

The following code example and figure illustrate the failure mechanism: The Alarm A event is lost (fails to generate interrupt) as it occurs in the failure window, that is, after checking the Alarm A event flag but before the effective clear of the EXTI interrupt flag by hardware. The effective clear of the EXTI interrupt flag is delayed with respect to the software instruction to clear it.

In the interrupt service routine, apply three consecutive event flag checks - source one, source two, and source one again, as in the following code example:
