# ***TMS320F2833x, TMS320F2823x DSCs Silicon Errata Silicon Revisions A, 0***

## **1 Introduction**

This document describes the silicon updates to the functional specifications for the TMS320F2833x and TMS320F2823x digital signal controllers (DSCs).

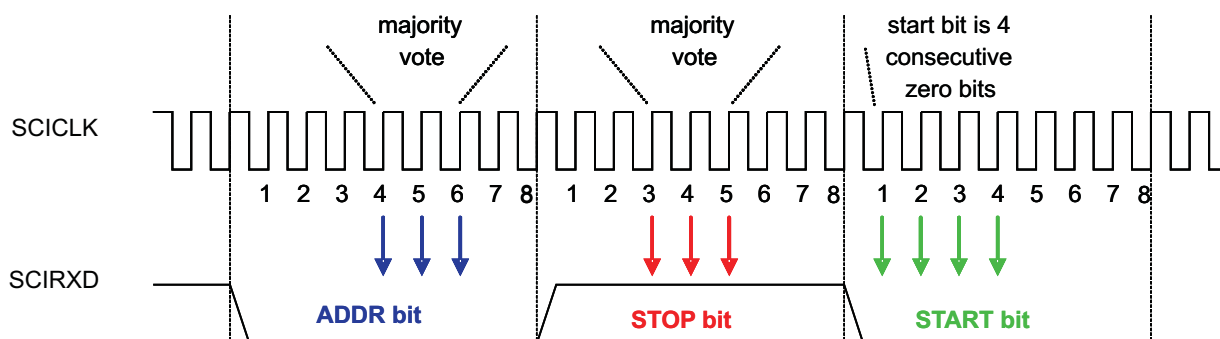
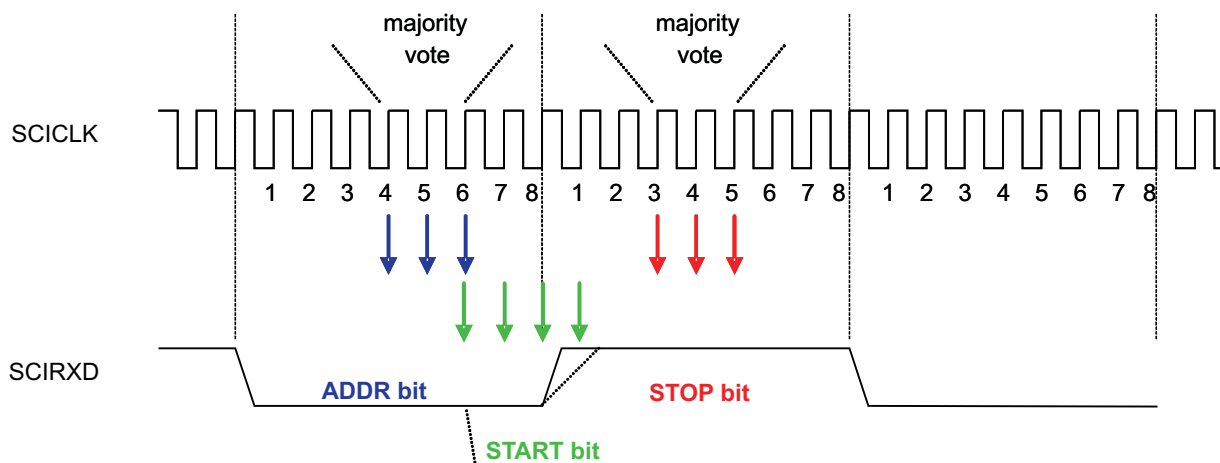
Figure 3. Difference Between Expected and Erroneous Operation of START Bit

SCI does not look for STOP bit after the ADDR bit. Instead, SCI starts looking for the start bit beginning on sub-sample 6 of the ADDR bit. Slow rise-time from ADDR to STOP bit can cause the false START bit to occur since the 4th sub-sample for the start bit may be sensed low.

Program the baud rate of the SCI to be slightly slower than the actual. This will cause the 4th sub-sample of the false START bit to be delayed in time, and therefore occur more towards the middle of the STOP bit (away from the signal transition region). The amount of baud slowing needed depends on the rise-time of the signal in the system. Alternatively, IDLE mode of the SCI module may be used, if applicable.

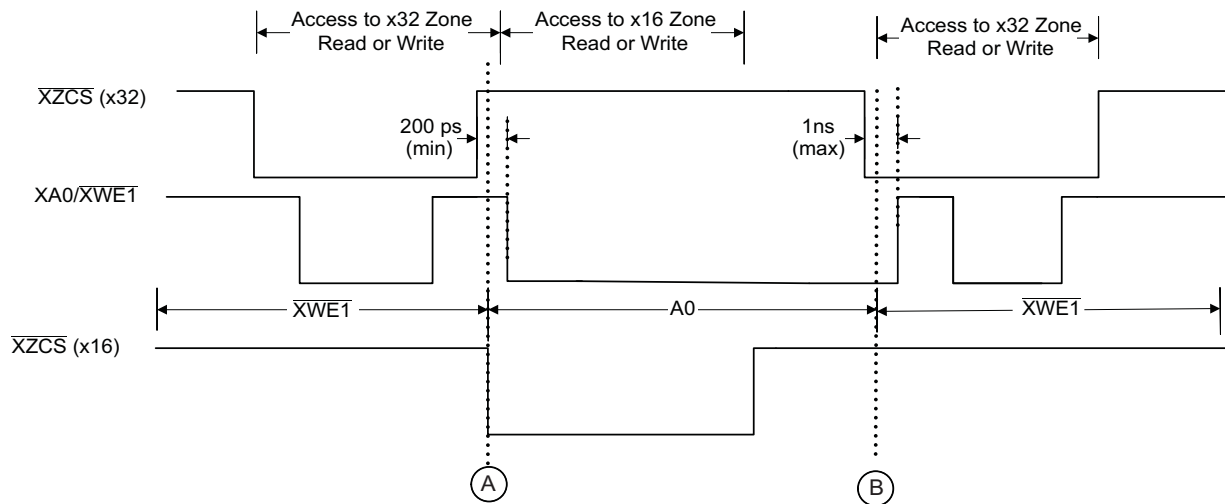
Figure 7 shows the behavior of zone chip select signals and  $\overline{XA0/XWE1}$  for back-to-back accesses between zones configured for different data bus widths.

For the x32-bit zone ( $XTIMINGx[XSIZE] = 1$ ) the  $\overline{A0/XWE1}$  signal is the write enable  $\overline{XWE1}$ . For the x16-bit zone ( $XTIMINGx[XSIZE] = 3$ ) the  $\overline{A0/XWE1}$  signal is address line  $\overline{A0}$ .

A Design simulation data indicates the delta between  $\overline{XZCS}$  (x32) high and  $\overline{XA0/XWE1}$  low can be as small as 200 ps.

B Design simulation data indicates  $\overline{XA0/XWE1}$  can stay low for as long as 1 ns after  $\overline{XZCS}$  (x32) goes low.

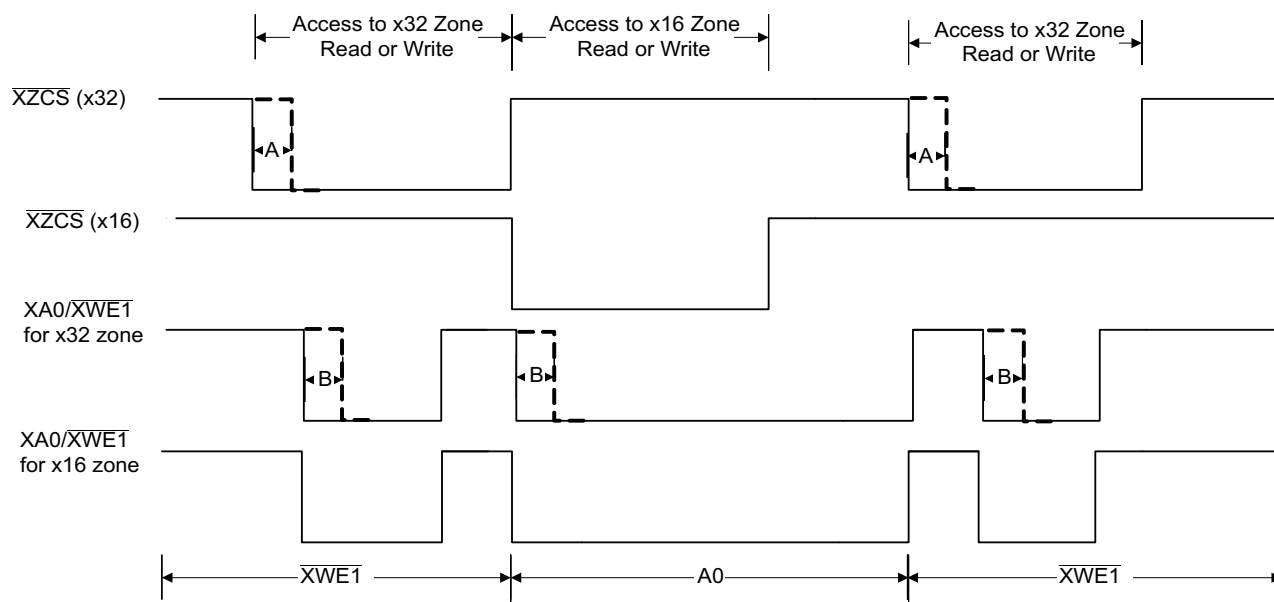
**Figure 8. Behavior After Application of Delay**

- A Delayed falling edge of zone chip select for x32 zone.
- B Delayed falling edge of  $\overline{\text{XWE1}}$ . The x16 zone will not see this delay.

5. Configure the GPIO MUX registers for XINTF operation.
3. Use external logic to delay the falling edge of the x32 zone chip select signal and the falling edge of the  $\overline{XWE1}$  signal as shown in Figure 8. With the delay the x32 zone chip select sees the  $\overline{XWE1}$  signal high at the critical points.

The timing configuration of the x32 zone must account for the additional delay. The zone chip select delay may require additional lead time. The  $\overline{\text{XWE1}}$  delay enable may require additional active write time. In addition, specify at least 1 trail cycle for writes to the x32 zone.
