## MSP430F5510 Device Erratasheet

The revision of the device can be identified by the revision letter on the [Package Markings](#) or by the [HW\\_ID](#) located inside the TLV structure of the device

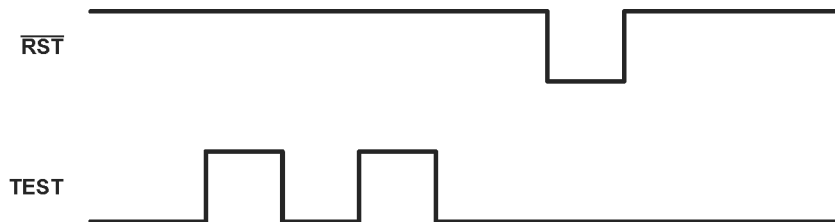
- Toggle the TEST pin twice when nRST is high and after 50us pull nRST low.

Note: This toggling of TEST pins is not subject to timing constraints. The appropriate level transitions on TEST pin, followed by a RST pulse after 50us, are sufficient to trigger an exit from BSL mode.
