dsPIC33EPXXGS202 Family Silicon Errata and Data Sheet Clarification

The dsPIC33EPXXGS202 family devices that you have received conform functionally to the current Device Data Sheet (DS70005208E), except for the anomalies described in this document.

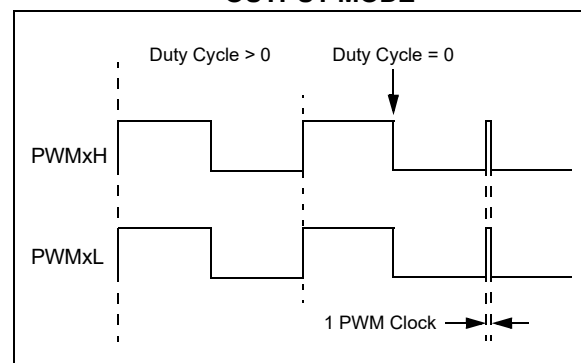
FIGURE 1: EXAMPLE FOR REDUNDANT OUTPUT MODE

In the Redundant Output mode (`IOCONx[11:10] = 0b01`) and Push-Pull Output mode (`IOCONx[11:10] = 0b10`), with the Immediate Update Enable bit disabled (`PWMCONx[0] = 0`), when the Duty Cycle register is updated from a non-zero value to zero, a glitch pulse of a width equal to one PWM clock will appear at the next PWM period boundary, as shown in Figure 1 (for the Redundant Output mode). The Duty Cycle register refers to the PDCx register if `PWMCONx[8] = 0` or the MDC register if `PWMCONx[8] = 1`.

If the application requires a zero duty cycle output, there are two possible work around methods:

1. Use the PWM override feature to override the PWM output to a low state instead of writing to the Duty Cycle register. In order to switch back to a non-zero duty cycle output, turn off the PWM override. The override-on and override-off events must be timed close to the PWM period boundary if the `IOCONx` register has been configured with `IOCONx[0] = 0` (i.e., output overrides through the `OVDDAT[1:0]` bits occur on the next CPU clock boundary).
2. Enable the Immediate Update Enable bit (`PWMCONx[0] = 1`) while configuring the PWMx module (i.e., before enabling the PWMx module, `PTCON[15] = 1`). With the Immediate Update enabled, writes to the Duty Cycle register can have an immediate effect on the PWM output. Therefore, the duty cycle write operations must be timed close to the PWM period boundary in order to avoid distortions in the PWM output.

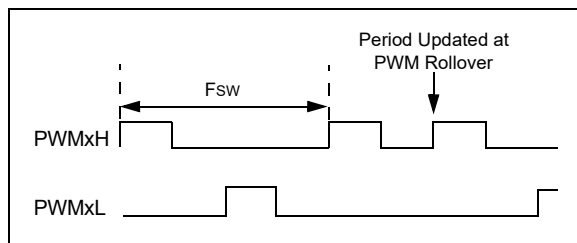
FIGURE 2:

When the PWM module is configured for Push-Pull mode ($IOCONx[11:10] = 0b10$) with the Enable Immediate Period Update bit enabled ($PTCON[10] = 1$), a write to the Period register that coincides with the period rollover event may cause the push-pull output logic to produce back-to-back pulses on the PWMx pins (Figure 2).

If the EIPU bit is set ($PTCON[10] = 1$), ensure that the update to the PWM Period register occurs away from the PWM rollover event. Use either the PWM Special Event Trigger ($SEVTCMP$) or the PWM Primary Trigger ($TRIGx$) to generate a PWM Interrupt Service Routine (ISR) near the start of the PWM cycle. The PWM Period register could be updated inside this ISR so that the period writes do not occur near the PWM period rollover event.

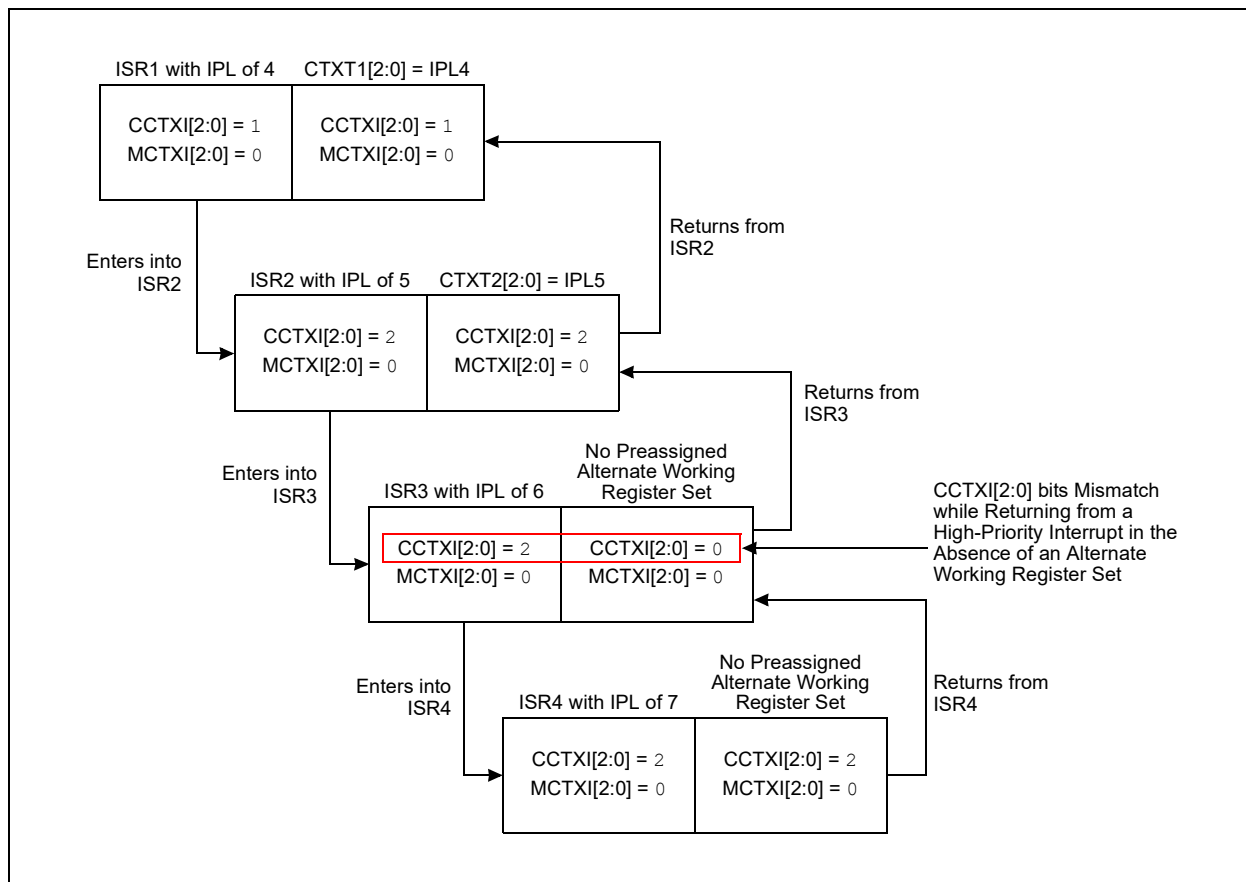
FIGURE 3: MISMATCH OF WORKING REGISTER SET WHEN NESTING MORE THAN ONE INTERRUPT WITHIN INTERRUPTS THAT USE ALTERNATE WORKING REGISTER SETS

When returning from an Interrupt Service Routine (ISR) by executing the `RETFIE` instruction, in the case of a nested interrupt, the Interrupt Priority bits (`IPC[3:0]`) associated with the lower priority interrupt are compared with the `CTXTn` bits field in the `FLTREG` Configuration register:

When using interrupts with the Alternate Working Register Set (automatic context assignment), no more than one ISR without an Alternate Working Register Set must be nested within an ISR with an Alternate Working Register Set.

Issue and work around are illustrated in [Figure 3](#) and [Figure 4](#), respectively. The figures show the status bits, `CCTXI[2:0]` and `MCTXI[2:0]`, after entering into an ISR from a lower priority ISR (left pane), and after returning to the same ISR from a higher priority ISR (right pane).

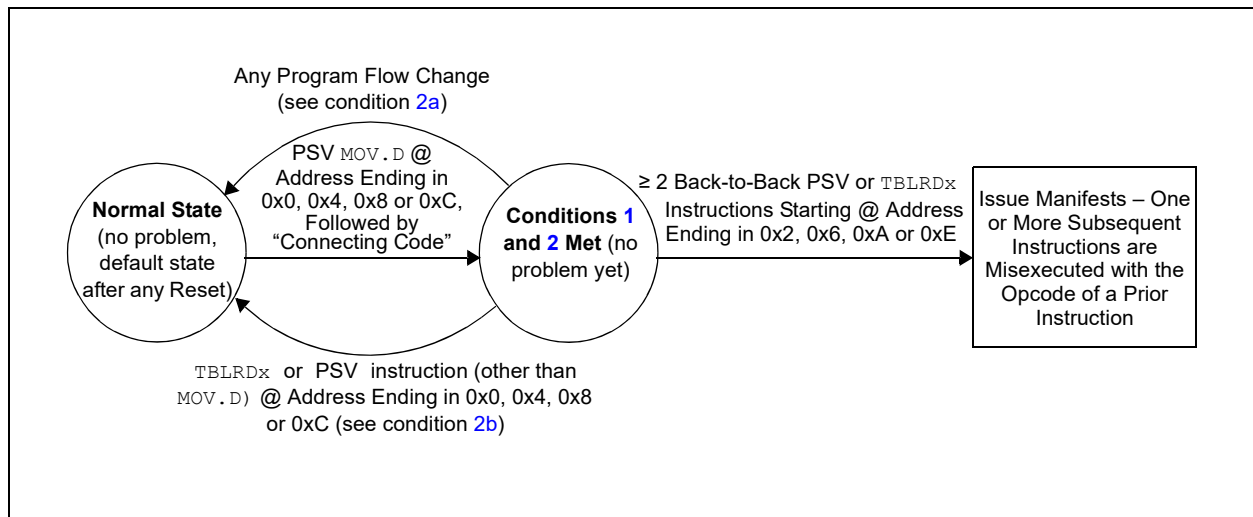
FIGURE 5: SIMPLIFIED BEHAVIOR

When two or more data Flash read instructions (via Program Space Visibility (PSV) read or table read) are executed back-to-back, one or more subsequent instructions can be misexecuted when all of the conditions in [Table 4](#) occur.

[Figure 5](#) provides an example of the effective behavior.

1. All instances of PSV MOV.D can be replaced with two PSV MOV instructions instead. Non-PSV MOV.D instructions acting on RAM/SFRs do not need to be modified; or
2. If not already present, a program flow change instruction (such as BRA \$+2) can be inserted above back-to-back data Flash read sequences; or
3. Back-to-back data Flash read instruction sequences can be broken up by inserting a non-Flash read instruction (such as a NOP), in between the Flash read instructions; or
4. The alignment of the code can be shifted to avoid the required opcode location addresses.

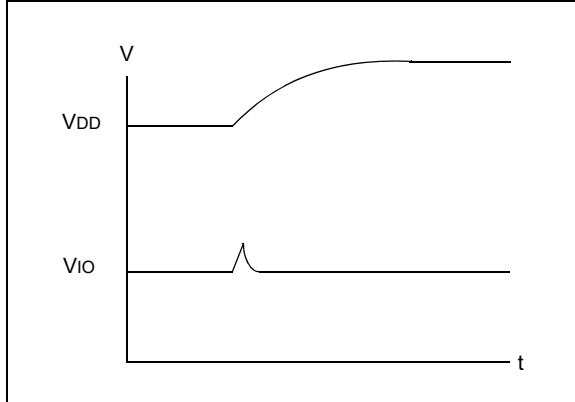
FIGURE 6: I/O RAMP

During device power-up, the I/O pins may drive up to 100 μ A current for a duration of up to 300 μ S. (Figure 6).

Ensure the circuitry that is connected to the pins can endure this pulse.
