# **TMS320C6455/54**

## **Digital Signal Processor**

### **Silicon Revisions 3.1, 2.1, 2.0, 1.1**

## **Silicon Errata**

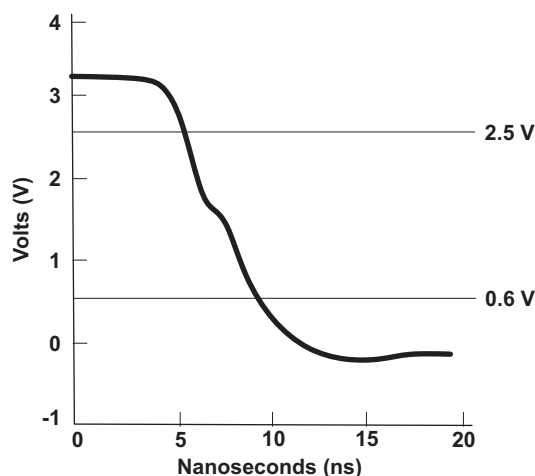
**Figure 3. Bad TCK Transition**

A TCK edge that can cause this problem might look similar to the one shown in [Figure 3](#). A TCK edge that does not cause the problem will look similar to the one shown in [Figure 4](#). The key difference between the two figures is that [Figure 4](#) has a clean and sharp transition whereas [Figure 3](#) has a "knee" in the transition zone. Problematic TCK signals may not have a knee that is as pronounced as the one in [Figure 3](#). Due to the TCK signal amplification inside the chip, any perturbation of the signal can create erroneous clock edges.

When examining a TCK signal for this issue, either in board simulation or on an actual board, it is very important to probe the TCK line as close to the DSP input pin as possible. In simulation, it should not be difficult to probe right at the DSP input. For most physical boards, this means using the via for the TCK pad on the back side of the board. Similarly, ground for the probe should come from one of the nearby ground pad vias to minimize EMI noise picked up by the probe.

As the problem may be caused by one or more of the above factors, one or more of the steps outlined below may be necessary to fix it:

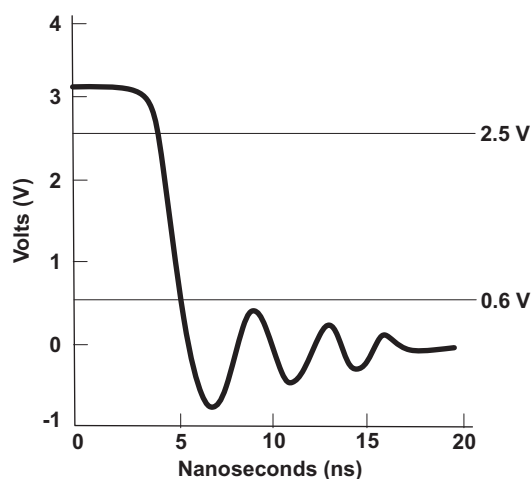
**Figure 4. Good TCK Transition**

As a result of the faster edge transition, there is increased ringing in [Figure 4](#). As long as the ringing does not cross logic input thresholds (0.6 V for falling edges, and 2.5 V for rising edges), this ringing is acceptable.

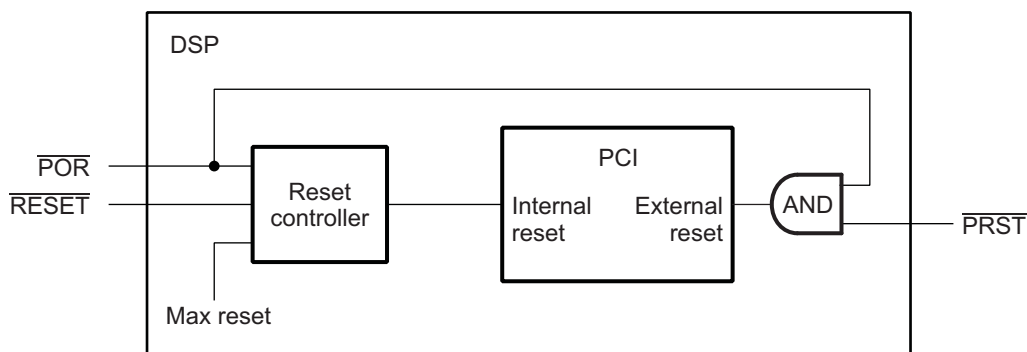
**Figure 5. Internal Reset Asserted By Reset Controller**

**Details:** The PCI module in the C6455/54 device has an internal and an external reset source. The internal reset is asserted by the reset controller during power-on, warm, and max reset, see [Figure 5](#). The internal reset is also asserted when the device state control registers are used to disable the PCI module. The external reset is asserted through the PCI reset pin,  $\overline{\text{PRST}}$ .

The PCI module can lock up or go into a bad state if its internal and external resets are asserted independently, meaning one is asserted and the other is not. Power-on and warm reset are controlled differently from system to system and, therefore, the effect of this issue is system specific.

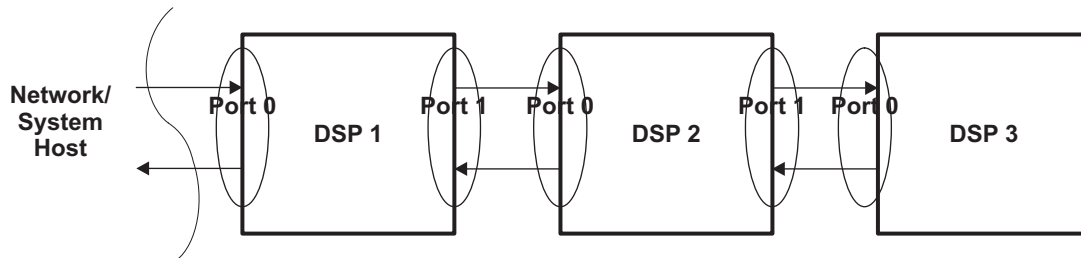
**Figure 9. Daisy-Chain Example**

The current SRIO design fails to correctly copy response packets with a payload greater than 16 bytes from the inbound to the outbound buffer. The first 16 bytes are correctly copied, but the remainder of the payload is discarded. This issue affects only NREAD response packets since their payloads can be up to 256 bytes. Packet types with small responses, such as NWRITE\_R, maintenance, message, and DOORBELL packets are not affected by this issue.

**Workaround 2:** Two options exist if NREAD response packets cannot be avoided; for example, when reading core dump information from an unresponsive processor which is unable to initiate traffic by itself. The first option is to use software to segment read requests into 16-byte NREADs. Note that this option will work functionally, but may take too much time.

The second option is illustrated in [Figure 9](#).

In this example, assume that DSP3 is down and the system host wants to do a large NREAD of DSP3 to examine the core dump. The issue discussed above prohibits the NREAD from completing correctly because, as the response packets from DSP3 are sent back, they are corrupted by DSP2 and DSP1 packet forwarding. Instead, the system host needs to request that the adjacent DSP (DSP2) generates the NREAD request to DSP3. The NREAD responses are sent to DSP2 and temporarily stored in memory. Then, DSP2 can generate NWRITE/NWRITE\_R/SWRITE packets to the system host with the needed payload. These packets are correctly forwarded by DSP1 to the system host since they are request packets and not responses.

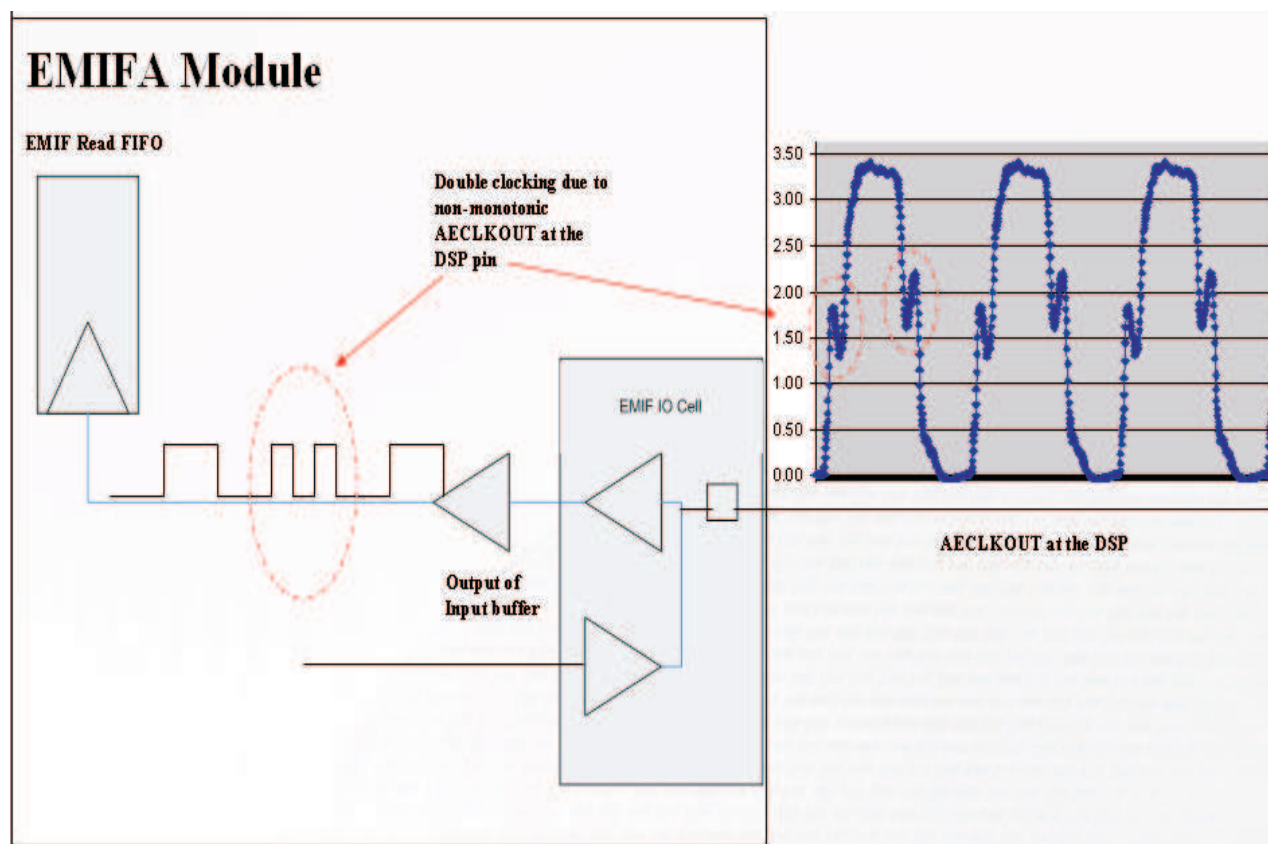
Figure 10. AECLKOUT at the DSP

- Minimize reflections at the DSP and external device.
- Over/undershoot within the device-specific data manual specification.
- The AECLKOUT is monotonic at the DSP and the external device between  $V_{IL}/V_{IH}$  for the rising/falling edge with respect to weak/strong buffers.

If the above conditions are not within specification — as defined in the *TMS320C6455 Fixed-Point Digital Signal Processor* data manual (literature number [SPRS276](#)) and the *TMS320C6454 Fixed-Point Digital Signal Processor* data manual (literature number [SPRS311](#)) — then read data corruption can occur. If the signal quality is not achievable with the proper termination, then external buffering may be required. This ensures that the AECLKOUT is monotonic at the DSP and at the external device between  $V_{IL}/V_{IH}$ . In all cases, techniques for high-speed digital design should be applied to the EMIFA interface. Since the AECLKOUT is looped back for read data latch, it is very important to terminate the AECLKOUT at the DSP to ensure clock signal integrity. There is an inherent "shelf" near the switch point at the driver, which causes the transition to be non-monotonic at the DSP. The impact of this issue depends on where the AECLKOUT is non-monotonic at the DSP. The AECLKOUT topology must ensure that the AECLKOUT signal at the DSP and the load is monotonic between  $V_{IL}/V_{IH}$ .

The workaround provides details on how to select the correct series termination values at the driver and loads to minimize reflections and over/undershoot. The workaround must also ensure that the AECLKOUT signal is always monotonic between  $V_{IL}/V_{IH}$  at the driver and the loads for weak and strong conditions.

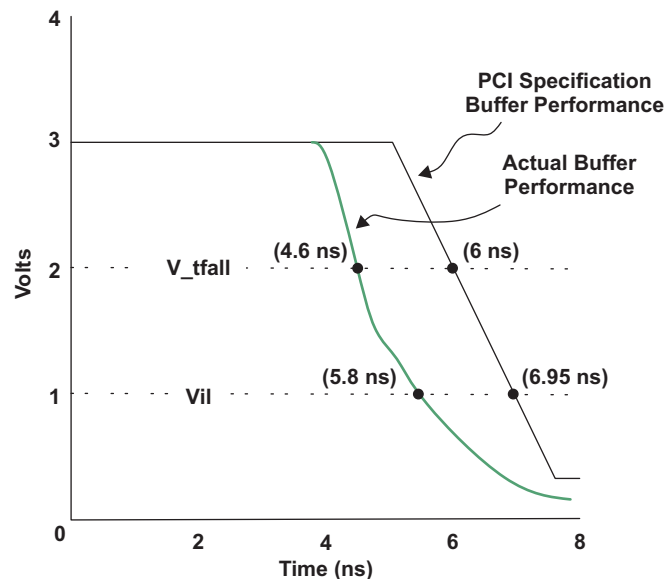
**Figure 11. 66-MHz Buffer Slew and Timing Performance vs Specification Performance**

[Table 12](#) shows the system timing budget for 66-MHz PCI with values from the specification and values in a system where the device is driving with reduced slew rate.

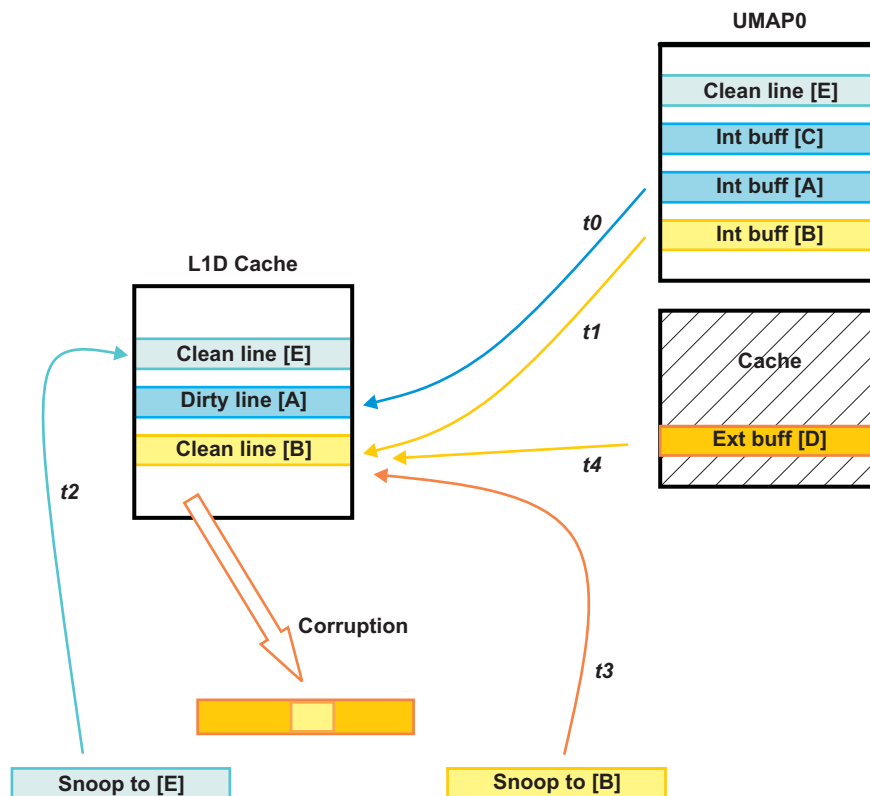
**Figure 13. Sequence of Events**

1. Cache Line D now holds data that was corrupted by the operation in Step C above (as a result of Step 2 above).
  - A subsequent read of this data returns a corrupted value.
  - Subsequent writes to this cache line also cause the corrupted values to be committed to lower levels of memory.

Figure 13 shows the sequence of events.
