# **AM571x (SR 2.0, 1.0) and AM570x (SR 2.0) Sitara™ Processors**

## **Silicon Errata**

Literature Number: SPRZ436C  
October 2015–Revised February 2017

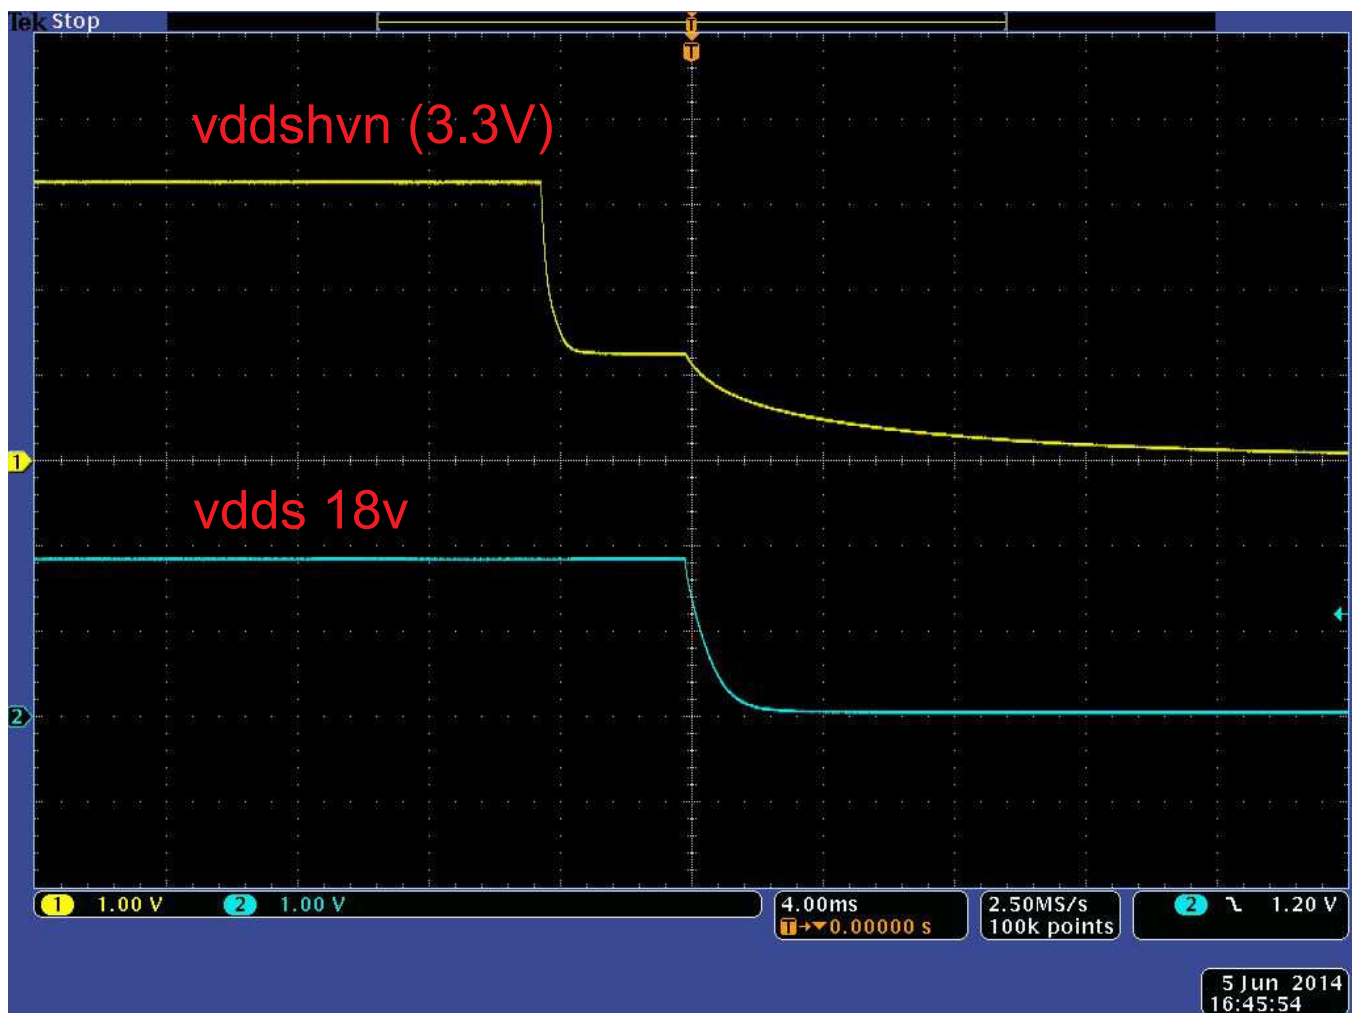
**Figure 4-1. PAB\_RevA**

A subset of the SOC's LVC MOS IOs (refer to DM for details) have a pull-up resistor that is active by default, including during reset and power-down. The SOC's IOs that have internal or external pull-ups will stay at Plateau Level (<1.5V) during the power-down. If other ICs on the board that are interfaced to the SOC's LVC MOS signals use a separate supply then it's possible that the other IC's signals can be pulled to the Plateau Level while its power supply is off.

The root cause of the plateau is related to the LVC MOS IO buffer Dual Voltage detection circuitry. The LVC MOS Dual Voltage IO includes voltage comparator circuitry to determine if the IO is in 3.3V mode or 1.8V mode. During powerdown of vddshvn domains, a current path in the internal bias transistors results in the vddshvn rail being held to an intermediate voltage level (<1.5 V). This path can consume at most 500 uA per IO - worst case estimate is ~150 mA (based on 280 IOs) from the vdds18v supply

during power down. This path is not a reliability concern for the device.

In general, TI recommends using the same supply source for connected components. E.g., a single LDO should drive vddshvn and the related 3.3V external components.
