**TMS320C6712, TMS320C6712C, TMS320C6712D**  
**Digital Signal Processors**  
**Silicon Errata**

**C6712 Silicon Revisions 1.0, 1.2, 1.3**

**C6712C Silicon Revision 1.1**

**C6712D Silicon Revision 2.0**

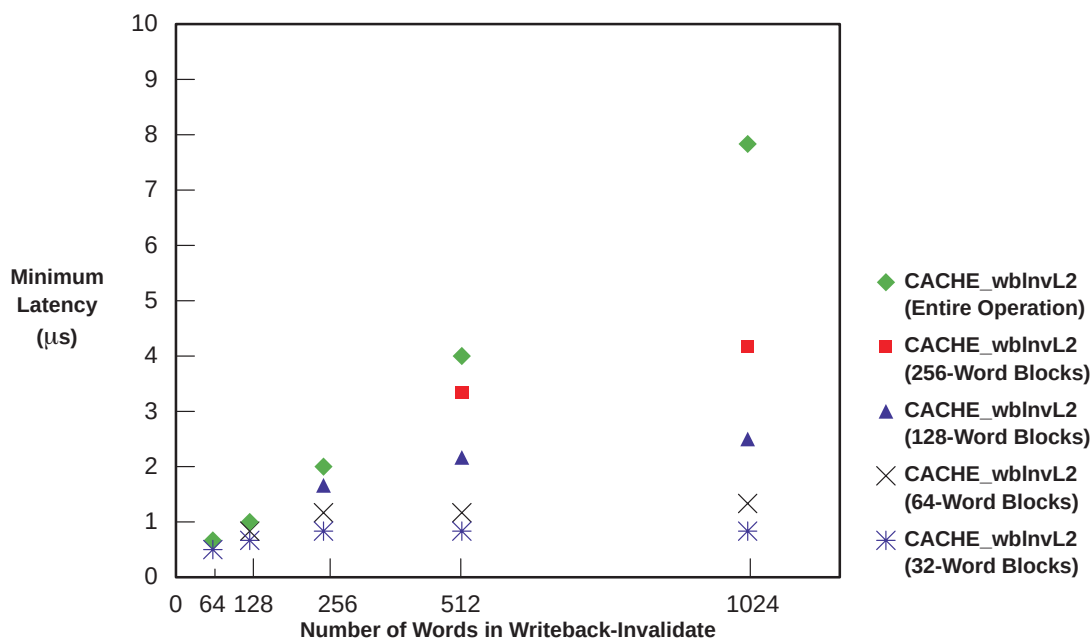
**Figure 2. Minimum Required Latency Between McBSP Events for a Successful Transfer with Concurrent L2 Writeback-Invalidates at 200-MHz CPU and 50-MHz EMIF, Using Entire Operations and Block Breakdown**

If the EMIF frequency is more than half of the CPU frequency, the device is able to service the L2 writeback requests faster than the requests can be issued, leaving some EMIF bandwidth available to service other EDMA requests, so the block-out problem is less noticeable. Therefore, breaking down cache operations into smaller blocks is more critical when the EMIF frequency is less than half of the CPU frequency. Figure 2 shows the minimum required latency between McBSP transfers to EMIF at 200-MHz CPU and 50-MHz EMIF when breaking down the cache operations. These McBSP transfers were performed with concurrent cache operations to EMIF, creating a block-out scenario. With the 1024-word cache writeback-invalidate operation broken into 32-word blocks, the McBSP is able to perform almost 10 times faster. The performance improvement is similar when breaking down the writeback-only operation.

For example, if the CPU is running at 200 MHz with a 50-MHz EMIF and you have a McBSP hard real-time deadline of 5  $\mu$ s, Figure 2 shows that a 1024-word L2 writeback-invalidate may cause data loss since back-to-back McBSP events can only be serviced at  $\sim 8 \mu$ s. By breaking down the L2 writeback-invalidate into 256-word blocks, you can then meet the 5- $\mu$ s McBSP deadline. In other words, when performing a 1024-word L2 writeback-invalidate operation with the CPU and EMIF conditions cited above, the McBSP events can be serviced in  $\sim 8 \mu$ s for the entire operation (one whole block), in  $\sim 4 \mu$ s when breaking it into 256-word blocks, in  $\sim 2.5 \mu$ s when breaking it into 128-word blocks, etc.

To avoid cache operations blocking other time-sensitive EDMA accesses, observe the following guidelines:

1. Avoid placing real-time data in EMIF address range. Instead, real-time data should be placed in the L2 address range.
2. If data must be placed in the EMIF address range:
  - Avoid global cache operations in favor of block-based cache operations.
  - Block-based cache operations should be submitted in small blocks, such that the total amount of time that the EMIF is blocked is less than the amount of time between serial samples.

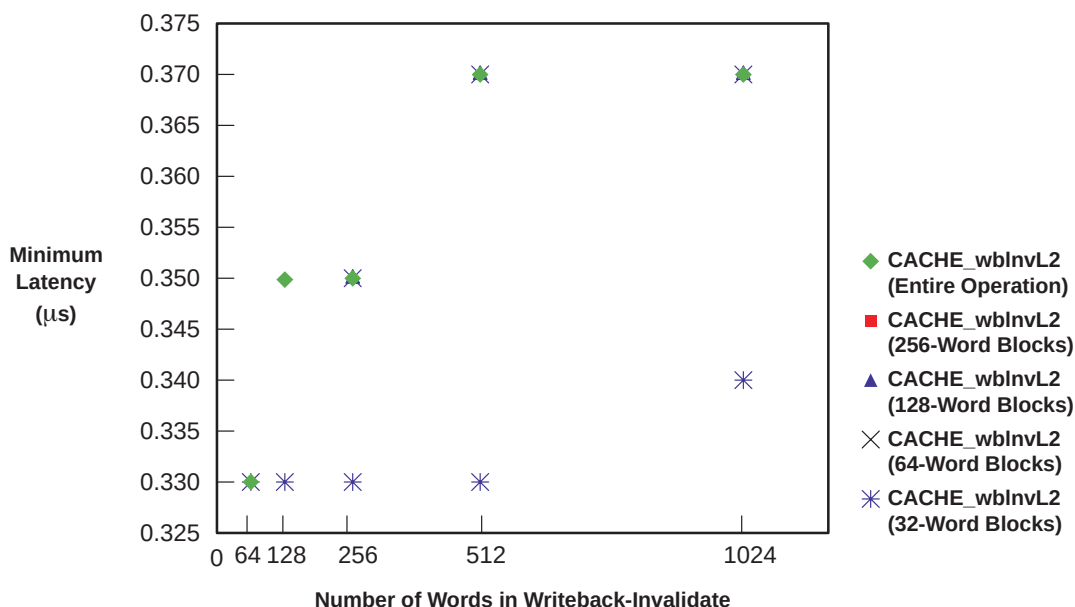
**Figure 4. Minimum Required Latency Between McBSP Events for a Successful Transfer With Concurrent Writeback-Invalidates at 150-MHz CPU and 100-MHz EMIF, Using Entire Operations and Block Breakdown**

When the CPU is set to 150 MHz and the EMIF is set to 100 MHz, there is virtually no benefit from breaking down the coherency cache operations. Figure 4 shows the McBSP's performance with this frequency ratio.

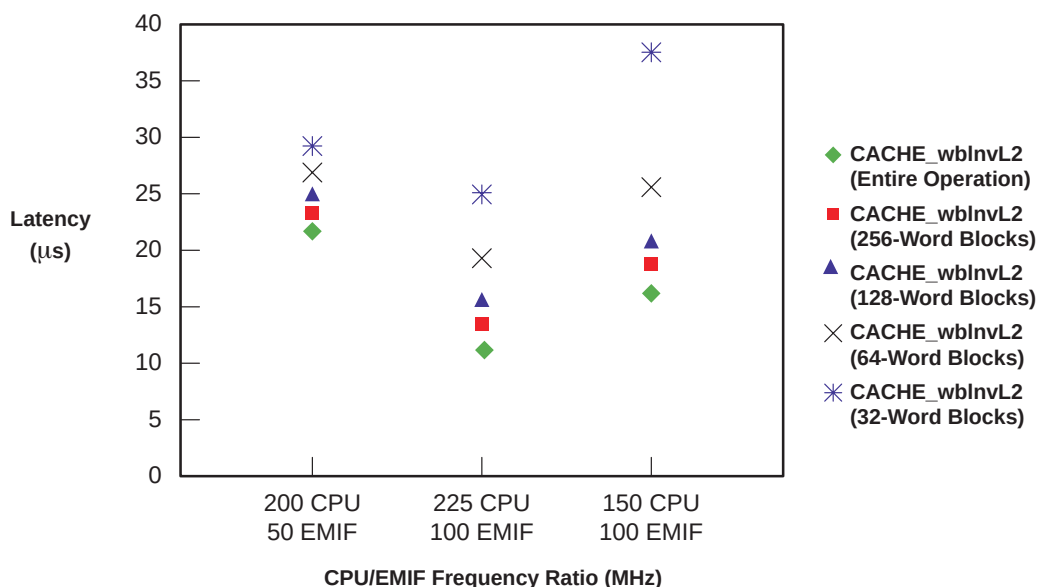
**Figure 5. 1024-Word L2 Writeback-Invalidate Performance at Various Frequency Ratios With Old and New CACHE\_wbInvL2()**

Breaking down the cache operations into smaller blocks takes longer to complete than performing the entire cache function as one large block. Figure 5 shows how much extra overhead is incurred by breaking down an L2 writeback-invalidate operation to transfer 1024 words with different sized blocks and at various frequency ratios. Notice that for the 200-MHz CPU and the 50-MHz EMIF frequency ratio, where the new functions are most critical for peripherals such as the McBSP, the least overhead is incurred.

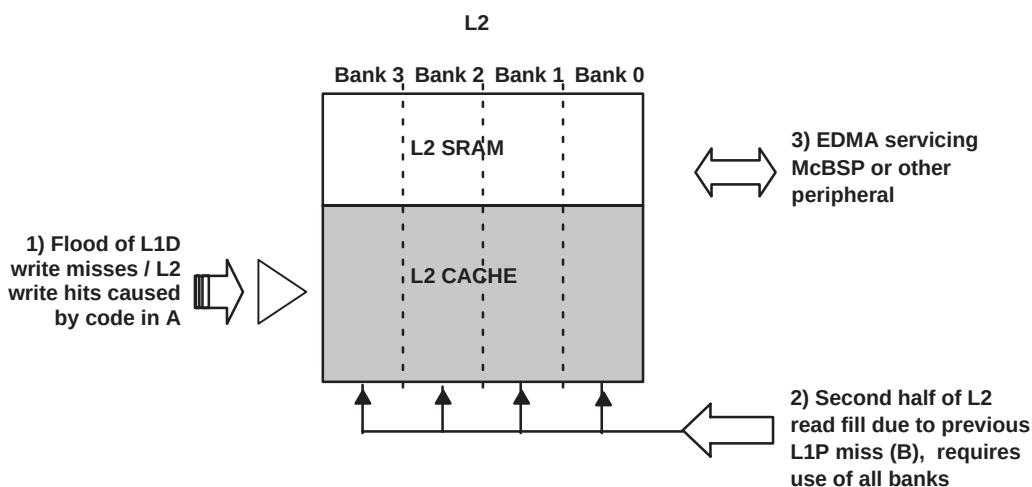
**Figure 10. Problem Scenario**

In this scenario, the next CPU fetch packet does not reside in either L1P or L2 cache; therefore, it causes an L1P and L2 miss. An L2 cache line (128 bytes, 4 fetch packets) must be fetched from external memory. The fetch from external memory is split into two requests (two halves) of 64 bytes, or two fetch packets each. In this document, the two halves are labeled A and B, respectively, as shown in Figure 10. The first half (A) to arrive in L2 is the half in which the missed fetch packet resides. This first half is immediately forwarded to L1P so that CPU can resume execution before the second half (B) is fetched from external memory. The second half of the L2 line (B) is to be fetched and written to L2 later.

The lockout condition occurs only when the second half (B) of the L2 cache line fill starts. When the B is ready, it attempts to write to L2. It will be unable to do so, however, because the line fill operation accesses all four banks of L2 whereas one bank is always busy servicing the higher priority L1D misses from the code in A. Thus, the line fill (B) cannot complete until the flood of writes from A has stopped. The line fill stays at the head of queue in the EDMA controller, so any other EDMA transfers that access L2 will also be blocked until the flood of stores has stopped *and* the L2 line fill (B) has completed.

The amount of time that an EDMA transfer is locked out of L2 is determined by the code running on the DSP (A), and ultimately by the amount of time that L1D write misses are happening in succession. When all of the conditions are met, the second half of the L2 line fill and the EDMA will be locked out of L2 as long as the flood of stores is sustained.

- Avoid the flood of L1D write misses. Pre-read all data locations prior to writing them. This will allocate them in L1D, preventing the L1D write misses from occurring. Recall that L1D read misses do not cause problems.
- Make sure that any algorithm or code segment that naturally produces a long string of writes inserts gaps in the write sequence such that writes occur at a frequency slower than 1 write miss every other cycle. The term "long" is based on the system requirements. Gaps in the L1D write misses means that the second half of the L2 read fill is given a chance to access L2.

- Run the algorithm or code segment that contains A from internal SRAM. There will not be L2 code read fill (A or B) coming into L2. The simulator can be used to detect such code segment. See the C6x1x Simulator section below for details.
- Ensure the problematic segment of algorithm or code is in cache. This can be accomplished by issuing any CPU read/load instruction from the beginning of the problematic code segment in external memory, that will cause both L1D and L2 miss. Assuming the code segment is not yet in L1/L2 cache, Performing CPU load instruction generates an L1D request, and CPU stalls until the code missed and data is returned from L2. After the load instruction, code segment will reside in the L2 cache, and an L2 read fill due to L1P miss will not occur.
