### Applicability

This document applies to the part numbers of STM32F030x4/x6/x8/xC devices listed in [Table 1](#) and their variants shown in [Table 2](#).

[Section 1](#) gives a summary and [Section 2](#) a description of device limitations and documentation errata, with respect to the device datasheet and reference manual RM0360.

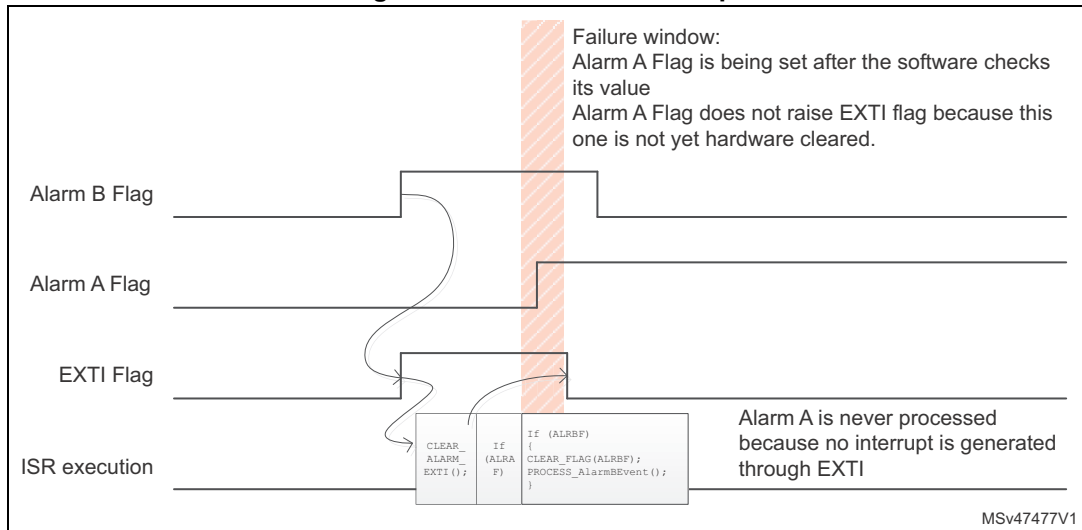
Figure 1. Masked RTC interrupt

One RTC interrupt can mask another RTC interrupt if both share the same EXTI configurable line, such as the RTC Alarm A and Alarm B, of which the event flags are OR-ed to the same EXTI line (refer to the **EXTI line connections** table in the **Extended interrupt and event controller (EXTI)** section of the reference manual).

The following code example and figure illustrate the failure mechanism: The Alarm A event is lost (fails to generate interrupt) as it occurs in the failure window, that is, after checking the Alarm A event flag but before the effective clear of the EXTI interrupt flag by hardware. The effective clear of the EXTI interrupt flag is delayed with respect to the software instruction to clear it.

In the interrupt service routine, apply three consecutive event flag checks - source one, source two, and source one again, as in the following code example:

```
void RTC_Alarm_IRQHandler(void)
{
    CLEAR_ALARM_EXTI(); /* Clear the EXTI's line Flag for RTC Alarm */
    If(ALRAF) /* Check if AlarmA triggered ISR */
    {
        CLEAR_FLAG(ALRAF); /* Clear the AlarmA interrupt pending bit */
        PROCESS_AlarmAEvent(); /* Process AlarmA Event */
    }
    If(ALRBF) /* Check if AlarmB triggered ISR */
    {
        CLEAR_FLAG(ALRBF); /* Clear the AlarmB interrupt pending bit */
        PROCESS_AlarmBEvent(); /* Process AlarmB Event */
    }
    If(ALRAF) /* Check if AlarmA triggered ISR */
    {
        CLEAR_FLAG(ALRAF); /* Clear the AlarmA interrupt pending bit */
        PROCESS_AlarmAEvent(); /* Process AlarmA Event */
    }
}
```
