AM1806 ARM Microprocessor Silicon Revisions 2.3, 2.1 and 2.0

Silicon Errata

Literature Number: SPRZ314H
March 2010–Revised September 2014

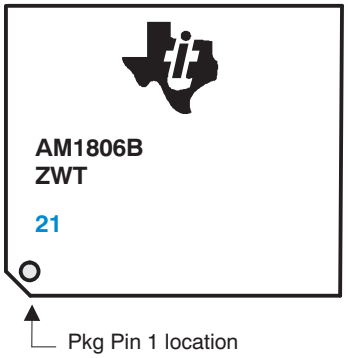
Figure 1. Device Markings

DEVICE REVISION CODE (xx)	SILICON REVISION	COMMENTS
E	2.3	-
B	2.1	Silicon Revision 2.1 can be differentiated from Revision 2.0 by a top side '21' marking on the package. See Figure 1 for details. Additionally the ROM ID code of may be used to distinguish Revision 2.1 from Revision 2.0
B	2.0	-

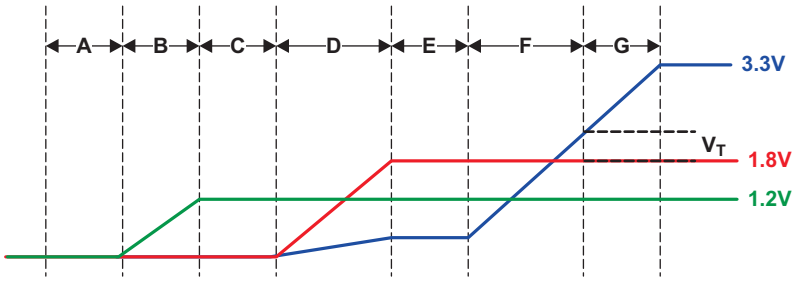
Figure 3. Normal power-supply ramp

- A. All device supplies are undriven
- B. The 1.2V supplies are ramped to their nominal levels
- C. Potential delay between supply ramps (not required)
- D. The 1.8V supplies (specifically DVDD18) are ramped to their nominal levels. During the DVDD18 ramp there will be some minor drift up in the undriven DVDD3318_x supplies. This is normal and is not a problem.
- E. Potential delay between supply ramps (not required)
- F. DVDD3318_x is ramping but is less than DVDD18 + V_T
- G. DVDD3318_x is ramping but is greater than DVDD18 + V_T

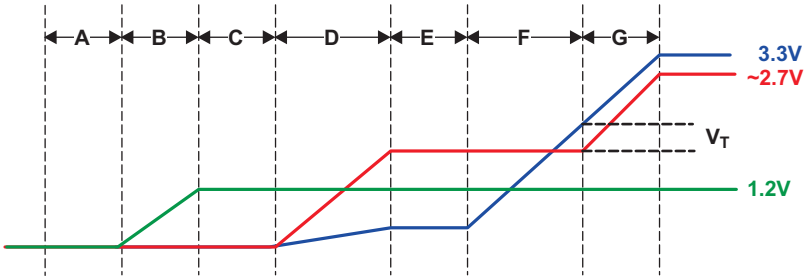
Figure 4. Faulty power-supply ramp

The behavior is the same until zone G. When the DVDD3318_x supply exceeds DVDD18 by a transistor V_T, the DVDD18 supply begins to be pulled up by the DVDD3318_x supply and follows the DVDD3318_x supply by DVDD3318_x- V_T. Since the DVDD18 supply is often connected to other 1.8V supplies in the design, these other supplies can be pulled up also.

1. Design simulation has indicated that under the worst-case process/voltage/temperature conditions the maximum leakage current into the DVDD18 supply due to this phenomenon will be 140 mA (the 140 mA is a cumulative current generated by all of the dual-voltage IOs). So this error state can be prevented by ensuring that the load on the DVDD18 supply during the DVDD13318_x supply ramp exceeds 140 mA. This can be achieved by any combination of the following as long as they cumulatively produce >140 mA load on DVDD18 during the DVDD3318_x ramp period:

(a) Maintain sufficient bulk capacitance on the DVDD18 supply such that the charging current for these capacitors provides all or part of the required >140 mA. Bulk capacitance in this context means the total capacitance seen by the DVDD18 supply (filter capacitors, bypass capacitors, etc.). Capacitor charging current is defined as I = C*(dV/dt). So the ramp rate of the DVDD3318_x supply and the total bulk capacitance on the DVDD18 supply can be used to calculate the current produced. This solution provides additional power supply filtering and little current leakage after the supplies are ramped (depending on the type of capacitors used).

2. Choose a regulator for the DVDD18 supply (or grouped 1.8V supplies) that is capable of actively regulating voltage up and down. Many high-efficiency switching regulators switch current into the load only when the voltage needs to be raised and rely on the load to pulldown the current. In this error condition, a regulator of this type will not be able to compensate for the leakage current described above. Synchronous buck regulators use external inductance to pulldown the regulated voltage when necessary.

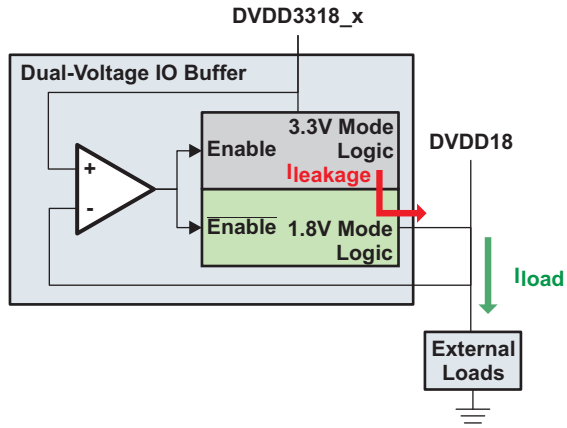
Figure 5. Behavior of the IO buffer during Zone F

As the DVDD3318_x supply ramps, but is not yet one V_T above the DVDD18 supply, the comparator enables the 1.8V mode logic section and disables the 3.3V mode logic section. No unexpected current flows between the two sections.

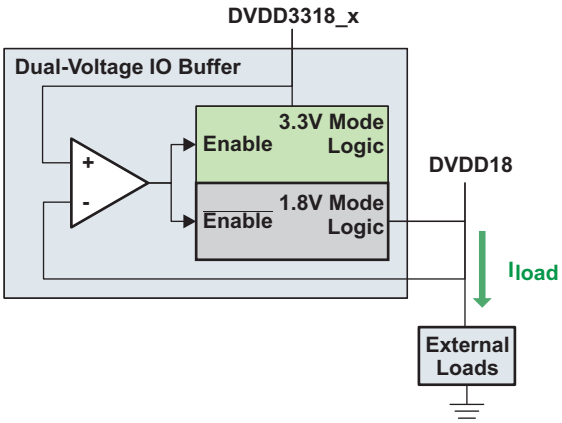
Figure 6. Error State of the IO buffer during Zone G

As DVDD3318_x exceeds DVDD18+V_T, some of the circuitry across the boundary of the two voltage domains will turn on and causes a leakage current (in red) to flow between the two voltage domains. This current pulls up the DVDD18 supply unless the power source providing that supply can oppose it or unless the load current is strong enough to counteract it.

If DVDD18 continues to rise as DVDD3318_x ramps, the comparator never sees enough difference between the two supplies to switch to 3.3V mode.

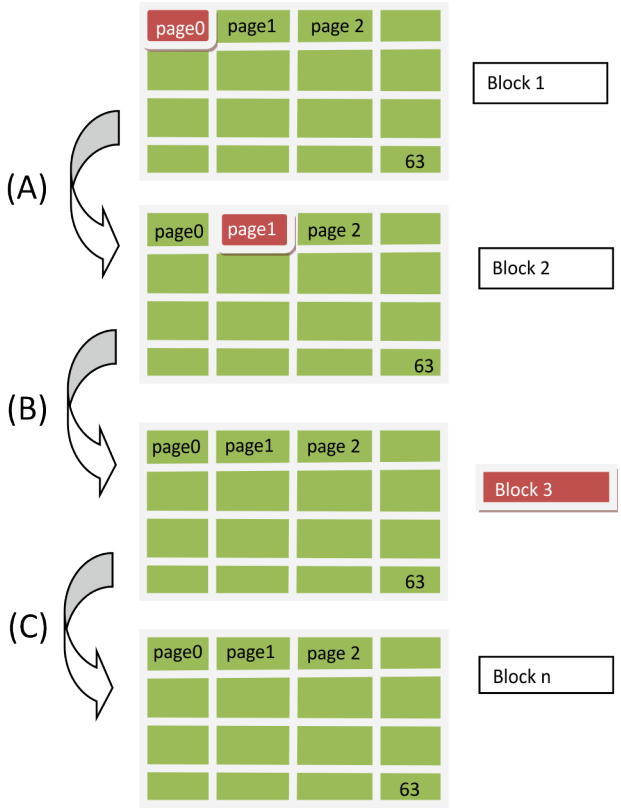
D800K008 ROM Behavior Before Application of Software Patch(1)

If page0 of the good block has an ECC data error or an uncorrectable error (more than 4 bit errors combined), the RBL skips to the next block (shown as (B) in D800K008 ROM Behavior Before Application of Software Patch(1)). This bad block check mechanism enables the device to check up to the first 32 blocks in the NAND flash for booting (the boot process will fail if all 32 blocks have uncorrectable or ECC data errors in page0). Note that the RBL does not abort on detecting an error in ECC data on page0.

The workaround ignores errors in ECC data (these errors do not need to be corrected) so that the boot process can continue, correcting errors in the user data (up to 4 bit errors total), as necessary. The workaround also includes a mechanism to restart the NAND read process from the next good block if an uncorrectable error (more than 4 bit errors) is detected on any page of a good block.

This workaround is implemented using a software patch that is loaded in device RAM at boot time and is designed to change the default behavior of the ECC Correct and Read functions in the RBL. The patch binary replaces function pointers to the ECC Correct and Read functions in the ROM function table, (defined in device internal memory), during boot. The patch binary will reside in page0 of the NAND block and so will be applied only after the page0 of a good block has been read.

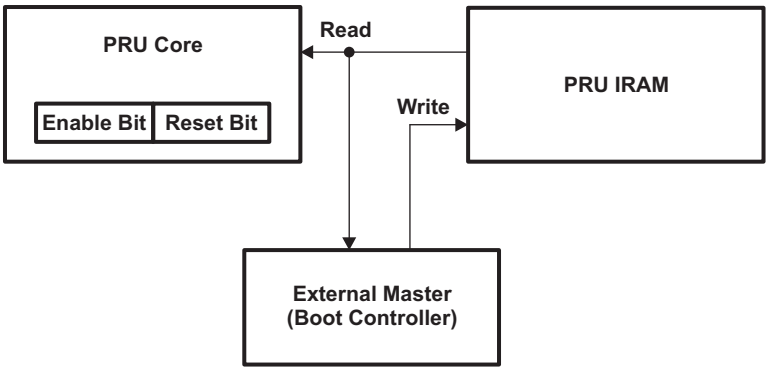
Figure 8. PRU and Boot Controller Block Diagram

The PRU instructions are located inside of an instruction RAM (IRAM) which is initialized by the Boot Controller (see Figure 8). After the instructions are stored to IRAM, the PRU is reset and enabled to execute its instructions. In this case, the PRU is instructed to initialize the ARM reset vector table.

When the device is first powered-on, the read bus from the PRU IRAM is not initialized and will contain random values (see Figure 9). Under unpredictable circumstances, the random value on the read bus may resemble a reserved instruction which can be interpreted by the PRU when the core is reset and not enabled.

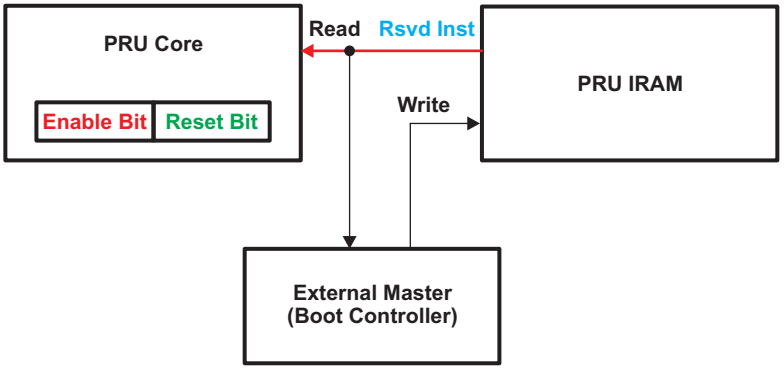
Figure 9. Boot Failure on Power-On

If the PRU core executes this reserved instruction, it will not be able to properly execute the first functional op-code in the PRU IRAM when the core is later enabled. In this fail state, the PRU will never acknowledge to the Boot Controller that the reset vector table was successfully initialized and the Boot Controller will be stuck in a polling loop waiting for the PRU to complete its task.

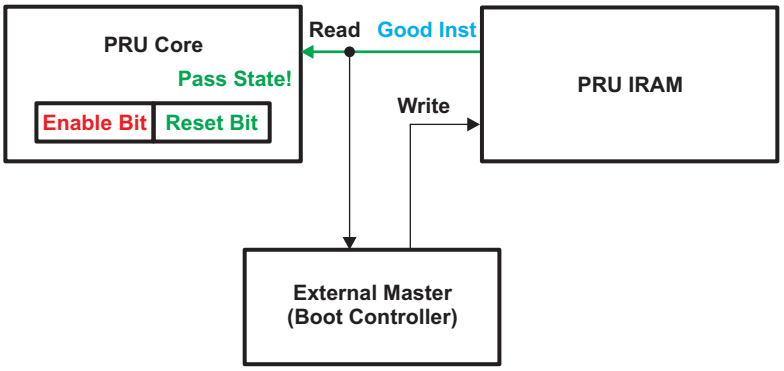
Figure 10. Secondary Reset

Although the PRU core execution is stuck, the PRU IRAM read bus is now initialized with a non-reserved instruction that was fetched from the IRAM by the PRU core (see Figure 10). If a secondary reset is provided to the device (either POR or WARM), the PRU will be able to execute its functional instructions as expected.

Note that in order to recover from this fail state with a secondary reset, the Boot Controller must be allowed to execute up to the point where the PRU has fetched a known instruction from the PRU IRAM. The approximate count of 15k clock cycles is sufficient.

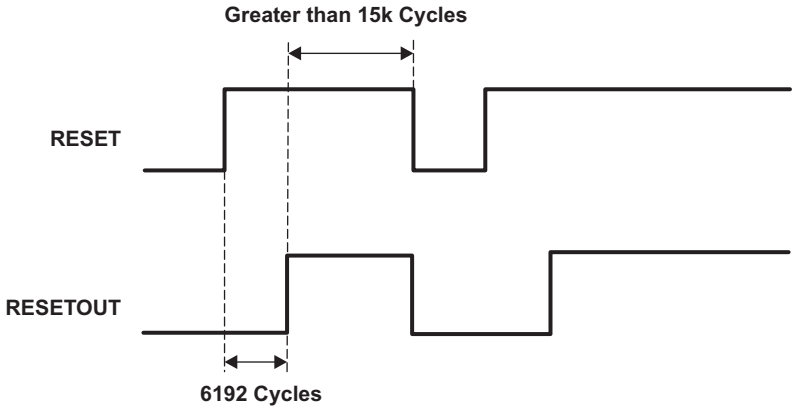
Figure 11. First POR Reset Timing

The 15k clock cycle count does not include the 6192 clock cycles required to complete a device POR reset (see Figure 11). With a 24MHz crystal, the first RESET signal must be asserted high for at least 883us (or approximately 1ms).

Modify the target board so that the affected device is given a secondary reset on power-up as shown in Figure 11. Two example methods are described in the sections that follow.

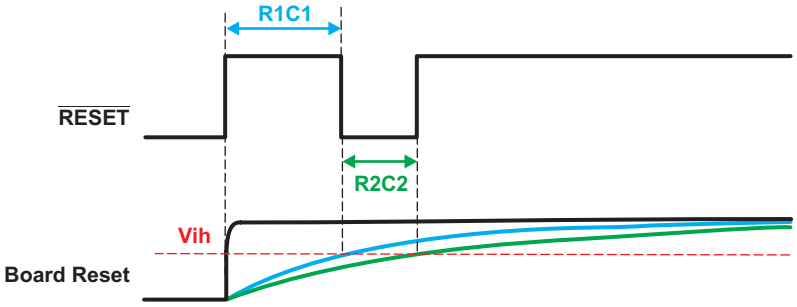
Figure 14. RESET Signal vs Board Reset

This is possible because each RC load connected to the board reset control signal can output a different rising-edge waveform. With increasing RC load, the resulting control signal will reach the Schmitt buffers' Vih level at a later point in time. Figure 14 shows the relationship between the board reset signal and the RESET signal produced by the circuit. The blue and green lines represent the voltage as seen by the Schmitt buffers. The output voltage of a charging RC circuit is defined as: Vo = Vi * (1 - e^[-t / RC])

Given ideal conditions, a 3.3V board reset signal, and an input buffer Vih of 1.4V, the following set of component values would generate an initial RESET high period (R1C1 region) of approximately 2ms and a RESET low period (R2C2 region) of approximately 0.5ms:
