DMVA3/4 DaVinci™ Digital Media Processor Silicon Revisions 1.1, 1.0

Silicon Errata

Literature Number: SPRZ406A
October 2013–Revised December 2013

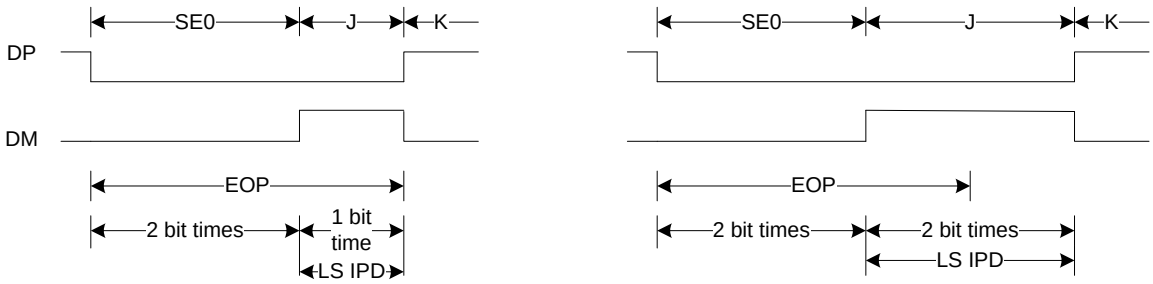
Details: The issue appears when connecting a specific USB Low Speed (LS) mouse to the processor's USB port which is in Host mode. In this scenario the Host sends an IN token to the mouse (Device) which sends the data back to the Host. The Host acknowledges the reception of the data with an ACK having an inter-packet delay (IPD) of 1. The mouse does not see the ACK (because it came too soon); therefore, it does not know that the Host has received the data. The Host sends a second IN token to the Device, expecting a second Data packet, but it receives the first Data packet instead. This is because the Device re-sent the first Data packet. Now the Host and Device are out of sync.

The problem is due to the length of the IPD between the Receiver-to-Transmitter (Rx-to-Tx) transactions. The Host IPD between Rx-to-Tx transactions for LS transactions should range from 2 to 6.5 LS bit times. It has been verified that the controller's LS IPD for Rx-to-Tx is only 1. This is shown in the following figure.

IPDs are measured from the SE0-to-J transition at the end of EOP to the J-to-K transition that starts the next packet.

IPD=1 and does NOT meet the IPD minimum standard
